## **Technical Bulletin**

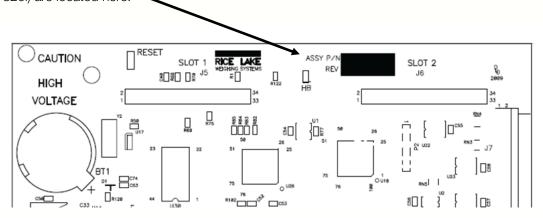
First, the hardware revision of the CPU board must be determined. The part number and revision for the 920i (similar for 720i & 820i) are located here:

Once the hardware revision of the CPU has been determined, then the firmware versions can be determined as shown below.
