January 13, 2010

Product: Ishida OMNi-4000 Automatic Wrapper

Issue: Power Related Error Messages

Cause: Low or Intermittent Power

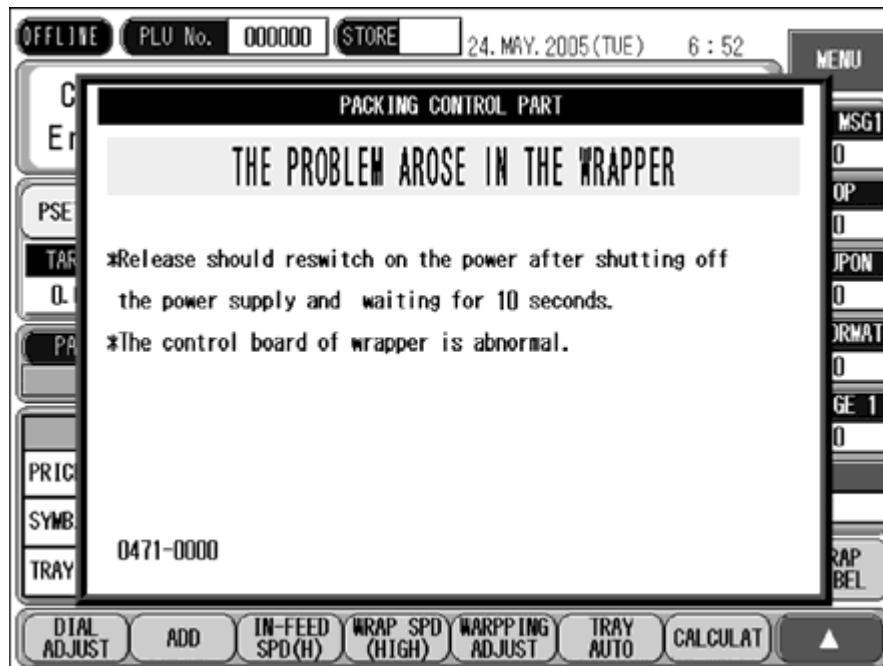
When the power supplied to an OMNi-4000 wrapper is chronically low or prone to drops the error code 0471-0000 "The Problem Arose in the Wrapper" may occur (see Fig 1.). Specifically, this error occurs when the output of the OMNi-4000's main 3-phase transformer falls below 180 volts.

Figure 1. Low Power Error Screen 0471-0000.

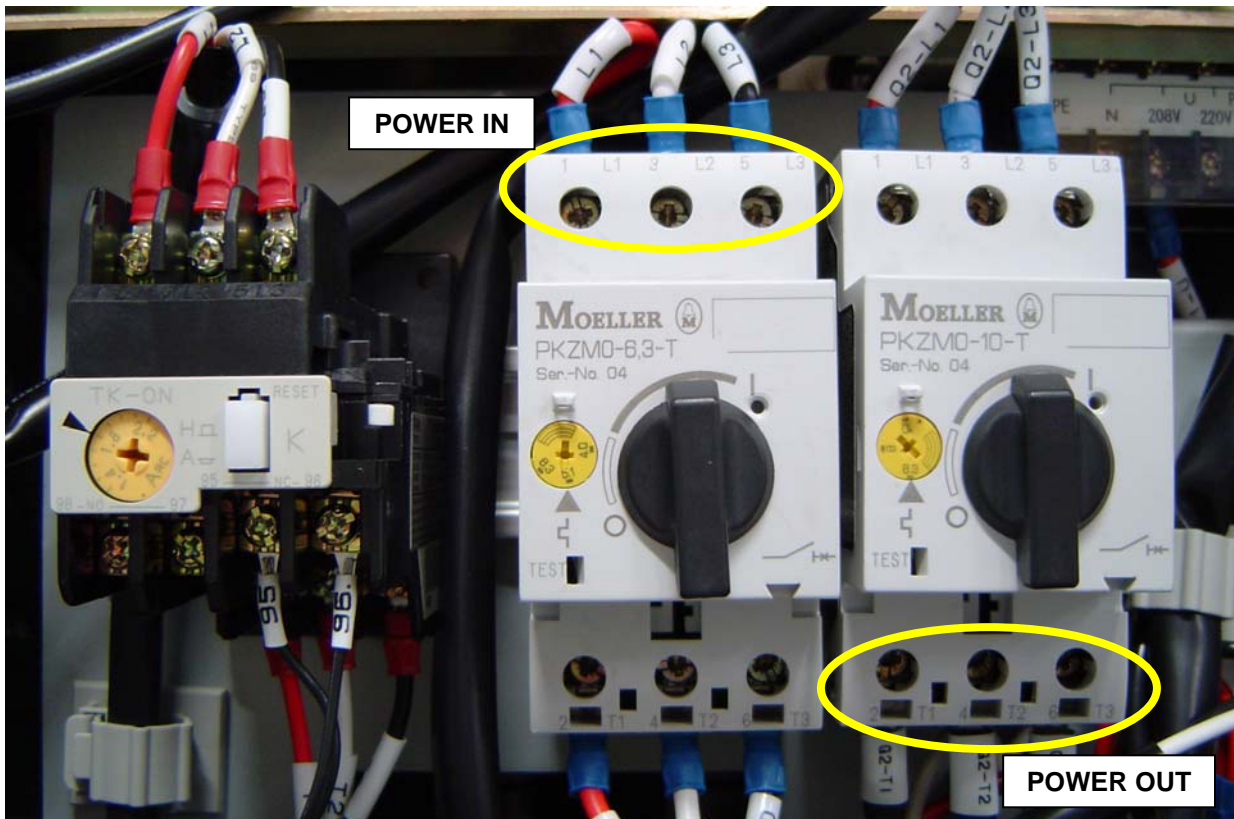
Figure 2. Test Points: Power In and Power Out of Main Transformer

After removing the rear, center panel take power measurements at the following points (see Fig. 2).

**Input Power:** Three terminals (L1, L2, L3) at the top of the 6.3A circuit breaker (PKZM0-6.3-T)

**Output Power:** Three terminals (T1, T2, T3) at the bottom of the 10A circuit breaker (PKZM0-10-T)

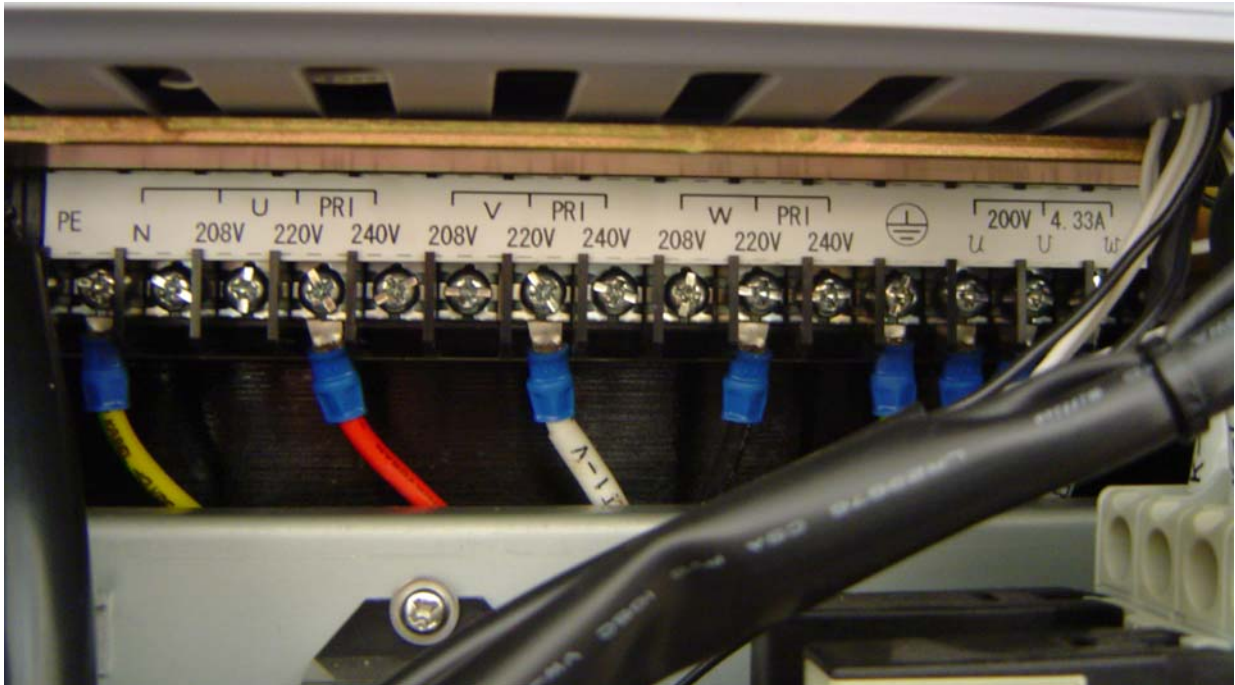
Figure 3. Main Transformer 3-Phase Input Taps Marked as "PRI"

The allowable transformer power output is  $200 \pm 10$  volts, i.e. 190 ~ 210 volts. The desired output is 205 ~ 210 volts. The higher voltage reduces the likelihood that power drops will reach the 180 volt error threshold.

Set the three transformer inputs to the lowest setting (208, 220, 240) that generates the target output (see Fig. 3). Each line is marked as “U”, “V”, and “W”. Be sure to set all three inputs on the same voltage tap. Unmatched taps will damage the wrapper.

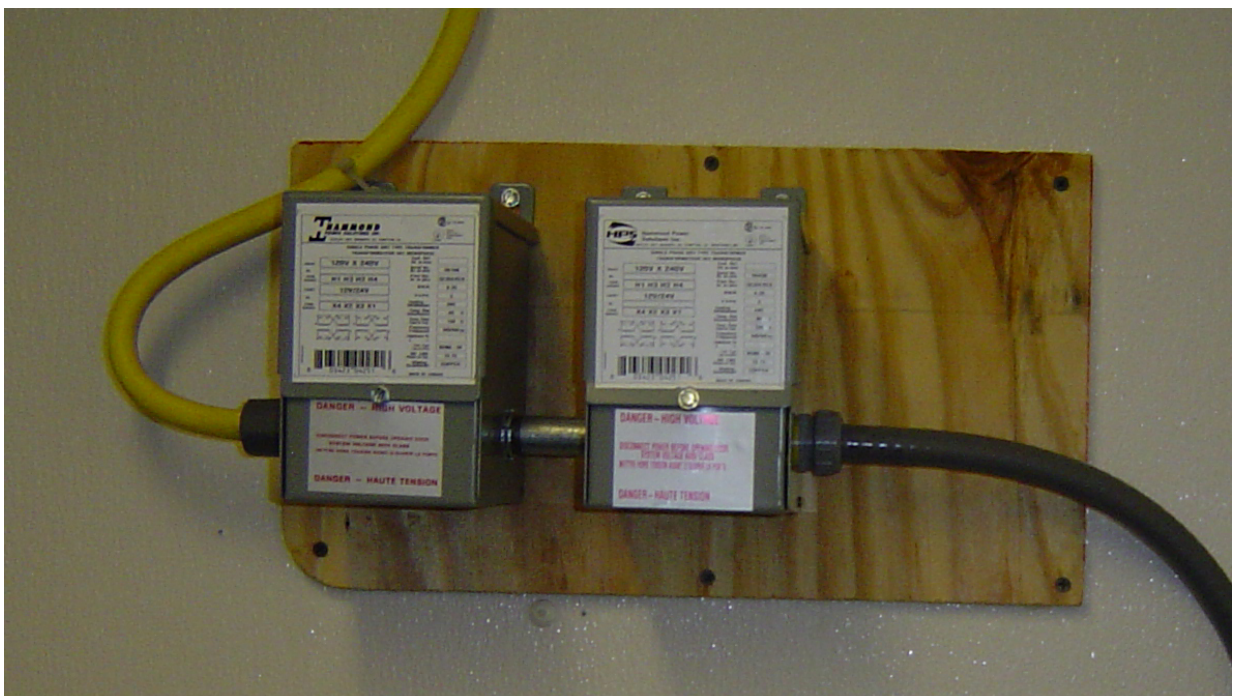
Figure 4. Two Buck-Boost Transformers for 3-Phase Delta Configuration

If the available 3-phase power is low or power 0471-0000 occurs frequently, the installation of Buck-Boost transformers is one method to increase power. Depending on the Electric Utility company in the area power may be supplied in either Delta or Wye configuration. Always consult a licensed electrician to determine the configuration and perform the wiring. The Delta or Wye configuration will determine if two or three Buck-Boost transformers are needed and their specifications. See Fig. 4, 5, 6, and 7.

**Delta:** Two transformers, 0.35kVA, ex. Hammond Power Solutions model QC35ERCB

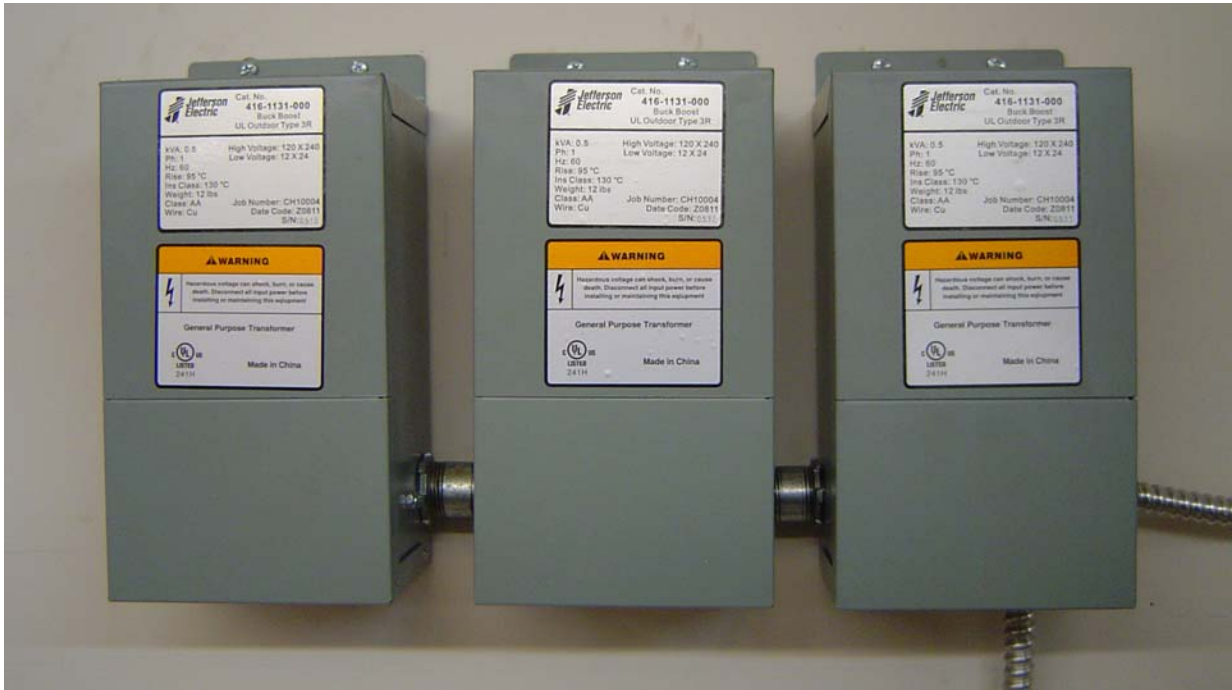
Figure 5. Three Buck-Boost Transformers for 3-Phase Wye Configuration

**Wye:** Three transformers, 0.20kVA, ex. Hammond Power Solutions model QC20ERCB

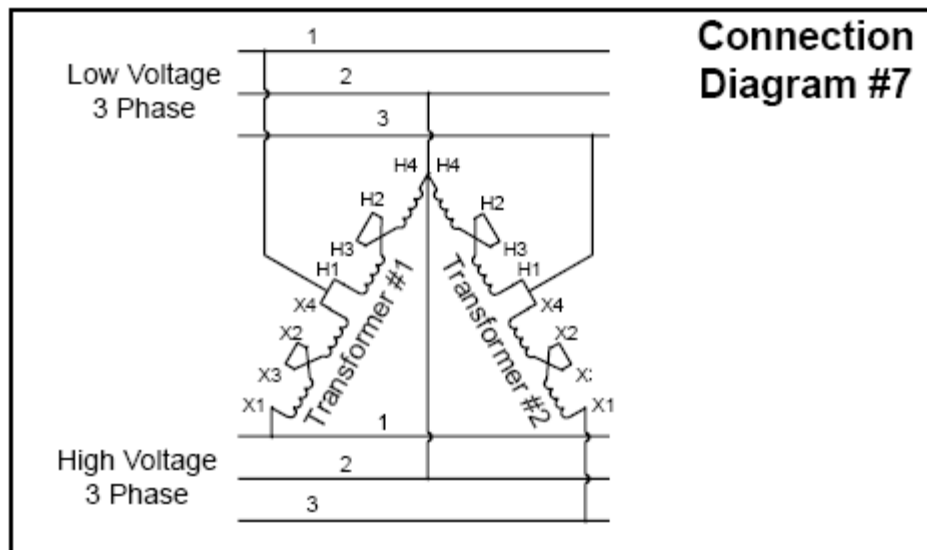
Figure 6. Typical Wiring for Two Buck-Boost Transformers for 3-Phase Delta Configuration\*

\* Always consult a licensed Electrician to perform the Buck-Boost transformer wiring.

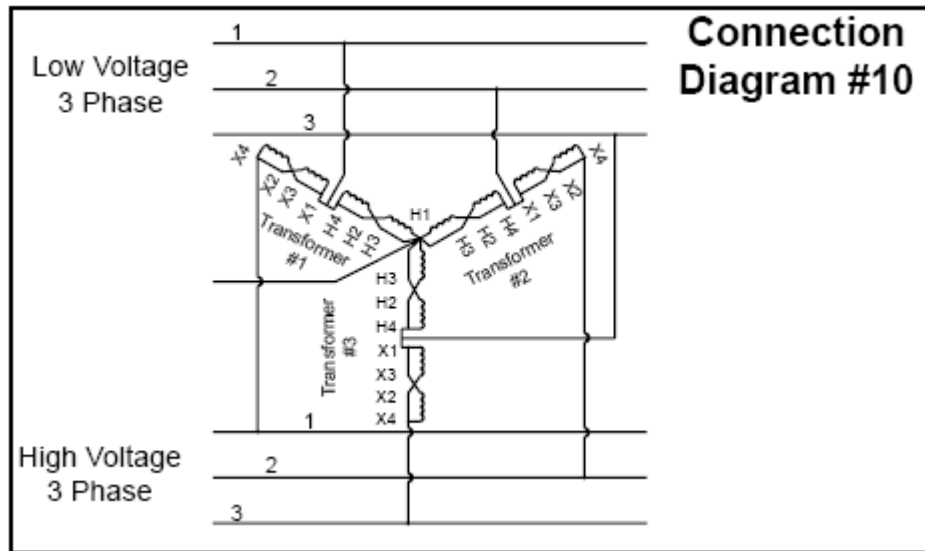
Figure 7. Typical Wiring for Three Buck-Boost Transformers for 3-Phase Wye Configuration\*

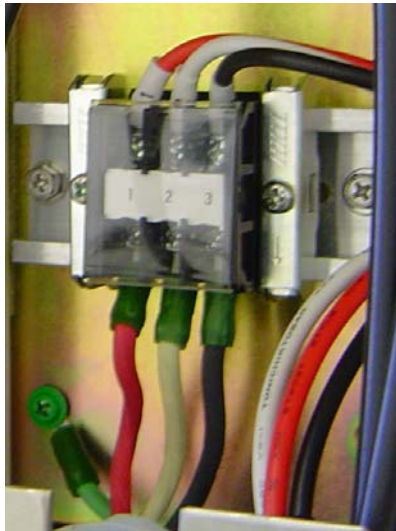
Figure 8. Incoming 3-Phase Power Connections

On a related topic, if the OMNi-4000 experiences random resetting (reboot), check if one of the 3-phase power lines is a high (wild) leg. Measure each line to ground to determine the relative voltages. If present, connect the high leg to the white wire at the incoming power terminal located at the rear of the wrapper (see Fig. 8). The white wire is the only 3-phase line connection not supplying power to the main CPU Control Unit.
