**September 9, 2019**

Product: Ishida Uni-7 and Uni-9H Scales and WM-Nano Wrapper

Issue: Peel Sensor Changes and Uni-7 PK-260B CPU Board

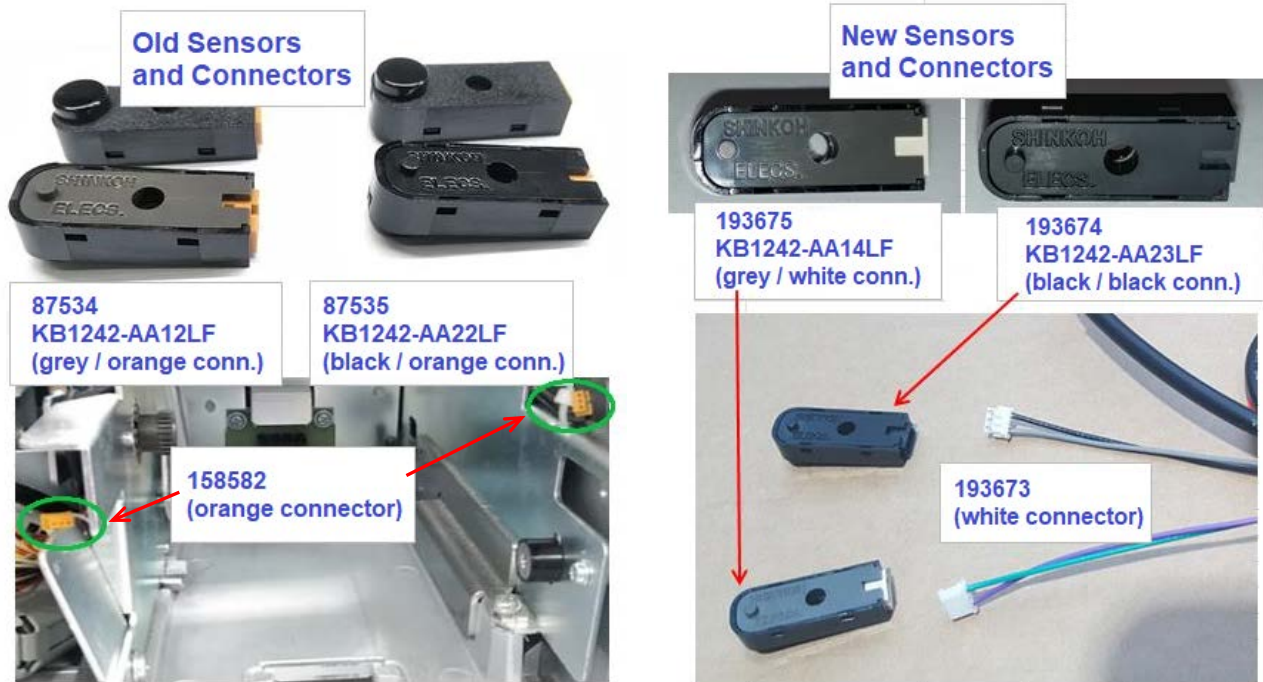
Dwg. No.	Old Part No. and Specification	Description	New Part No. and Specification
33	158582 (orange connector)	Peel sensor harness C4*	193673 (white connector)
34	87535 KB1242-AA22LF (black / orange conn.)	Peel sensor, receiver (right)	193674 KB1242-AA23LF (black / black conn.)
35	87534 KB1242-AA12LF (grey / orange conn.)	Peel sensor, transmitter (left)	193675 KB1242-AA14LF (grey / white conn.)

\* The Uni-9H peel sensor harness C5 (p/n 194852) is compatible with both old-style and new-style sensors.

Beginning with production in January 2016 (serial number 100237828), the peel sensors and harness were changed. The old and new sensors and harness are not compatible.

The old-style sensors are still in stock at Rice Lake as of August 2019. But when they are no longer available the old-style sensors and harness must be replaced with the new-style.

The peel sensors should always be recalibrated and checked after replacement. The peel sensor adjustment procedure remains the same.

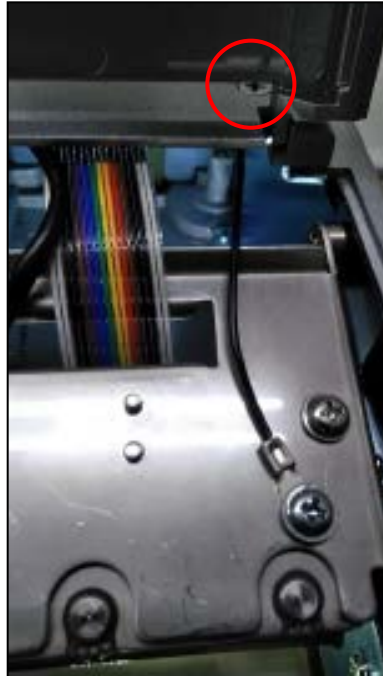
3. Slide the other end of the ground wire under the top cover and secure at the front screw.
4. Reinstall the second screw removed from the top cover.
5. Confirm the print head alignment by printing test labels. Adjust the alignment as needed.

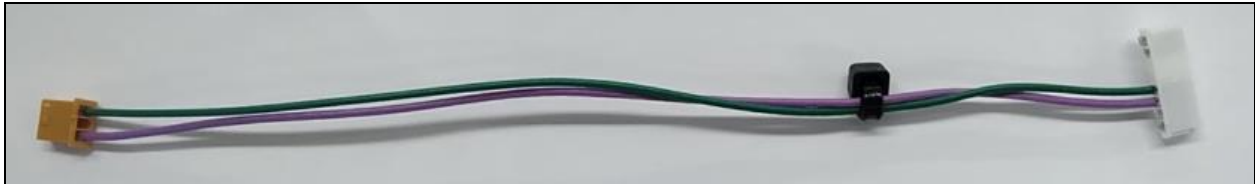
Left-Side Peel Sensor Harness C2, New-Style White Connector  
p/n 195857 for Uni-7 s/n 100237828 to 100422688

To facilitate field updates, a separate harness is available to isolate the left-side peel sensor (transmitter) by connecting to a different socket on the PK-260B CPU board. The steps to switch the left-side peel sensor connection are listed below.

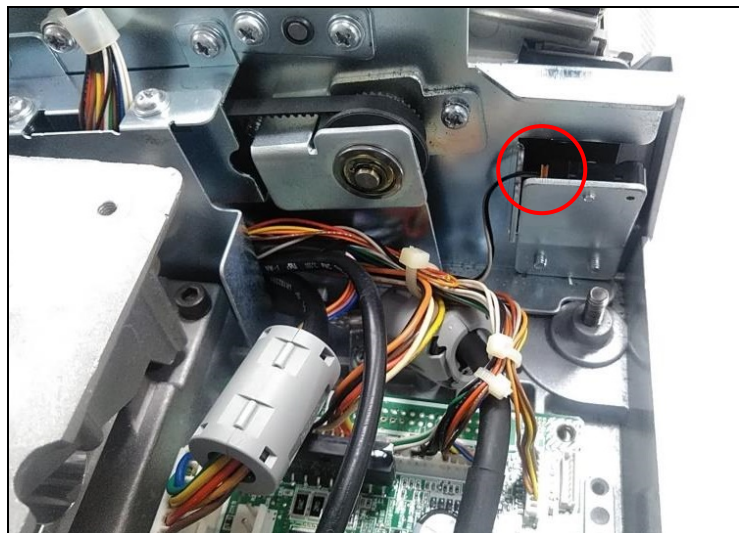
1. Remove the upper case.
2. Disconnect the peel sensor connector.

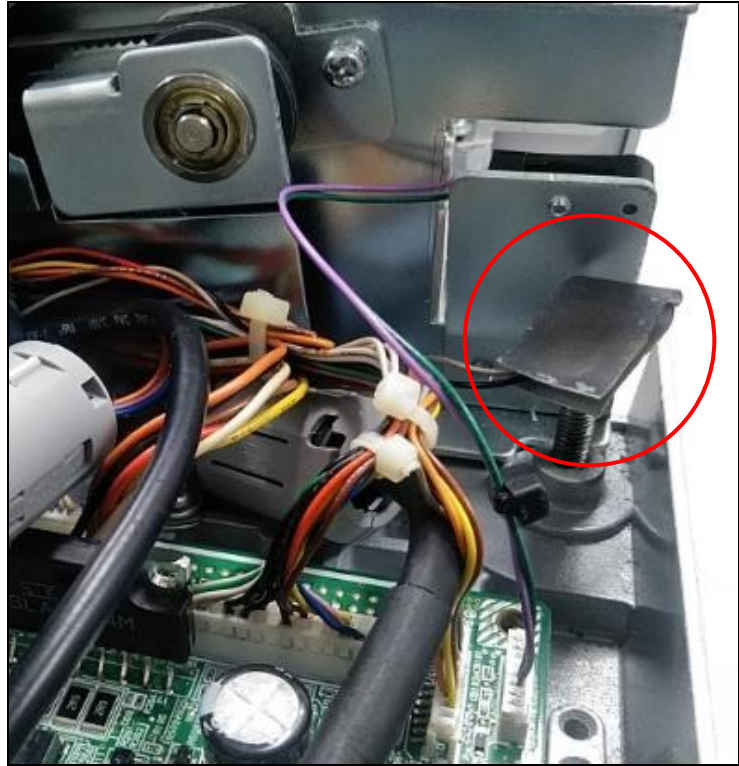
3. Cover the old harness connector with insulating electrical tape.
