WM-4000 AUTOMATIC WRAPPER

Error Codes and Solutions

100 – 399

March 2015

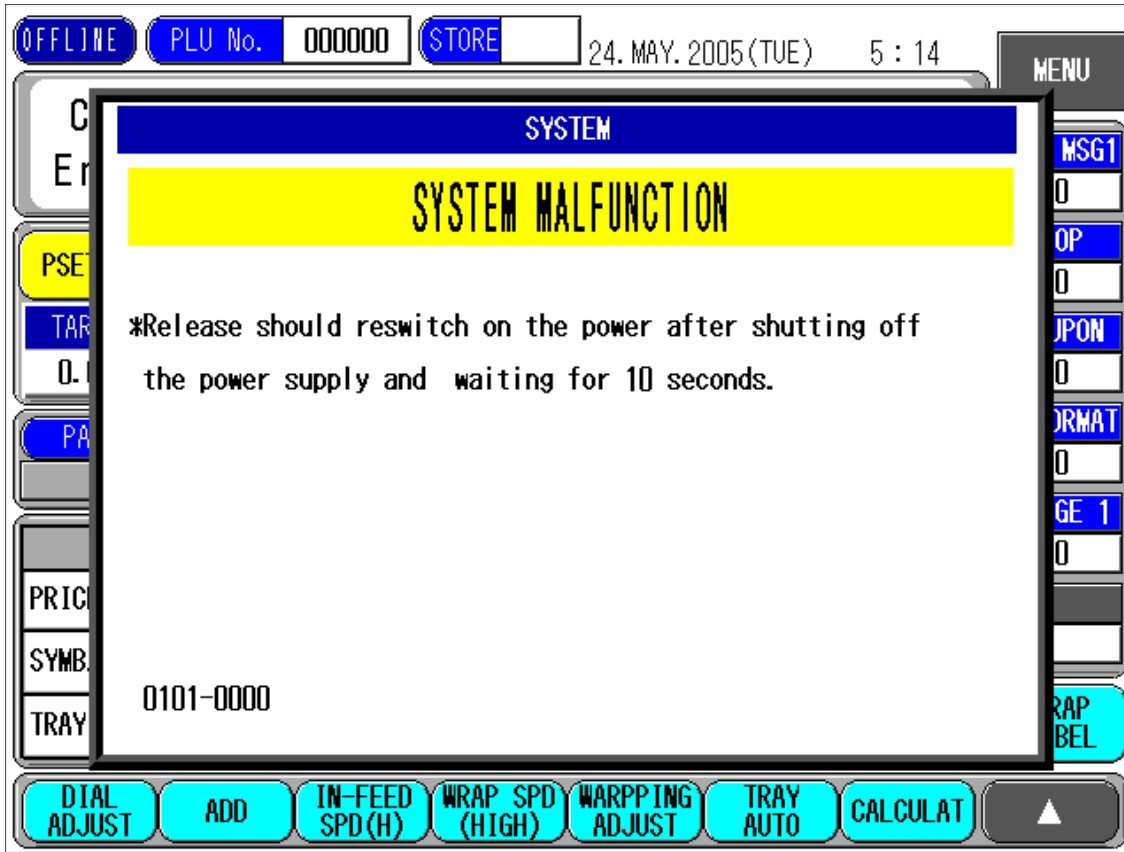
0101

[Error content]	The system has become unstable.
[Detail]	malloc area was not secured.
[Solution]	Restore power.
[Remarks]	
[Cause]	Does not occur during normal operation.
[Response]	Contact S/C if this error occurs.

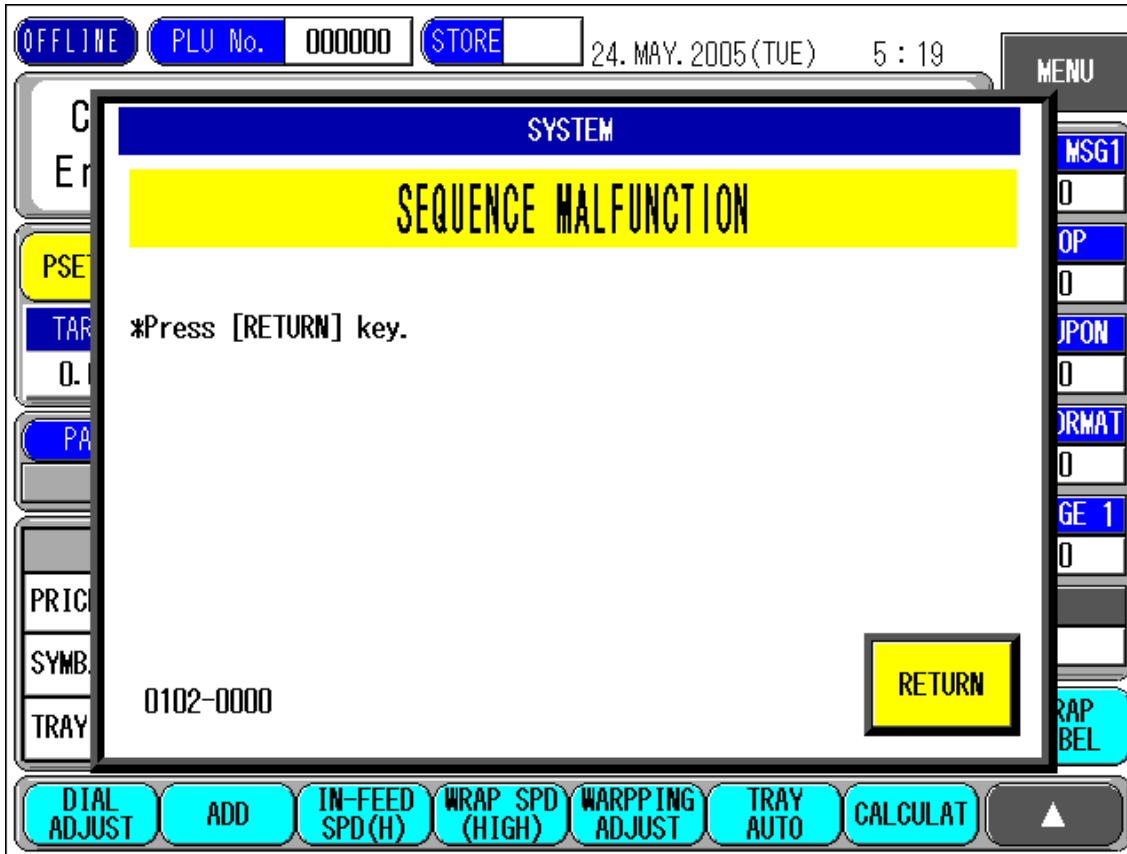
0102

[Error content]	A commodity is out of sequence.
[Detail]	The peripheral devices are controlled by assigning each cycle a sequence number. This error occurs when these are not consistent.
[Solution]	[Return] button
[Remarks]	When this error occurs, communication log with the peripheral devices is cut.
[Cause]	The peripheral devices are controlled by assigning each cycle a sequence number. These are inconsistent.
[Response]	Does not occur during normal operation. Contact S/C if this error occurs.

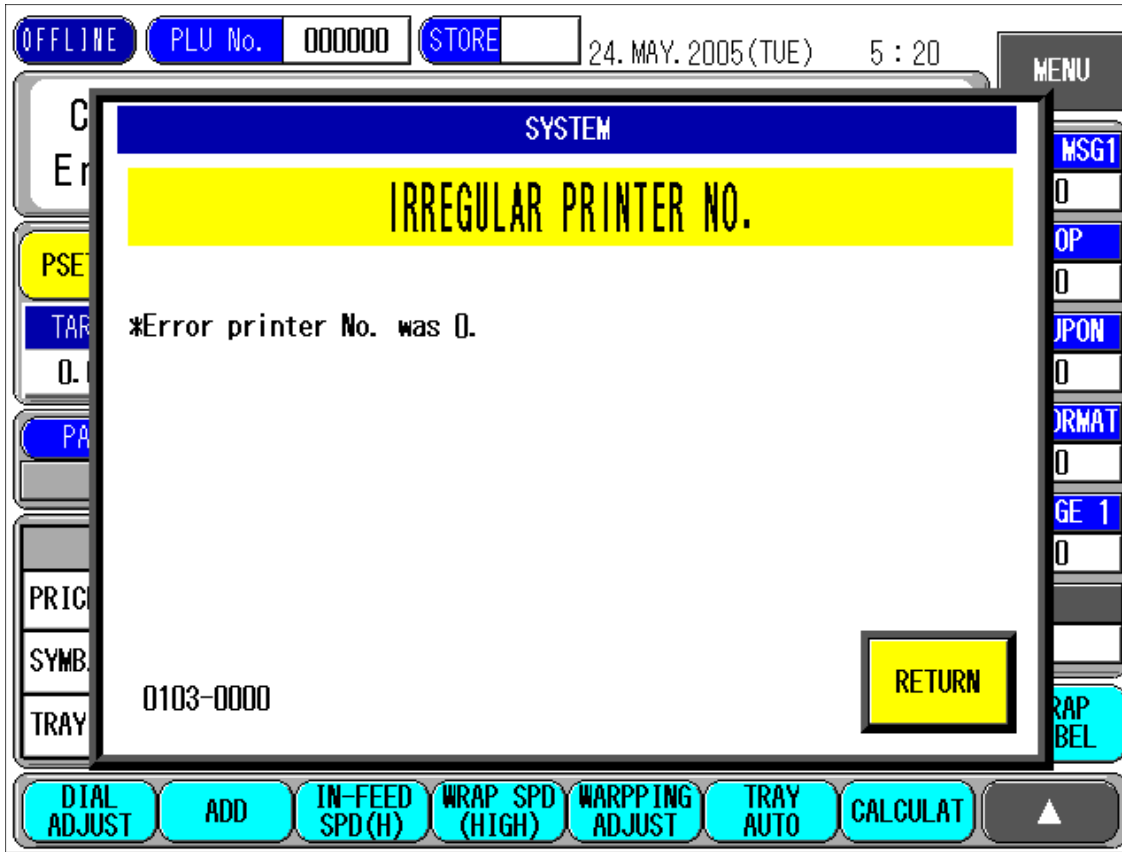
0103

[Error content]	Attempting to send a message to a non-existent printer.
[Detail]	
[Solution]	Resolve the error with the return button
[Remarks]	Possible to locate where a sub-error has become an error.
[Cause]	Does not occur during normal operation.
[Response]	Contact S/C if this error occurs.

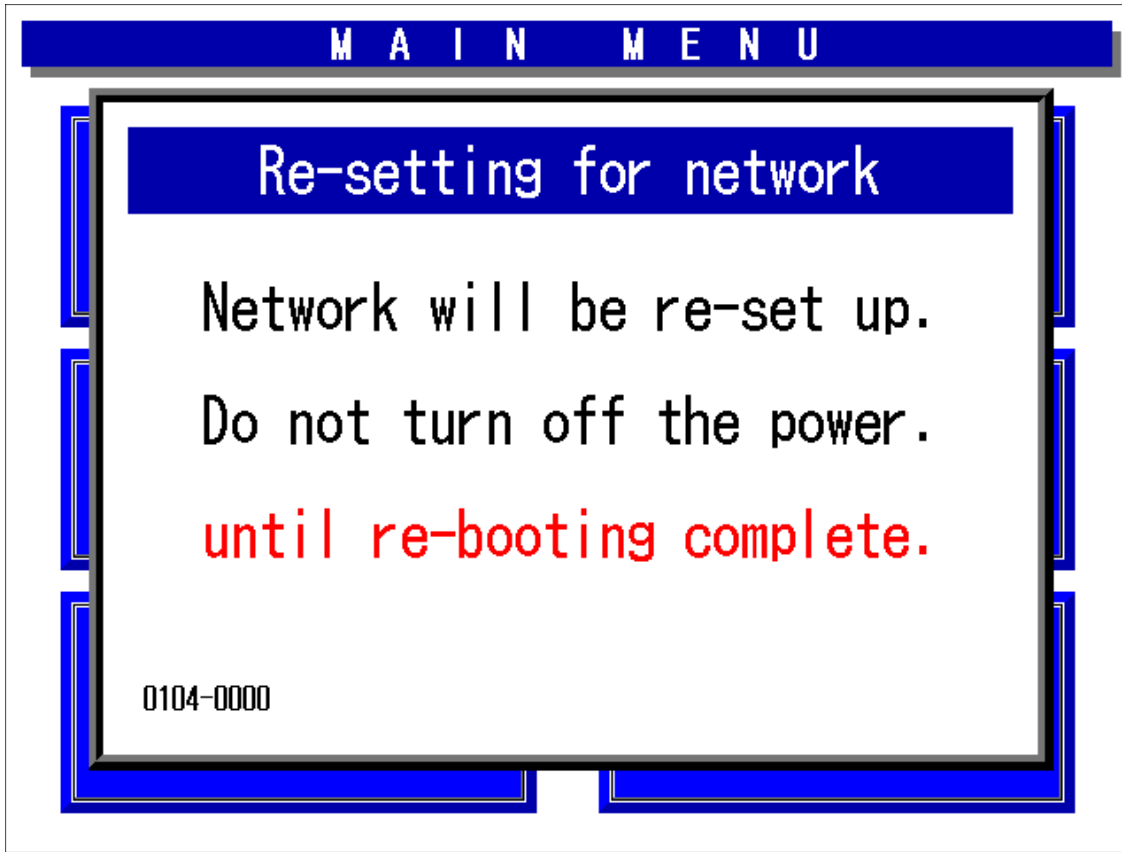
0104

[Error content]	Network settings have been lost.
[Detail]	
[Solution]	Restarts automatically
[Remarks]	Reset network settings.
[Cause]	Performing network setting.
[Response]	The device will automatically restart. Please wait a moment.

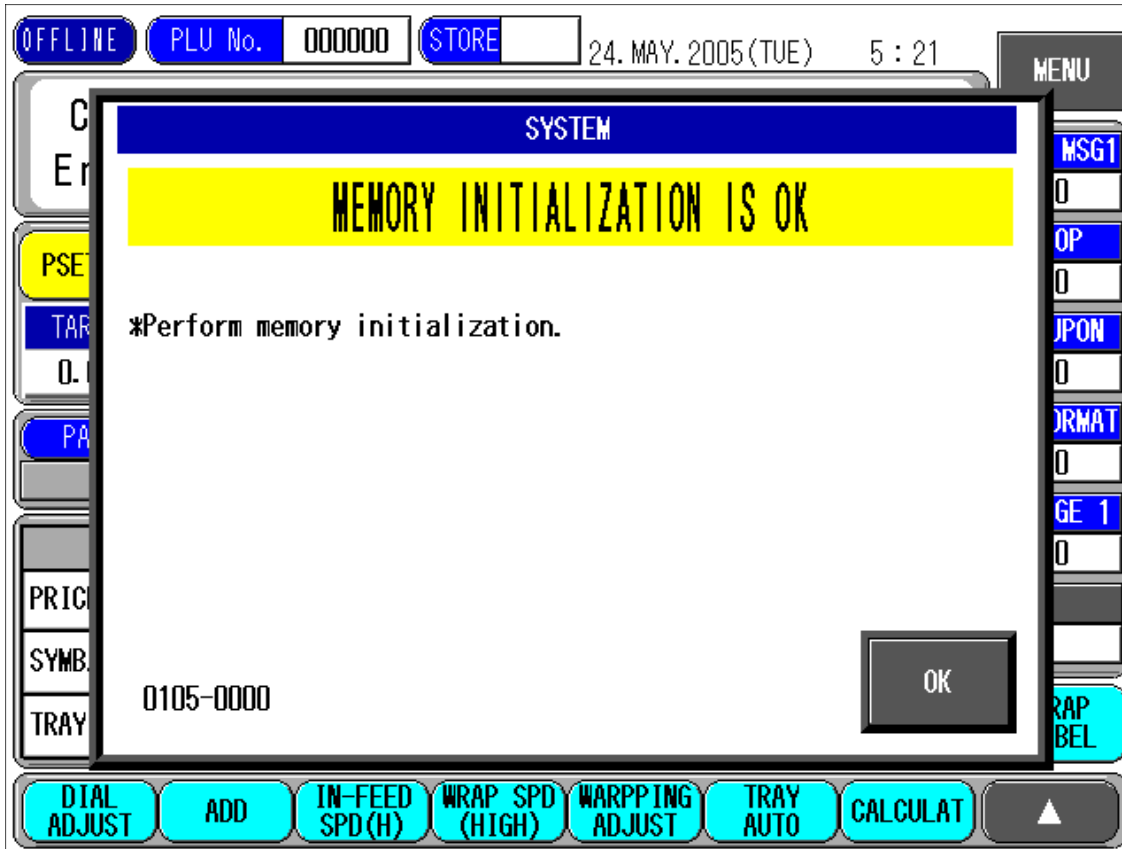
0105

[Error content]	Memory has not been initialized.
[Detail]	
[Solution]	[OK] button, Numeric keys
[Remarks]	Memory needs to be cleared in test mode memory initialization. Can you enter from test mode.
[Cause]	Initialization of P-910 memory has not been performed.
[Response]	Initialize P-910 memory in test mode.

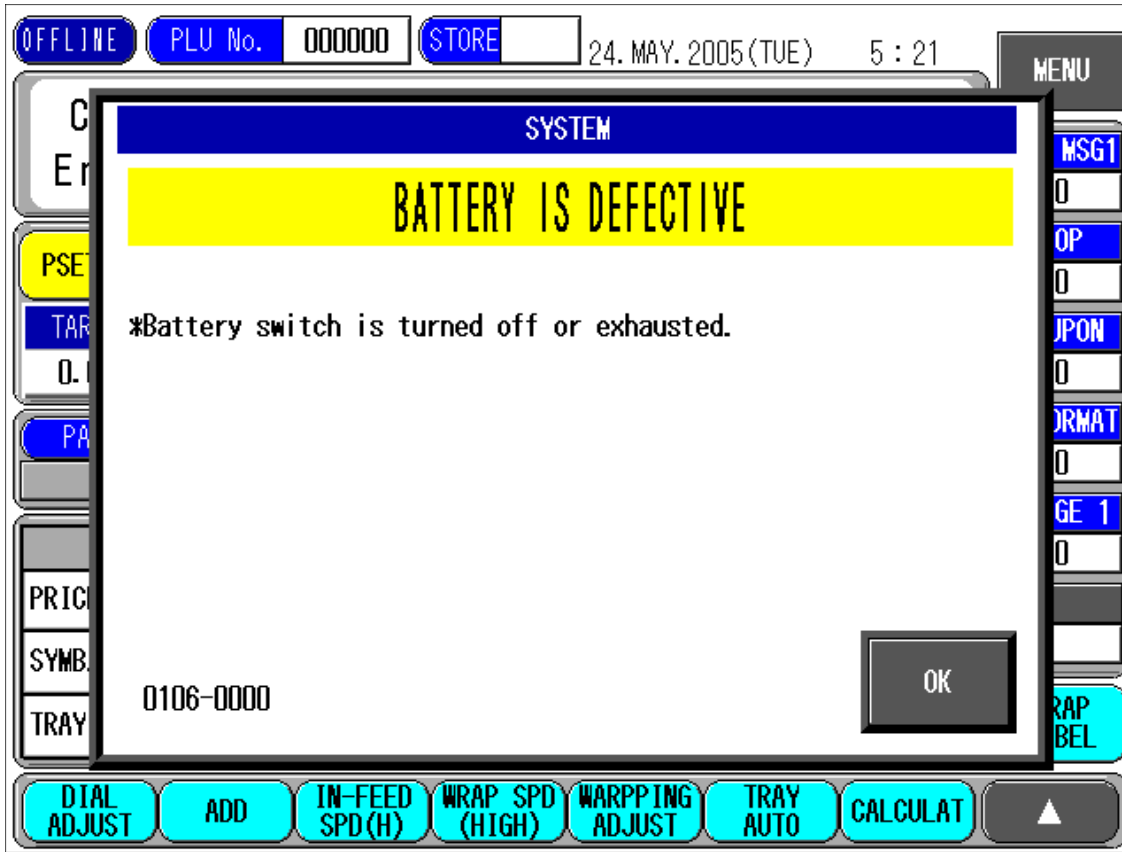
0106

[Error content]	P-910 battery switch is OFF or the battery is exhausted.
[Detail]	
[Solution]	[OK] button, Numeric keys
[Remarks]	Can only enter test and system modes.
[Cause]	P-910 battery switch is OFF or burnt out.
[Response]	<ol style="list-style-type: none"> 1. Confirm switch is in the ON position, switch ON. 2. If the battery is ON, the battery is exhausted. Replace P-910 main board.

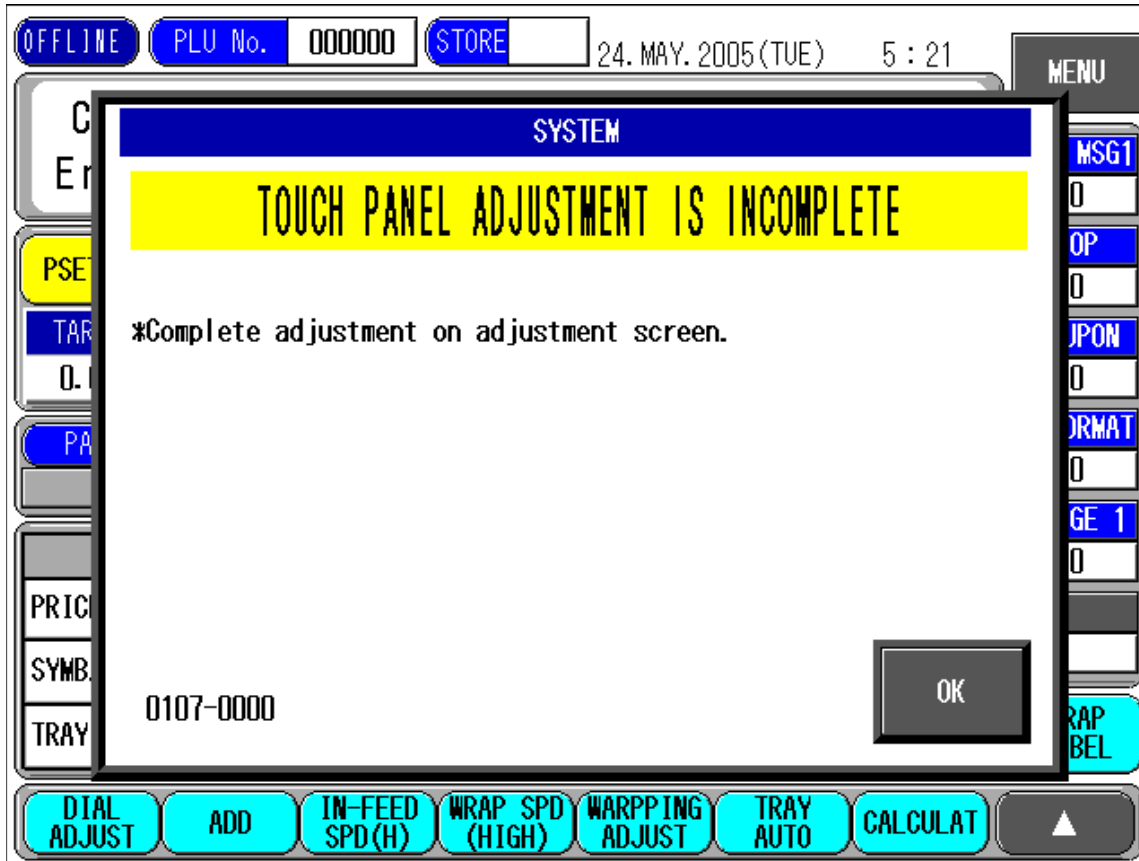
0107

[Error content]	Touch panel adjustment is incomplete.
[Detail]	
[Solution]	[OK] button, Numeric keys
[Remarks]	Can only enter test mode and system mode.
[Cause]	Touch panel adjustment is incomplete.
[Response]	Perform touch panel adjustment on adjustment screen.

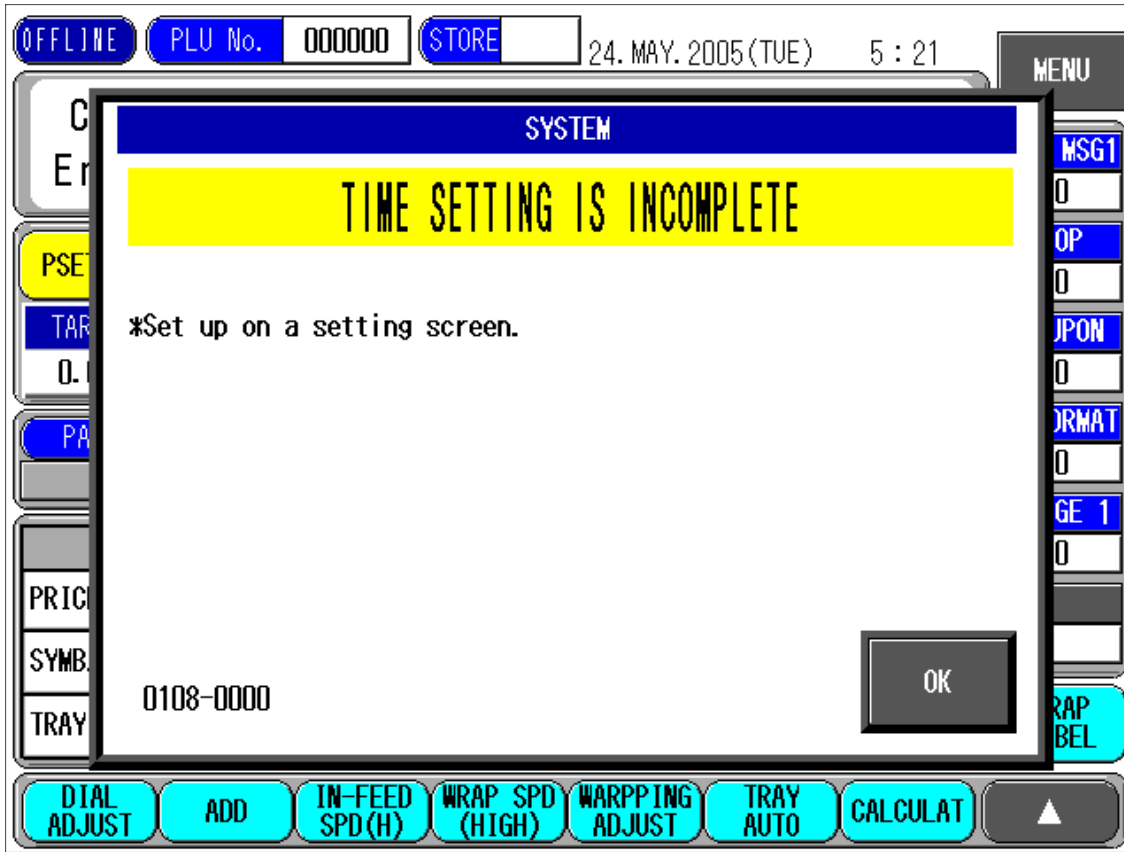
0108

[Error content]	Time setting is incomplete.
[Detail]	
[Solution]	[OK] button, Numeric keys
[Remarks]	
[Cause]	Time setting is incomplete.
[Response]	Set clock.

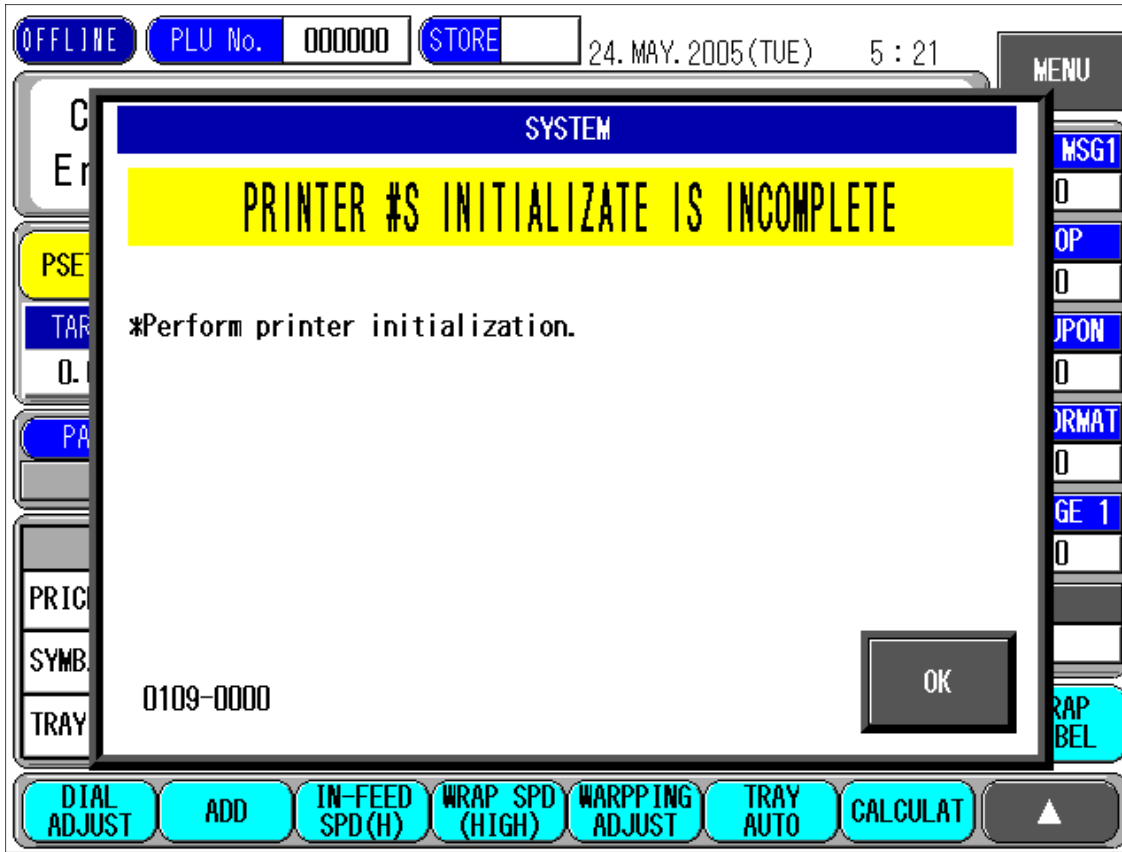
0109

[Error content]	Printer initialization is incomplete.
[Detail]	Sub-error is the printer number.
[Solution]	[OK] button, Numeric keys
[Remarks]	Can you enter from test mode or system modes.
[Cause]	Printer initialization is incomplete.
[Response]	In test mode, initialize printer unit memory in printer adjustment screen 1/2.

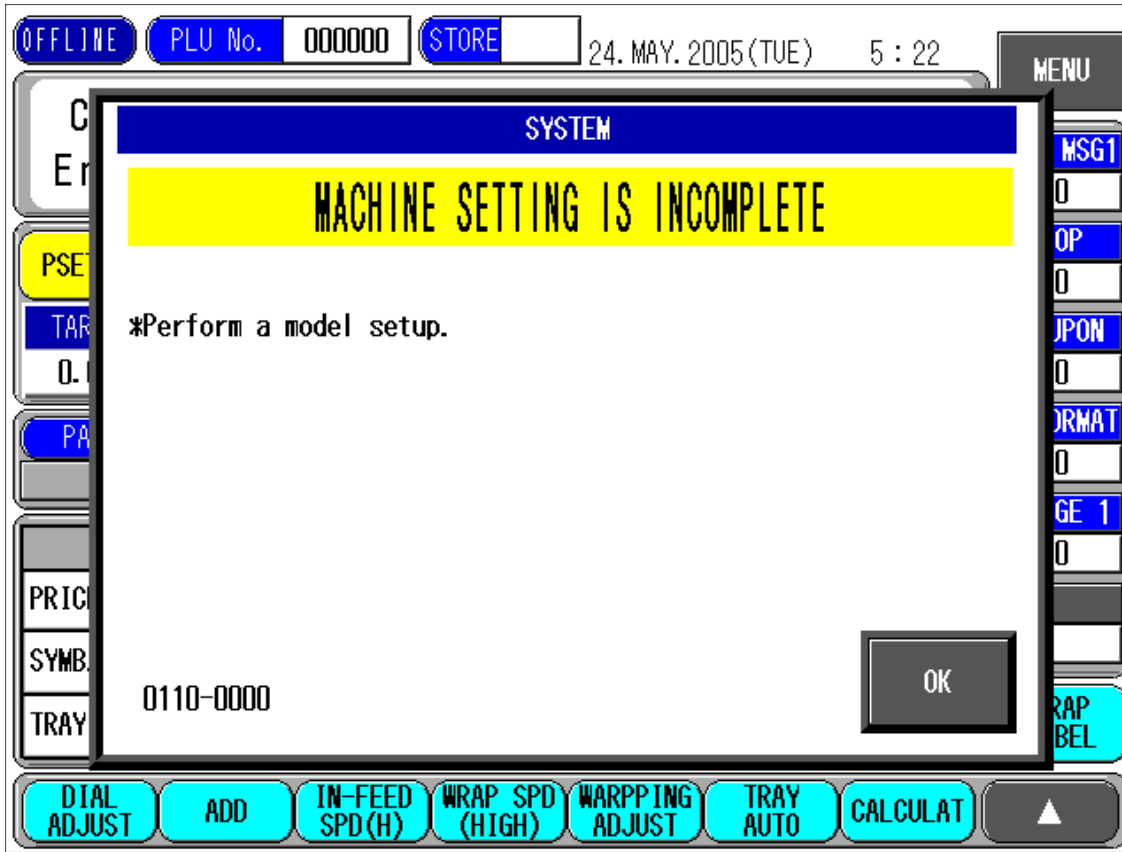
0110

[Error content]	Model setting is incomplete.
[Detail]	
[Solution]	[OK] button, Numeric keys
[Remarks]	Can you enter from test mode or system modes.
[Cause]	Model setting is incomplete.
[Response]	Set model settings in test mode.

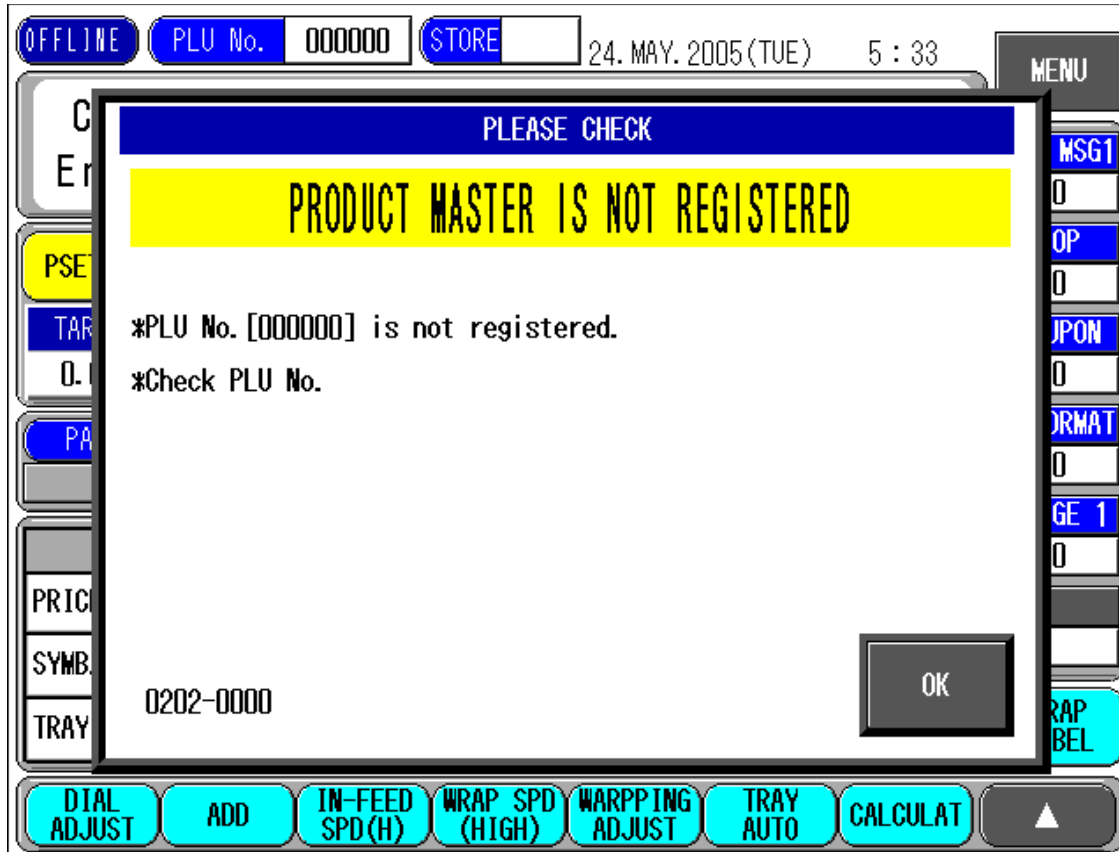
0202

[Error content]	Product master is not registered.
[Detail]	Does not exist in internal master.
[Solution]	Numeric keys, [OK] button
[Remarks]	Product number is displayed.
	Product master is not registered.
[Cause]	Product master is not registered.
[Response]	Register product master.

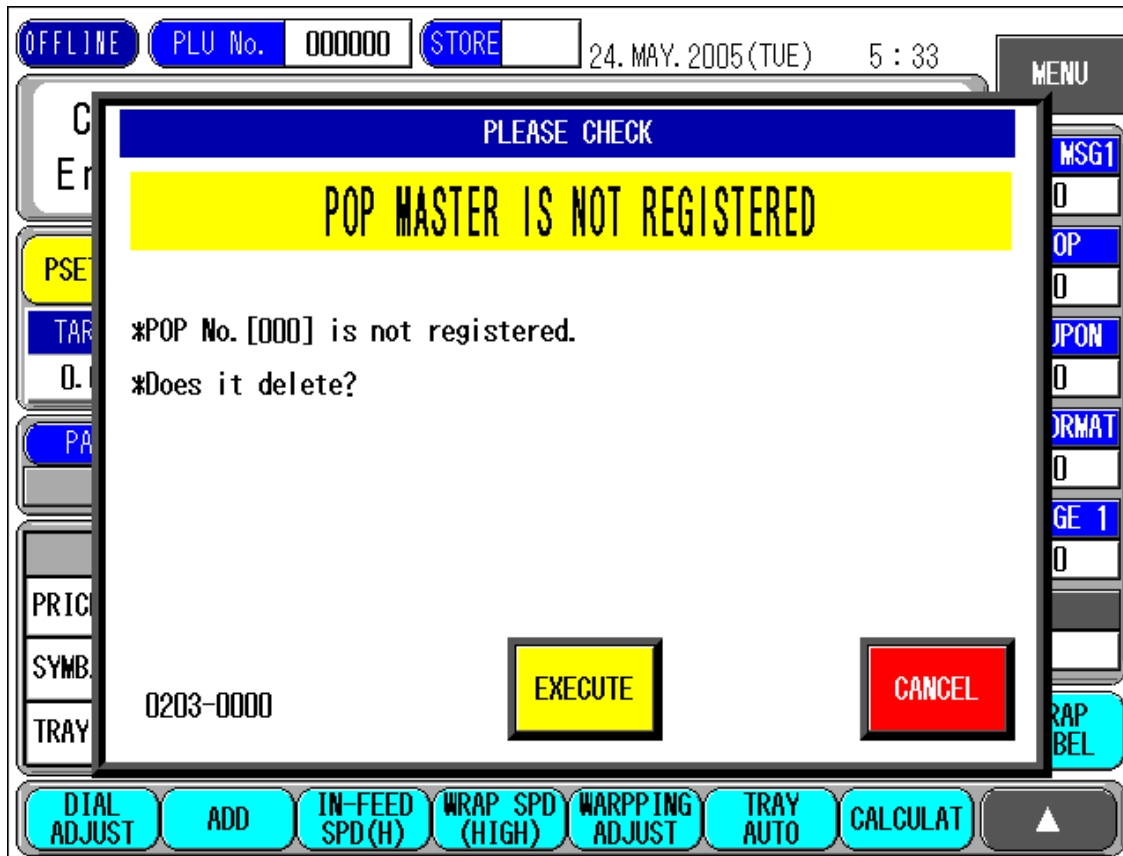
0203

[Error content]	POP master is not registered.
[Detail]	Does not exist in internal master.
[Solution]	[EXECUTE] button: Delete Product Master POP No. [CANCEL] button: Cancel error.
[Remarks]	In the case of no automatic POP No. update, it is not deleted even after pressing [EXECUTE]. Error display can be changed in link master error settings.
[Cause]	POP master is not registered.
[Response]	Register POP master.

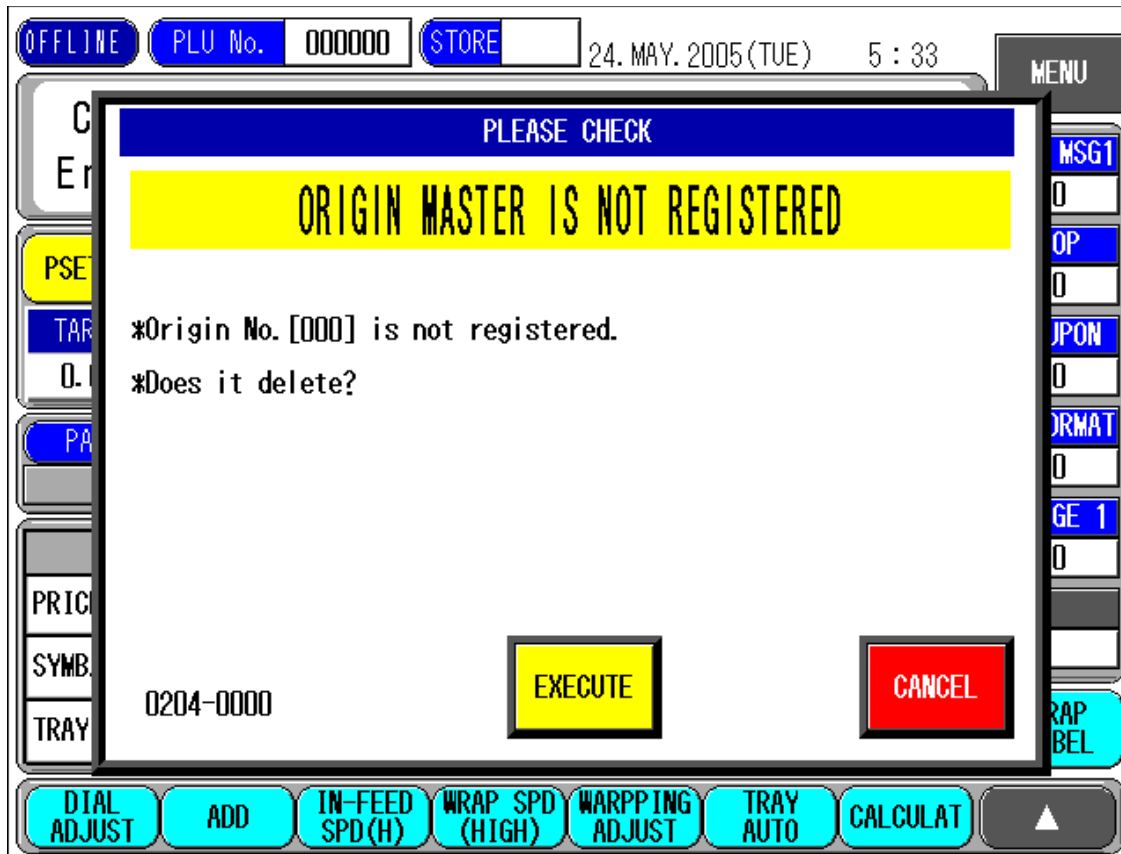
0204

[Error content]	Origin master is not registered.
[Detail]	Does not exist in internal master.
[Solution]	[EXECUTE] button: Delete product origin master no. [CANCEL] button: Cancel error.
[Remarks]	In the case of no automatic origin update, it is not deleted even after pressing the [EXECUTE] button. Error display can be changed in link master error settings.
[Cause]	Origin master is not registered.
[Response]	Register origin master.

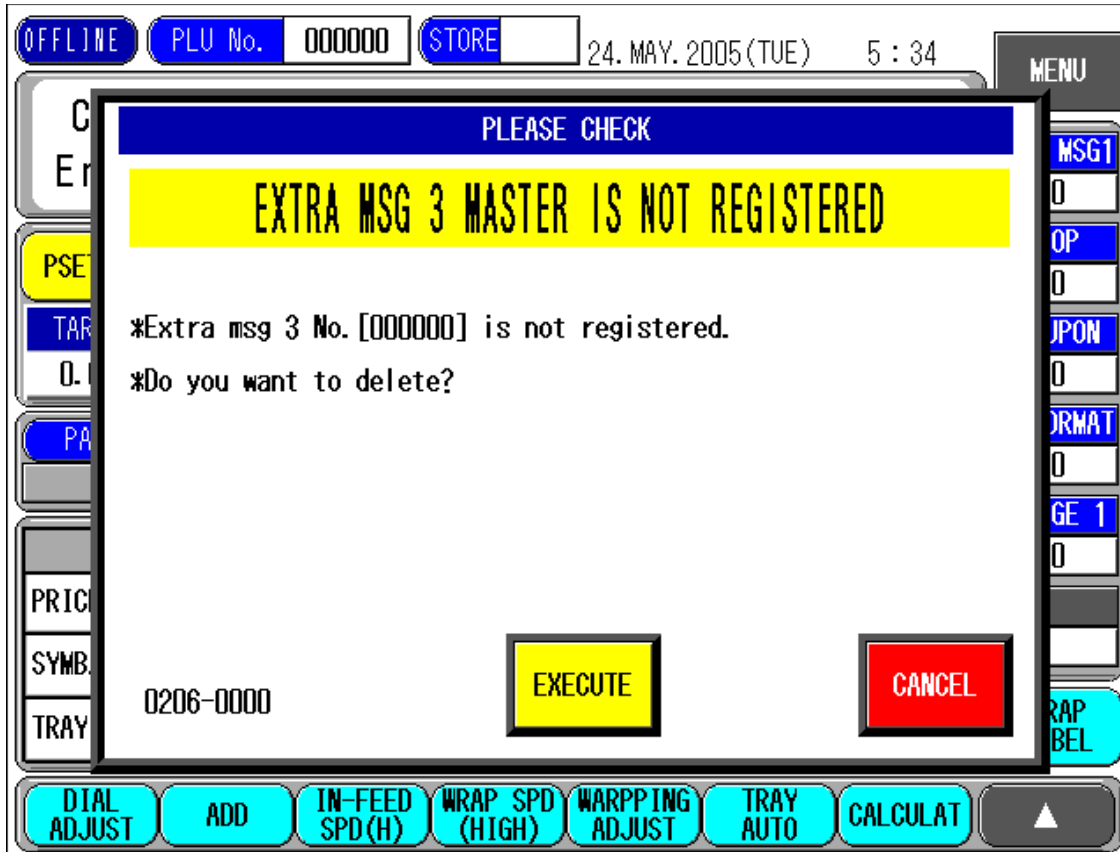
0206

[Error content]	Storage method master is not registered.
[Detail]	Does not exist in internal master.
[Solution]	[EXECUTE] button: Delete product master storage method no. [CANCEL] button: Cancel error.
[Remarks]	In the case of no storage method automatic update, it is not deleted even after pressing the [EXECUTE] button. Error display can be changed in link master error settings.
[Cause]	Storage method master is not registered.
[Response]	Register storage method master.

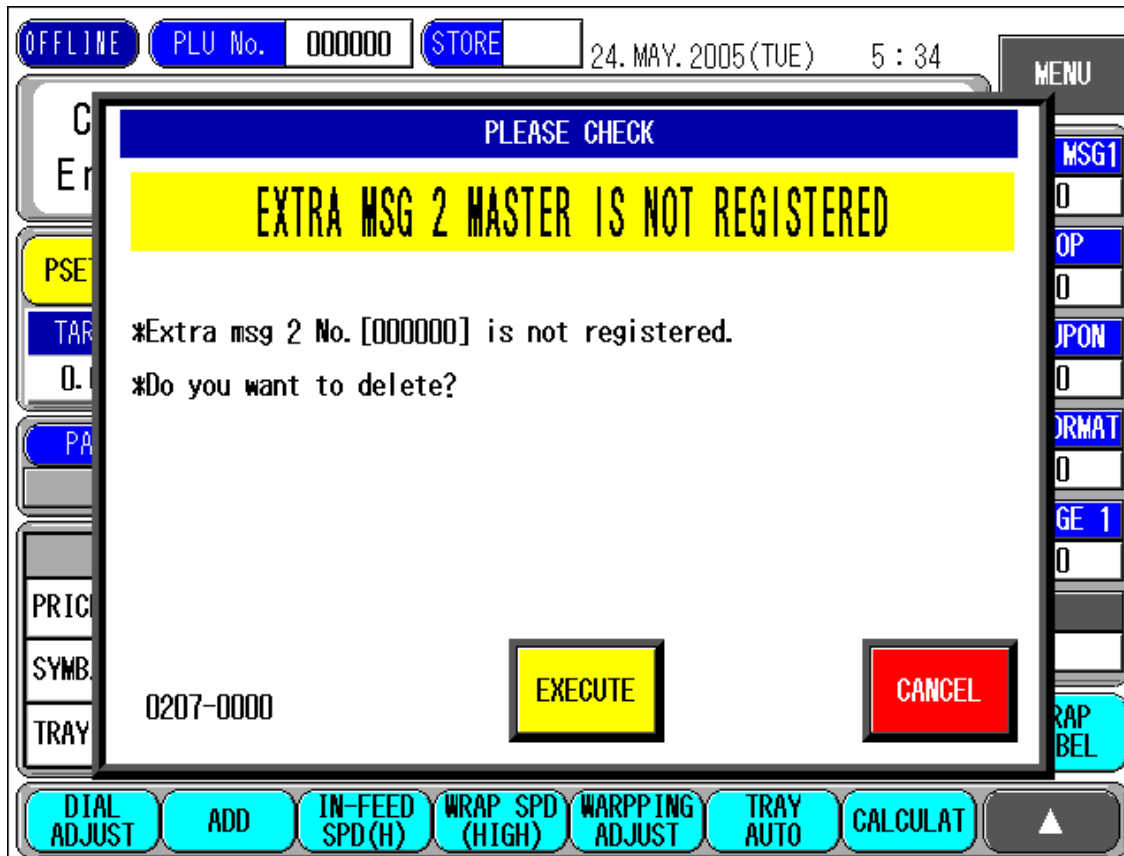
0207

[Error content]	Storage Temperature master is not registered.
[Detail]	Does not exist in internal master.
[Solution]	[EXECUTE] button: Delete product master storage temperature no. [CANCEL] button: Cancel error.
[Remarks]	In the case of no automatic storage temperature update, it will not be deleted even after pressing [EXECUTE]. Error display can be changed in link master error settings.
[Cause]	Storage temperature master is not registered.
[Response]	Register storage temperature master.

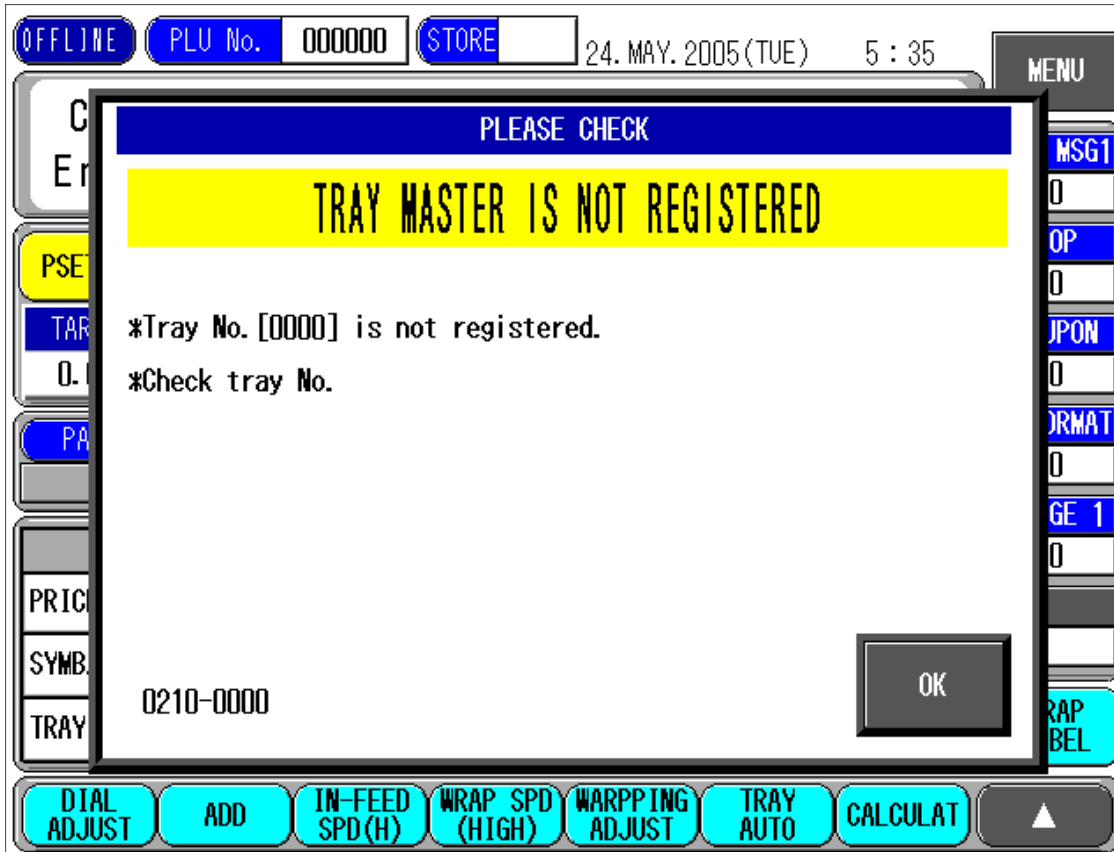
0210

[Error content]	Tray master is not registered.
[Detail]	
[Solution]	[OK] button
[Remarks]	In the case of no automatic tray update, it is not deleted even after pressing [EXECUTE].
[Cause]	Tray master is not registered.
[Response]	Register tray master.

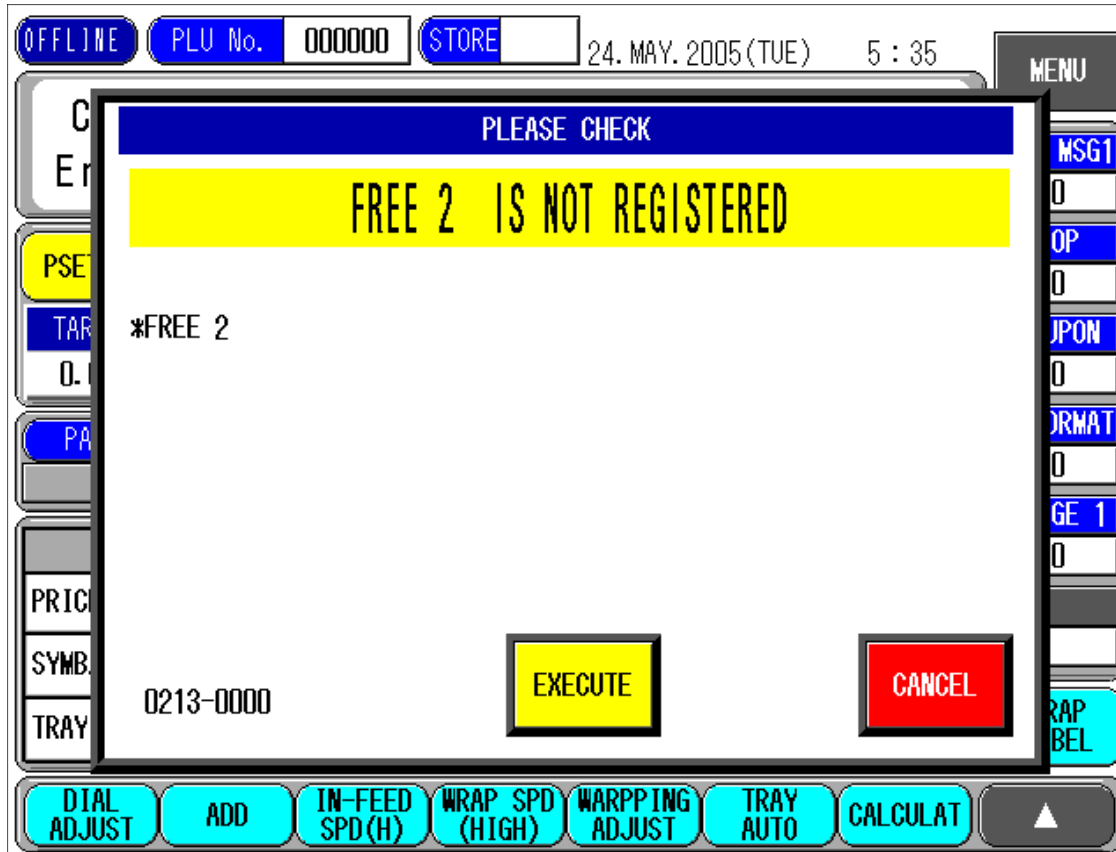
0213

[Error content]	Free 2 master is not registered.
[Detail]	
[Solution]	[EXECUTE] button: Delete product master free no. 2. [CANCEL] button: Cancel error.
[Remarks]	In the case of no automatic free 2 update, it is not deleted even after pressing [EXECUTE]. It is possible to change the name of Free 2 in "Free master name settings" in system mode. Error display can be changed in link master error settings.
[Cause]	Free 2 master is not registered.
[Response]	Register free 2 master.

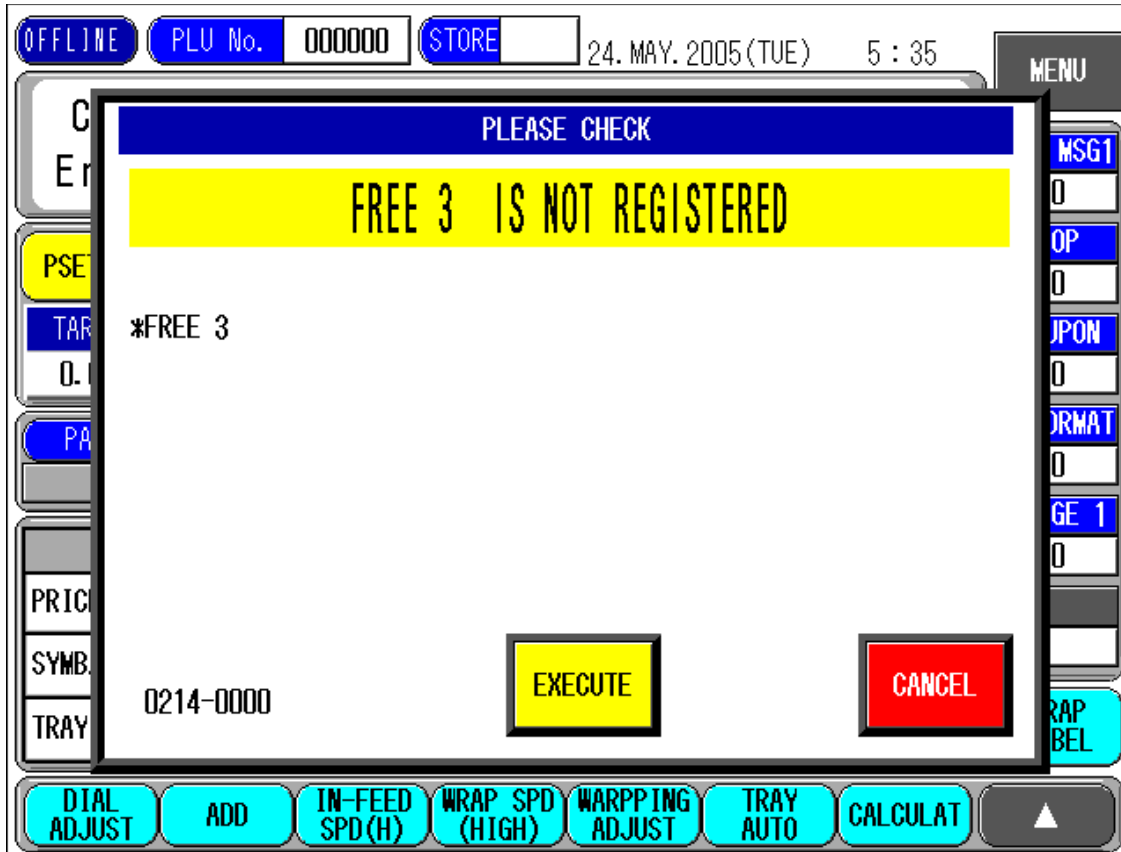
0214

[Error content]	Free 3 master is not registered.
[Detail]	
[Solution]	[EXECUTE] button: Delete product master free no. 3. [CANCEL] button: Cancel error.
[Remarks]	In the case of no automatic free 3 update, it is not deleted even after pressing [EXECUTE]. It is possible to change the name of free 3 in "Free master name settings" in system mode.
[Cause]	Free 3 master is not registered.
[Response]	Register free 3 master.

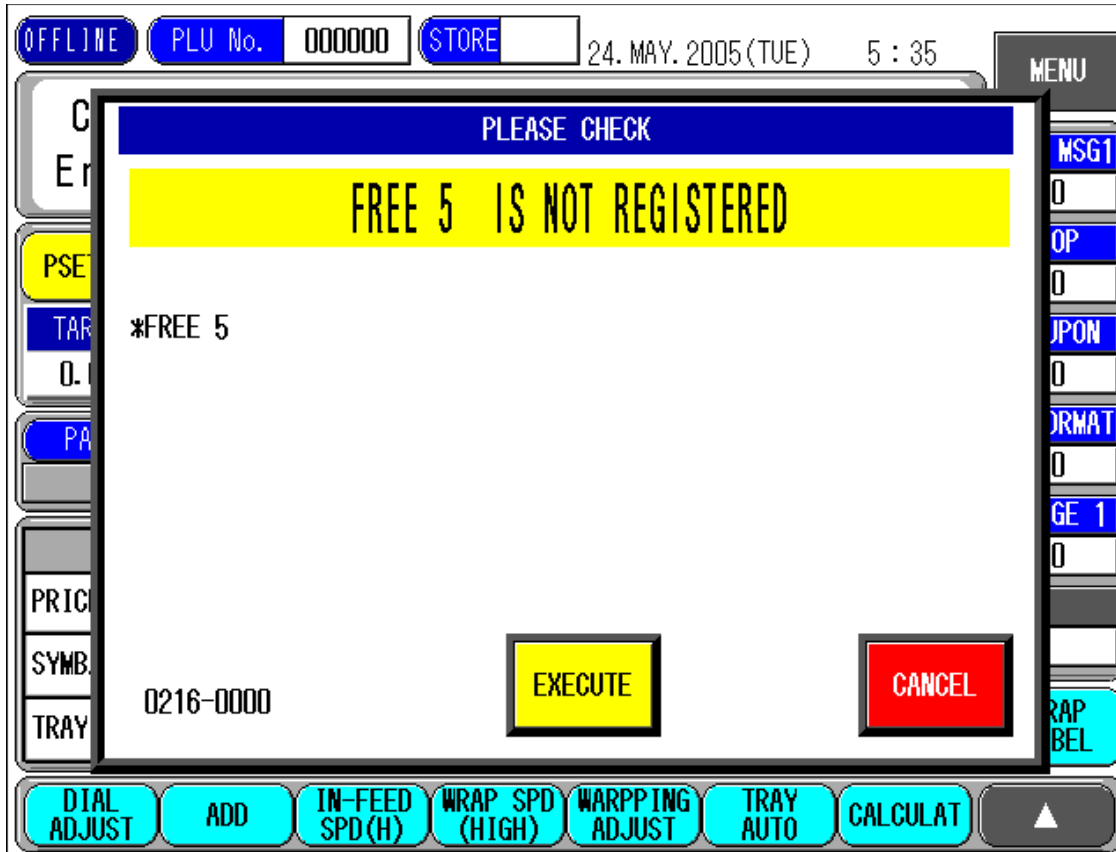
0216

[Error content]	Free 5 master is not registered.
[Detail]	
[Solution]	[EXECUTE] button: Delete product master free no. 5. [CANCEL] button: Cancel error.
[Remarks]	In the case of no automatic free 5 update, it is not deleted even after pressing [EXECUTE]. It is possible to change the name of free 5 in "Free master name settings" in system mode. Error display can be changed in link master error settings.
[Cause]	Free 5 master is not registered.
[Response]	Register free 5 master.

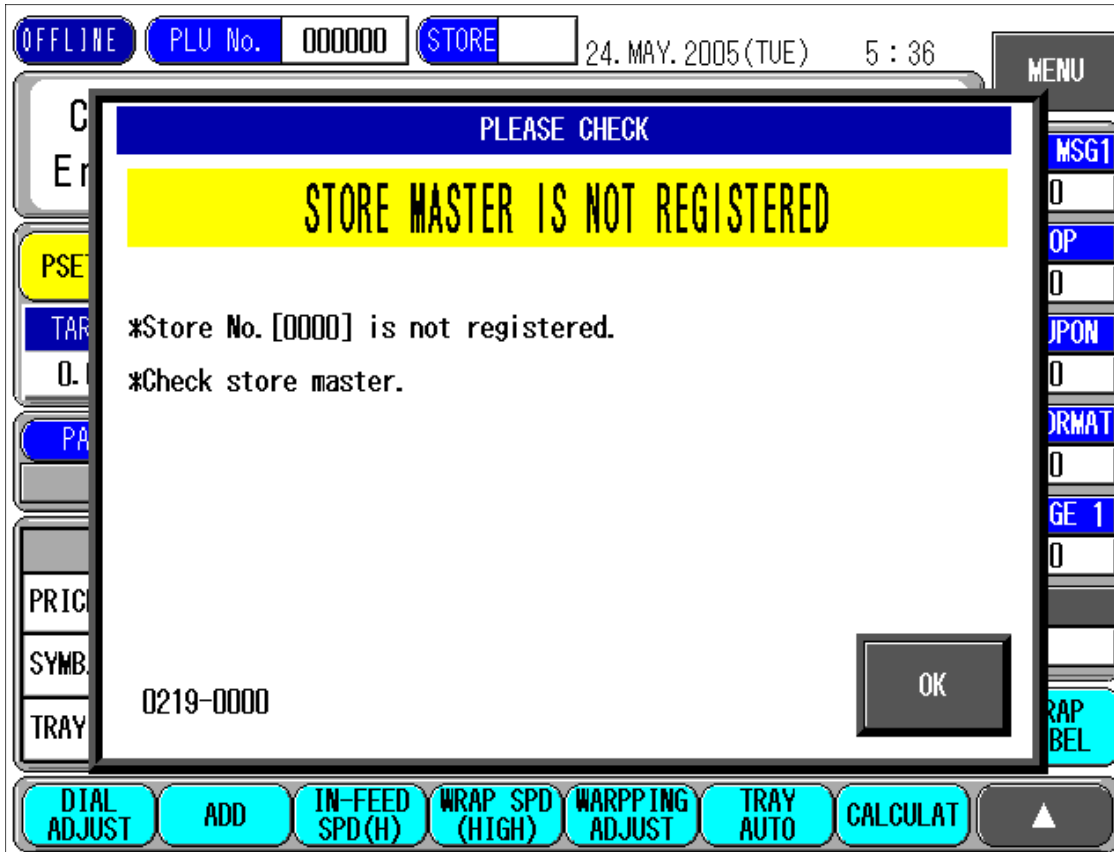
0219

[Error content]	Store Master is not registered.
[Detail]	Does not exist in internal master.
[Solution]	Numeric keys, [OK] button
[Remarks]	
[Cause]	Store Master is not registered.
[Response]	Register Store Master.

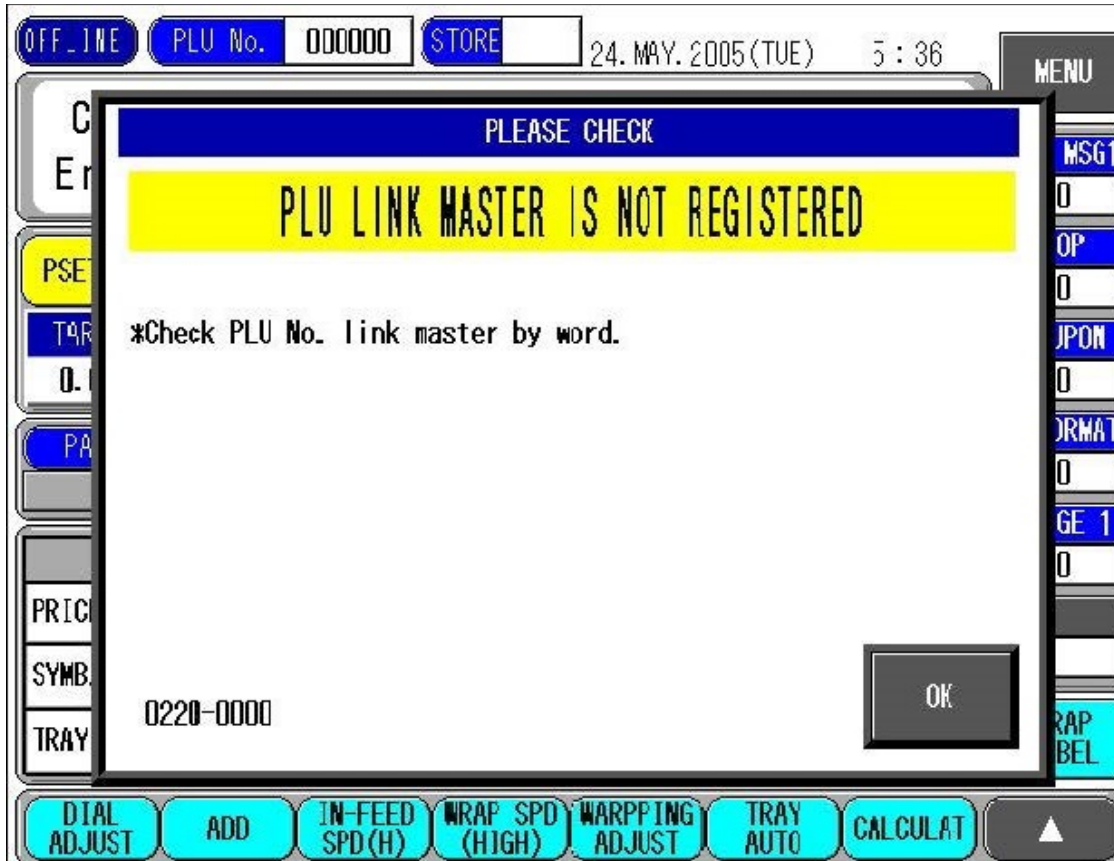
0220

[Error content]	PLU link master is not registered.
[Detail]	This error occurs when alphabetical search is attempted in normal mode and there is no PLU link master.
[Solution]	[OK] button
[Remarks]	
[Cause]	PLU link master by word is not registered.
[Response]	Register the PLU link master by word.

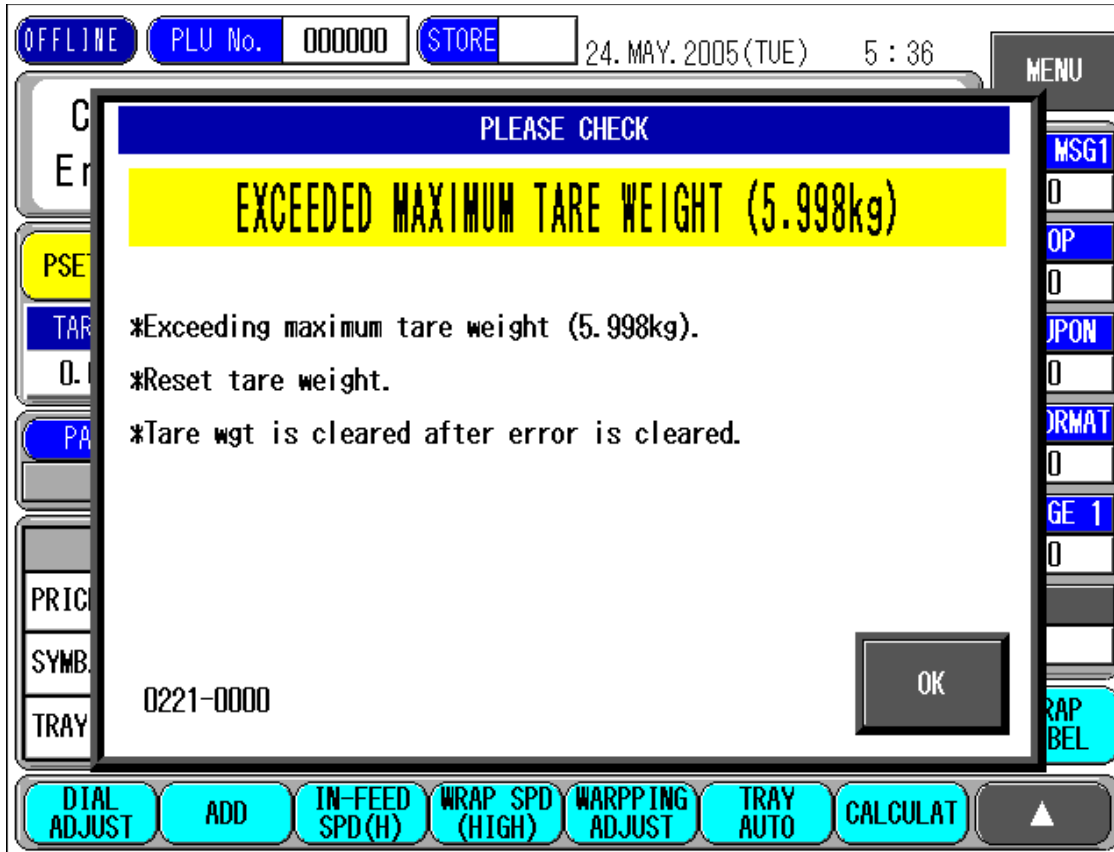
0221

[Error content]	Tare is greater than 999g.
[Detail]	
[Solution]	Numeric keys, [OK] button
[Remarks]	Tare is cleared after the error is cleared.
[Cause]	Tare is greater than 999g.
[Response]	Check tare.
