WM-4000 AUTOMATIC WRAPPER

Error Codes and Solutions

100 – 399

March 2015

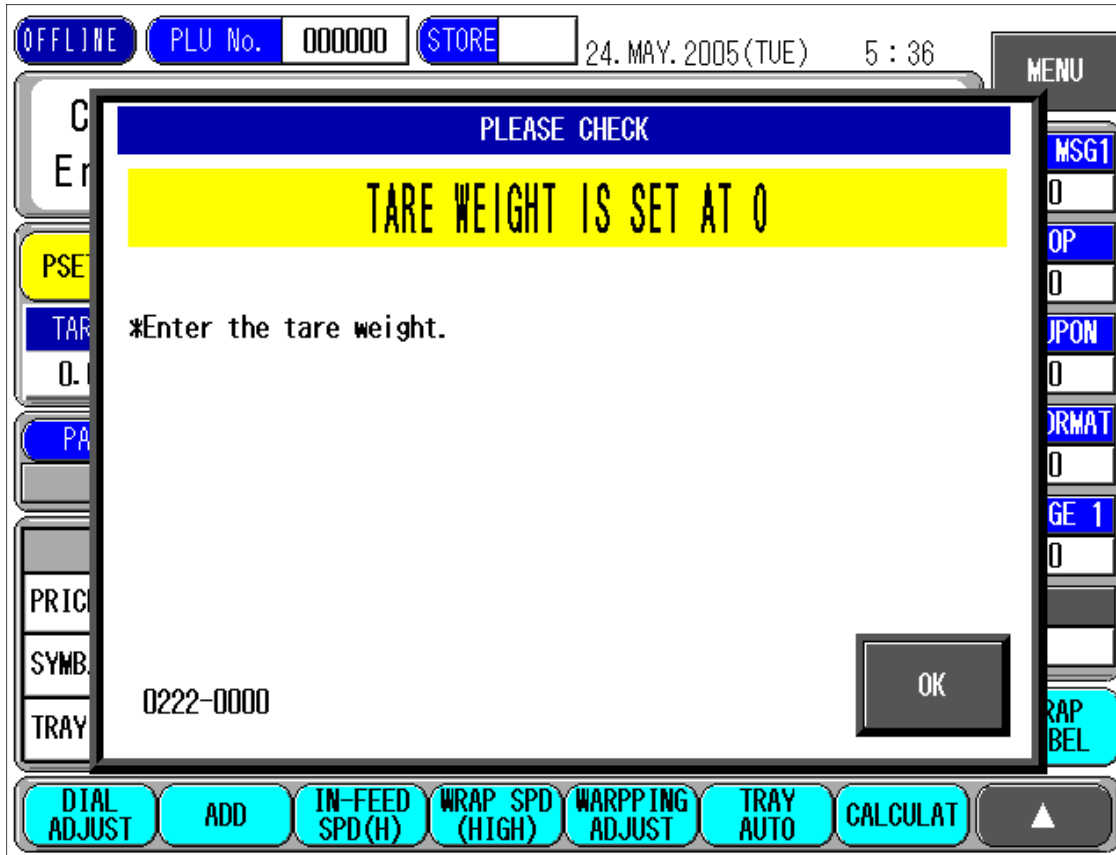
0222

[Error content]	Tare weight is set at 0.
[Detail]	
[Solution]	Numeric keys, [OK] button
[Remarks]	Tare weight is set at 0 error does not occur when "Do not display" is selected.
[Cause]	Tare weight is set at 0.
[Response]	Enter the tare weight.

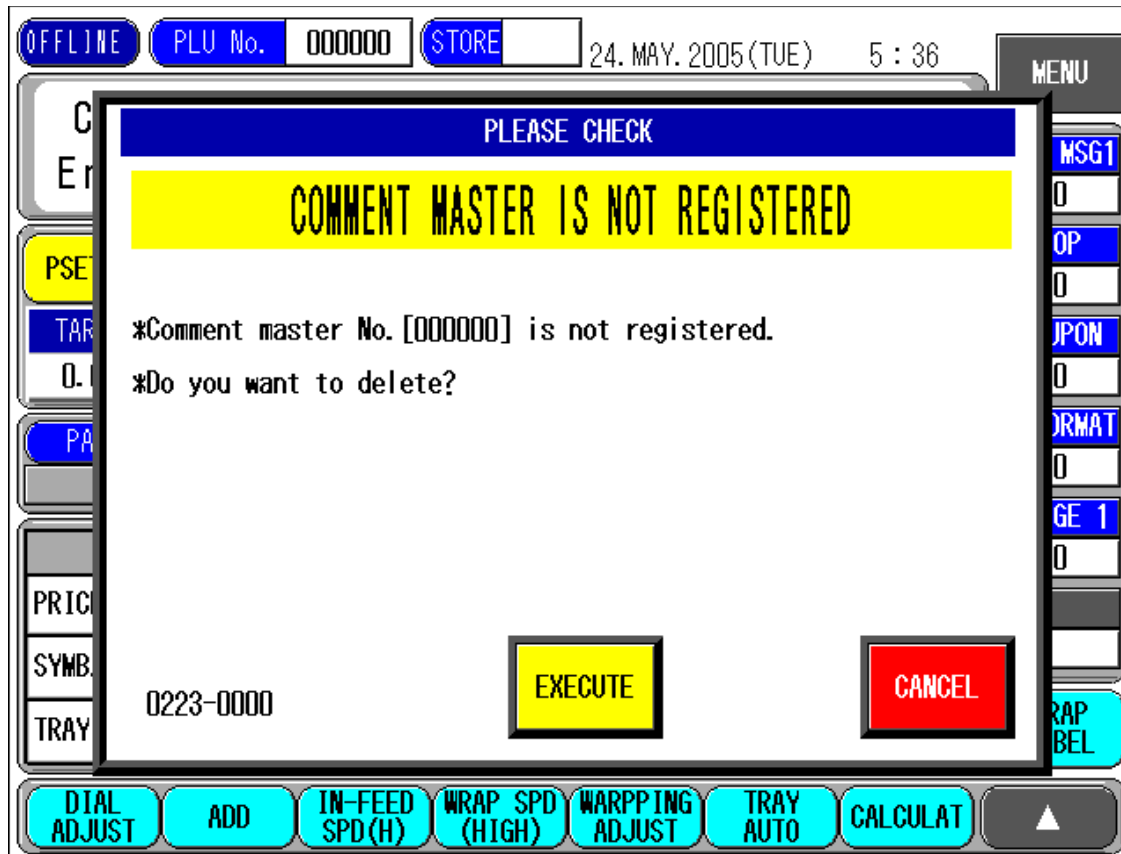
0223

[Error content]	Comment master is not registered.
[Detail]	Does not exist in the internal master.
[Solution]	[EXECUTE] button: Delete product master comment no. [CANCEL] button: Cancel error.
[Remarks]	In the case of no automatic comment update, it is not deleted even after pressing [EXECUTE]. Error display can be changed in link master error settings.
[Cause]	Comment master is not registered.
[Response]	Register comment master.

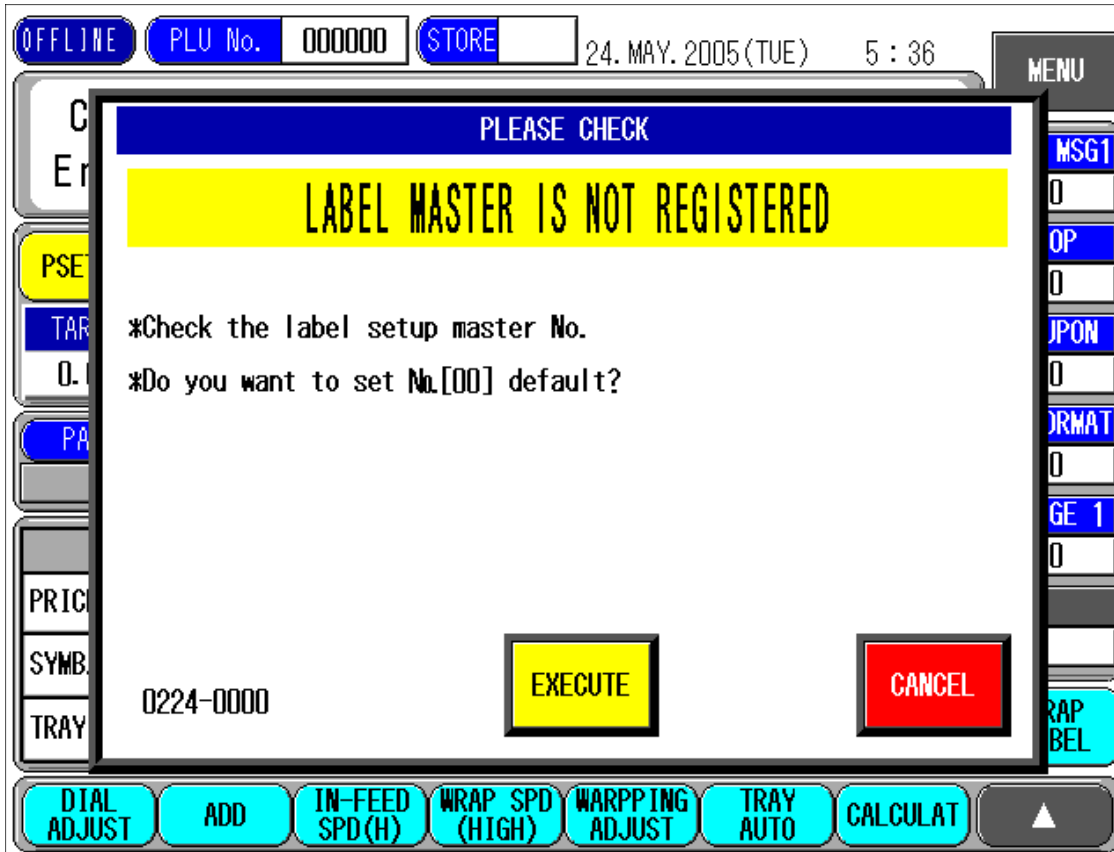
0224

[Error content]	Label master no. unregistered error.
[Detail]	Occurs when trying to create a new label master no. in System Mode>Label Issue Pattern Settings>Label Details.
[Solution]	[EXECUTE] button: New registration by call number [CANCEL] button: Cancel.
[Remarks]	
[Cause]	Label master no. unregistered error.
[Response]	Register label master.

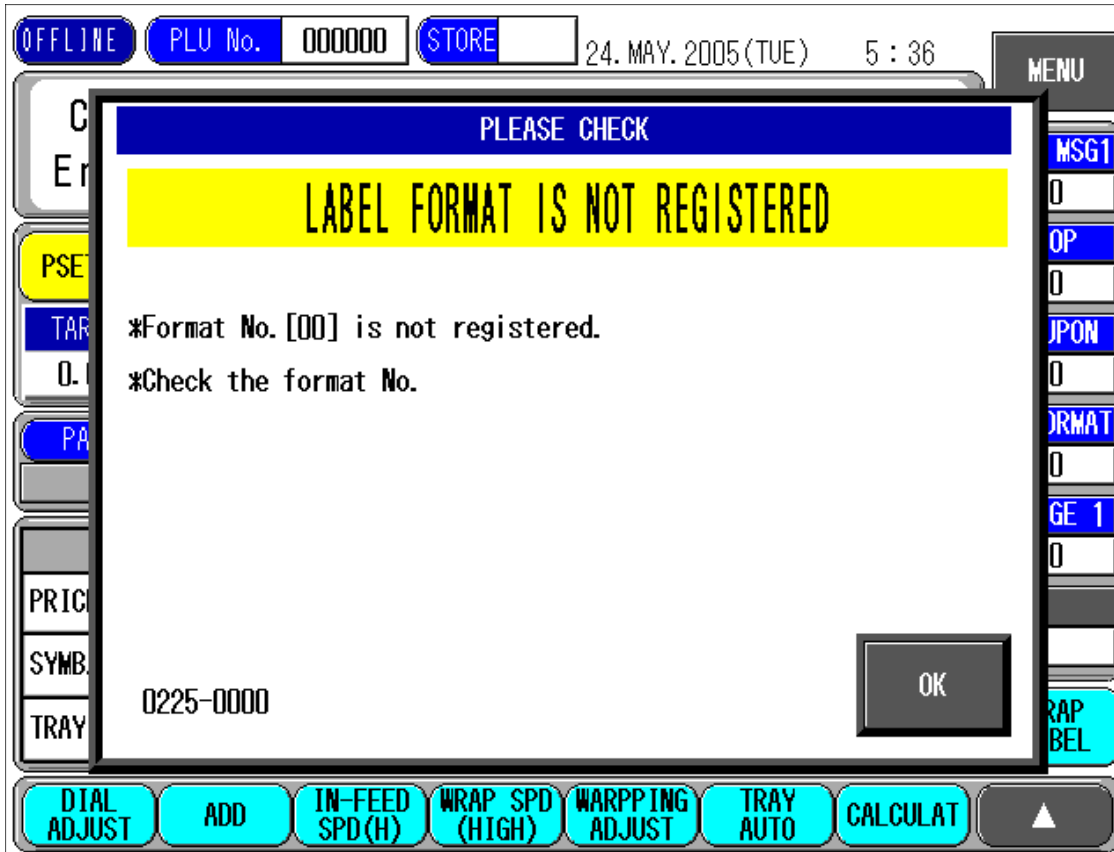
0225

[Error content]	The label format no. attempted to configure is not registered.
[Detail]	
[Solution]	[OK] button
[Remarks]	
[Cause]	The label format no. attempted to configure is not registered.
[Response]	Register format.

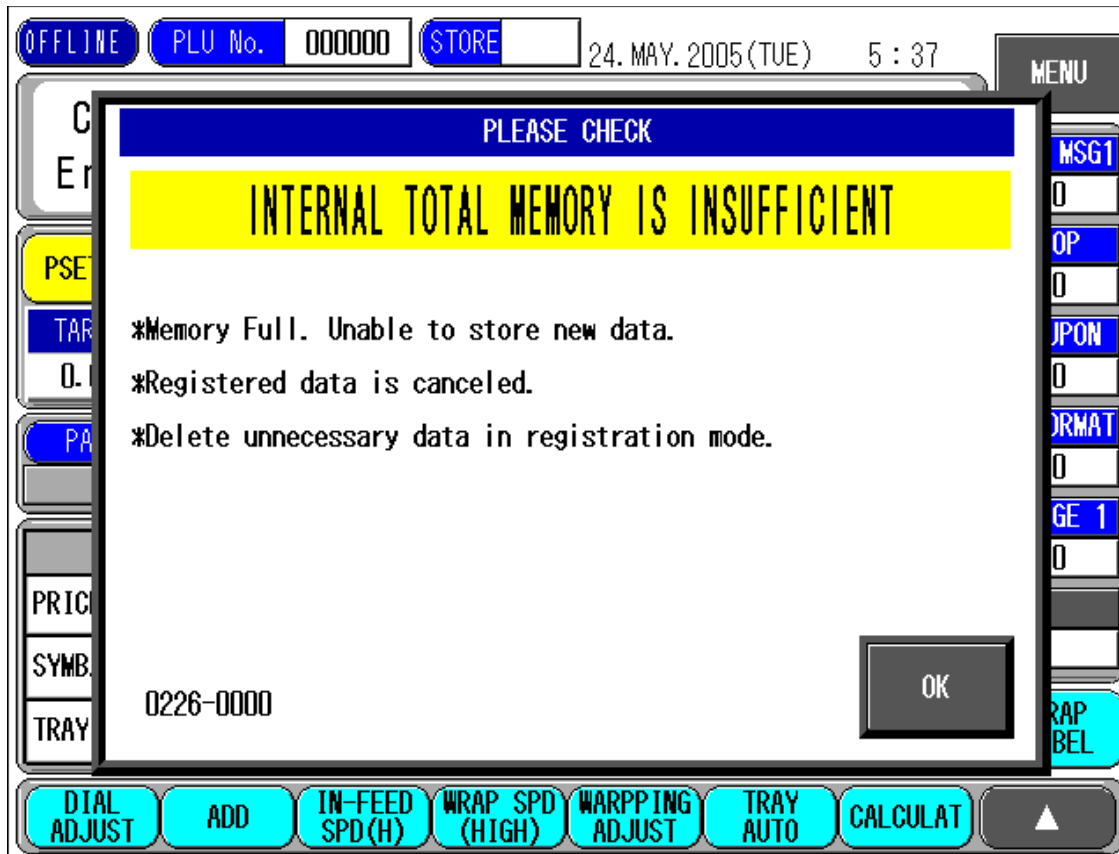
0226

[Error content]	Internal memory full error.
[Detail]	Insufficient internal master area free space.
[Solution]	[OK] button
[Remarks]	The data to be saved will be lost. Delete unnecessary data.
[Cause]	Internal memory full error.
[Response]	Delete unnecessary data.

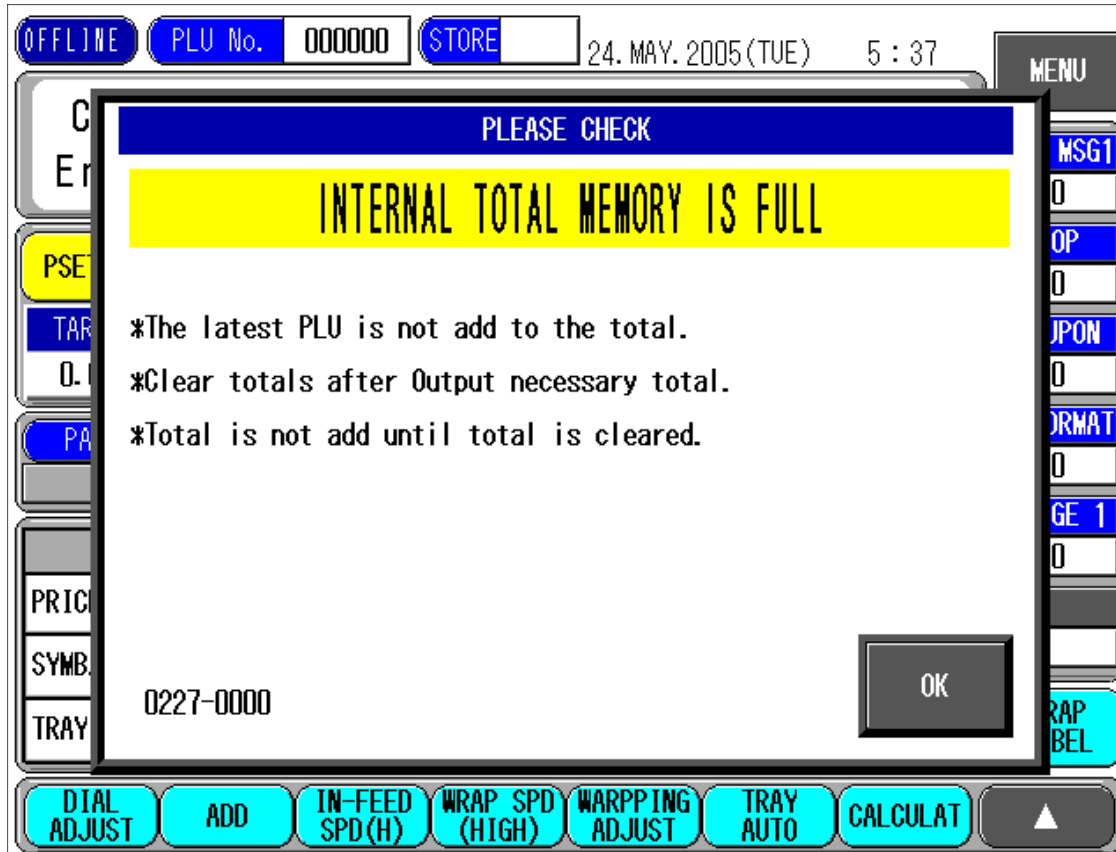
0227

[Error content]	Internal total memory full error.
[Detail]	Insufficient total memory.
[Solution]	[OK] button
[Remarks]	The data to be added will be lost. Delete total data
[Cause]	Internal total memory full error.
[Response]	Delete total data.

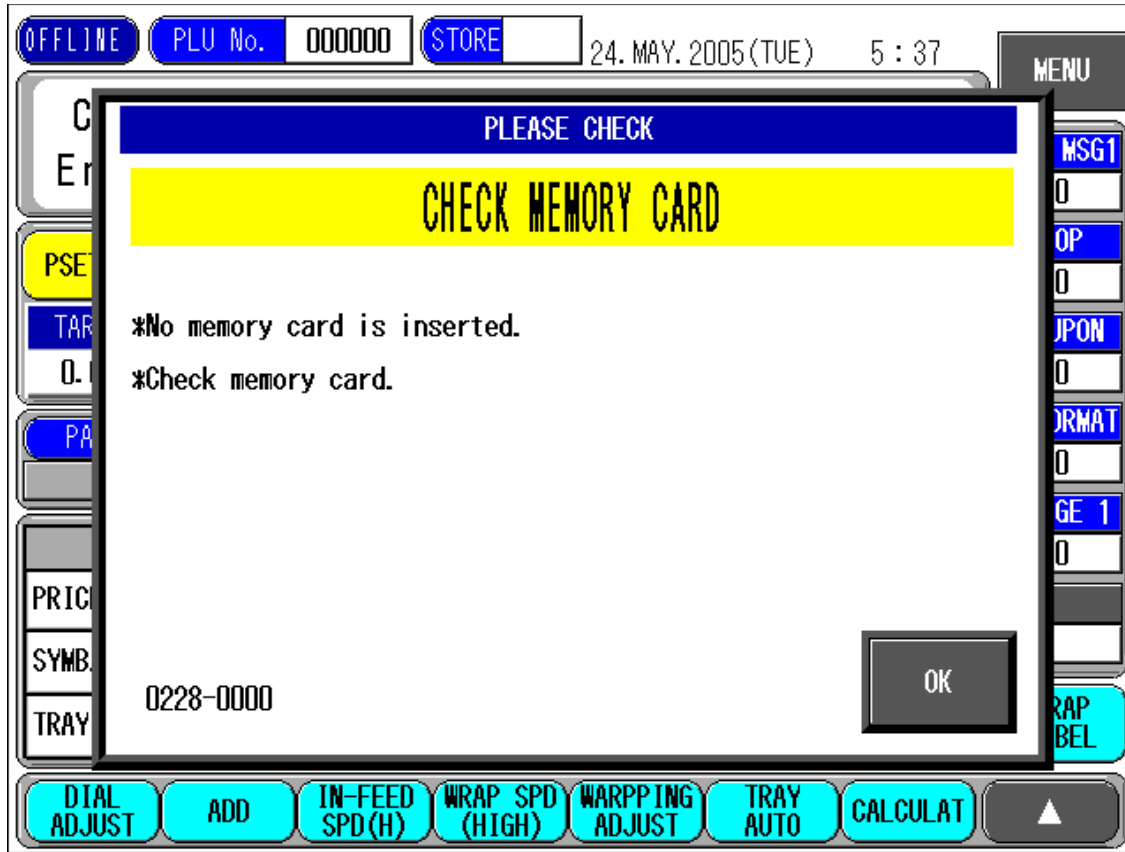
0228

[Error content]	No memory card is inserted.
[Detail]	This error occurs when save results are set to CF-2, SRAM 1, SRAM 2 in system mode option settings and the card is not inserted when normal mode is entered.
[Solution]	[OK] button
[Remarks]	
[Cause]	No memory card is inserted.
[Response]	Insert memory card.

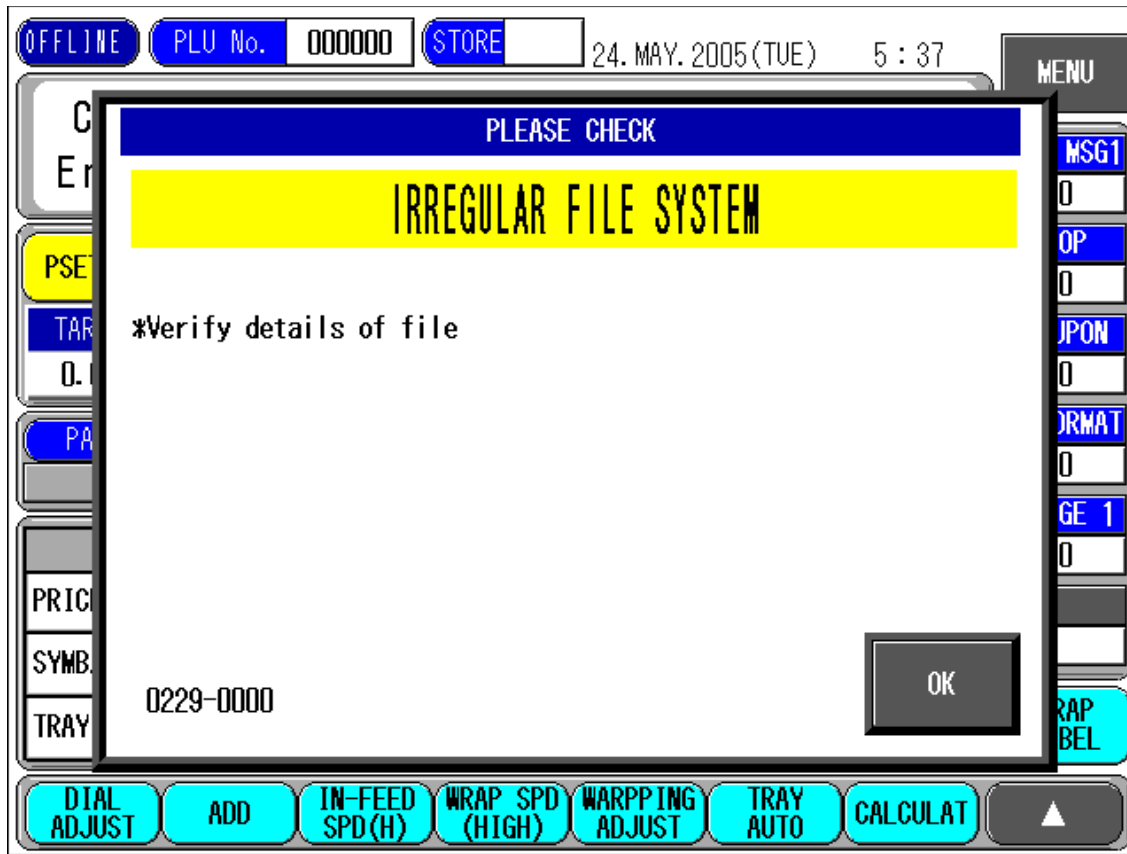
0229

[Error content]	Occurs when there is an internal file is abnormal.
[Detail]	Sub-error enters internal error details. (FMGR, H)
[Solution]	[OK] button
[Remarks]	Re-setup.
[Cause]	<ul style="list-style-type: none"> · No file · Unformatted
[Response]	<ol style="list-style-type: none"> 1. Remove the battery and let stand for ten minutes. Replace battery and reformat the RAM disk. 2. If it isn't fixed after reformatting, replace the P-910 board.

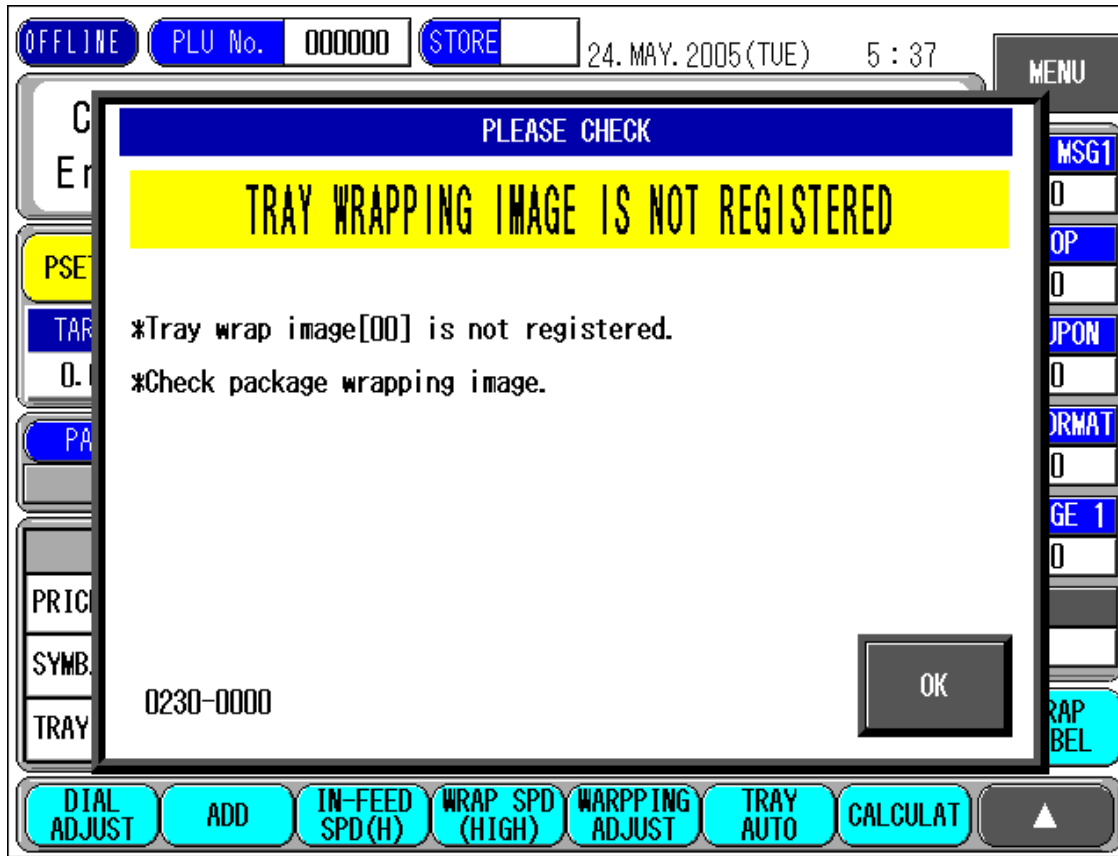
0230

[Error content]	Occurs when tray and packaging image is not in CF.
[Detail]	Occurs when multiple value functions have been set and the image for that number is not in CF.
[Solution]	[OK] button
[Remarks]	Re-setup
[Cause]	Occurs when tray and packaging image is not in CF
[Response]	Register tray and packaging image in CF.

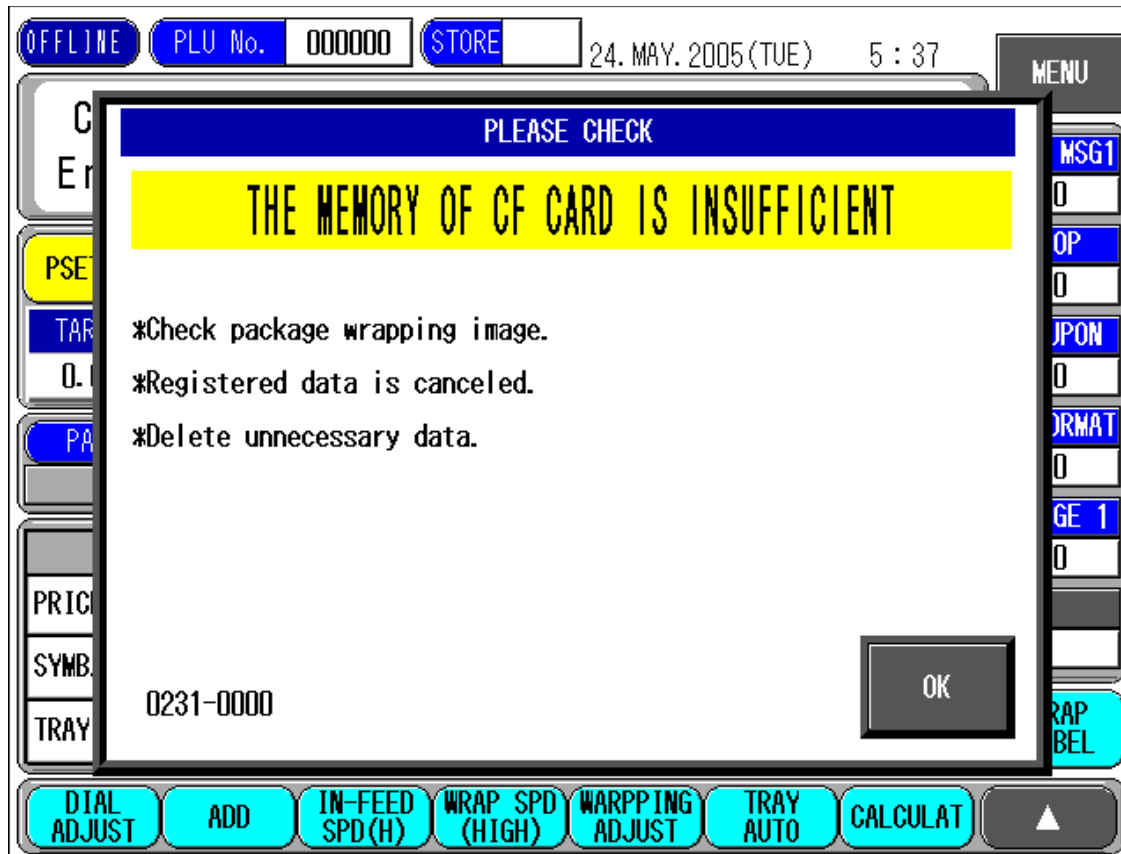
0231

[Error content]	Occurs when there is insufficient memory to write data on the CF card.
[Detail]	Occurs when there is insufficient CF card memory.
[Resolution]	[OK] button
[Remarks]	
[Cause]	Occurs when there is insufficient memory to write data on the CF card.
[Response]	Ensure space for writing data on the CF card.

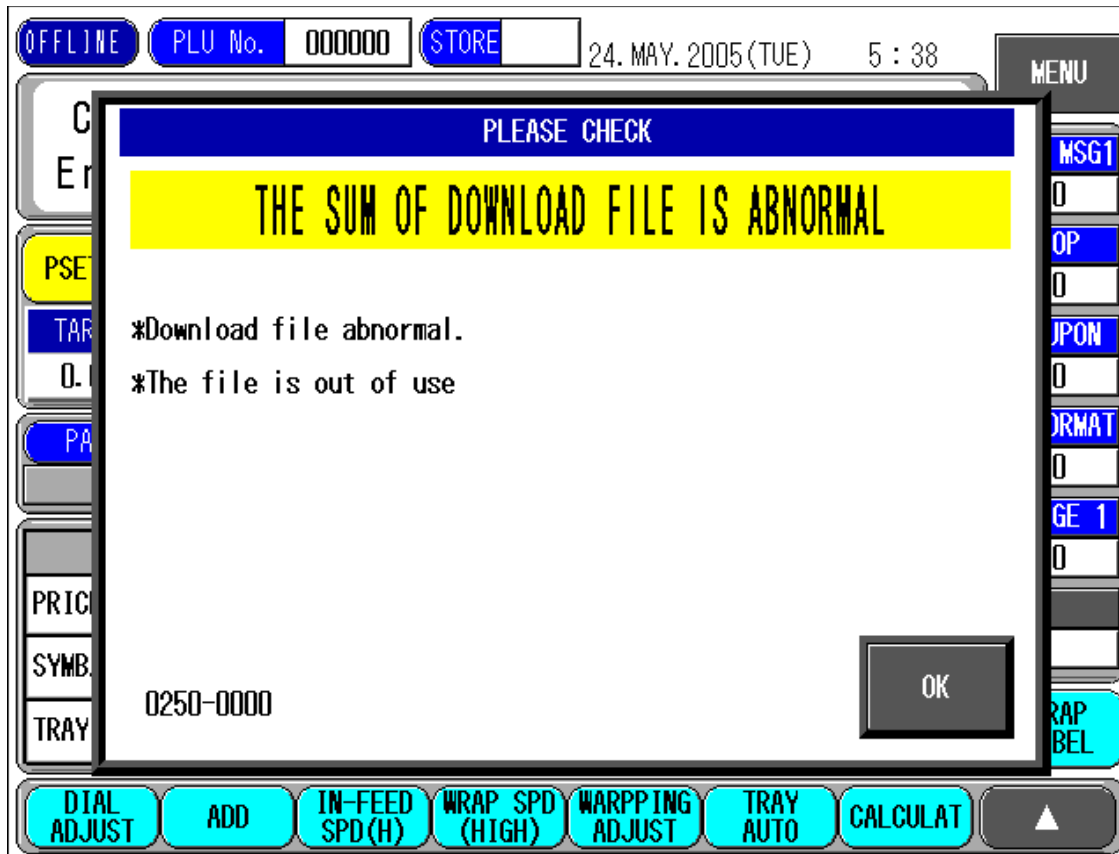
0250

[Error content]	Download file sum error.
[Detail]	Occurs during execution of program download in test mode. Occurs when the SUM value is out of sync in the download file (*.MOI).
[Solution]	[OK] button
[Remarks]	
[Cause]	1. There is an abnormality in the ***.MOI file on the CF. 2. CF is defective
[Response]	1. Replace all software on the CF. (There is the possibility of a writing error to CF) 2. Change CF .

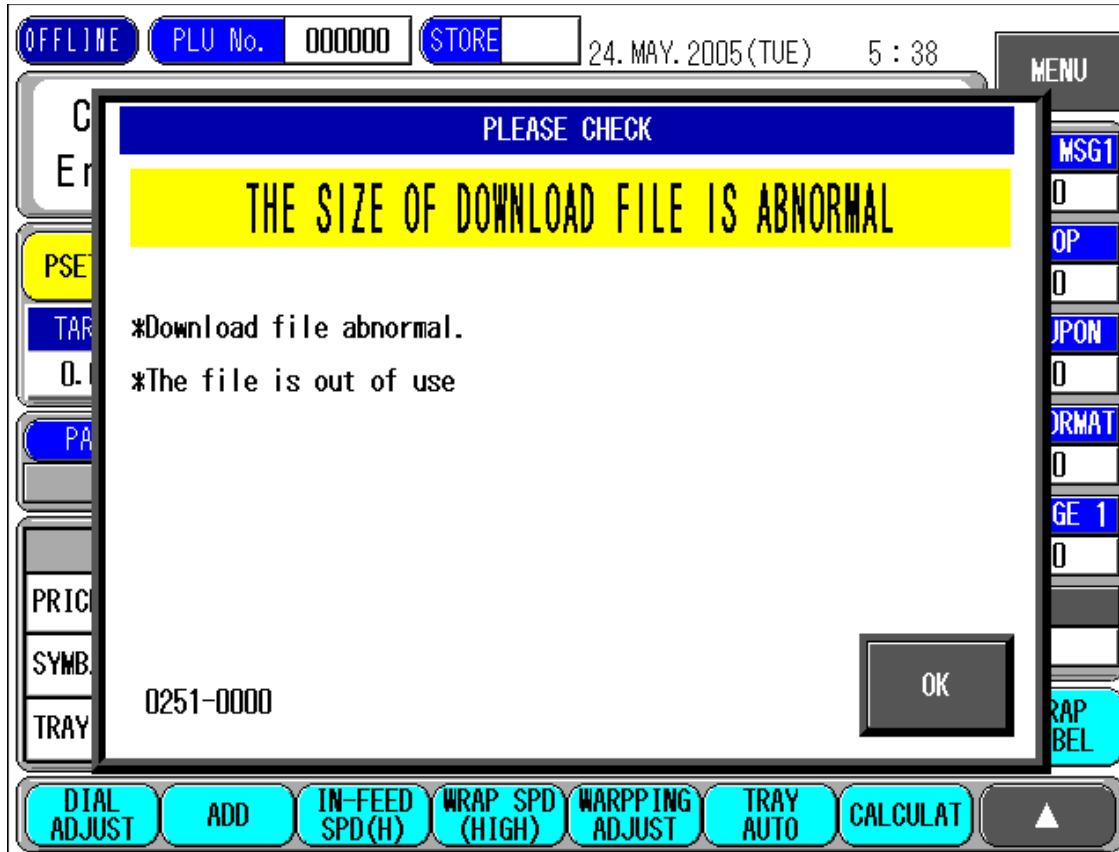
0251

[Error content]	Download file size error.
[Detail]	Occurs during execution of program download in test mode. Occurs when the download file (*.MOT) is larger than its download location.
[Solution]	[OK] button
[Remarks]	
[Cause]	Download file size error.
[Response]	This error does not normally occur. Reception-side space is already ensured when sending from the P-910 CF to the writing board. When this error occurs, re-write the program information on the CF board.

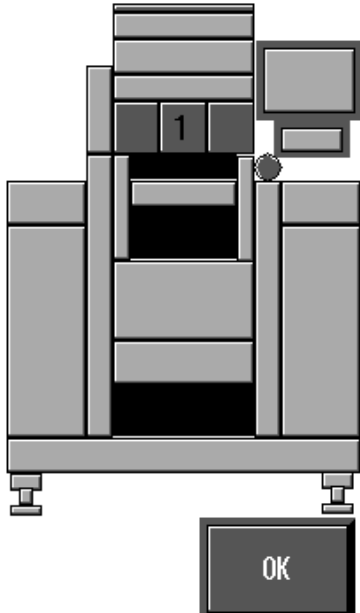
0301-0000

THE EMERGENCY STOP SWITCH IS PRESSED

*Release EMERGENCY STOP switch.

[Error content]	Emergency stop switch is pressed.
[Detail]	The emergency stop switch is pressed before operation. The emergency stop switch is blinking red on the wrapping unit display.
[Solution]	Release emergency stop switch, [OK] button
[Remarks]	
[Cause]	Emergency stop switch is pressed.
[Response]	Release emergency stop switch.

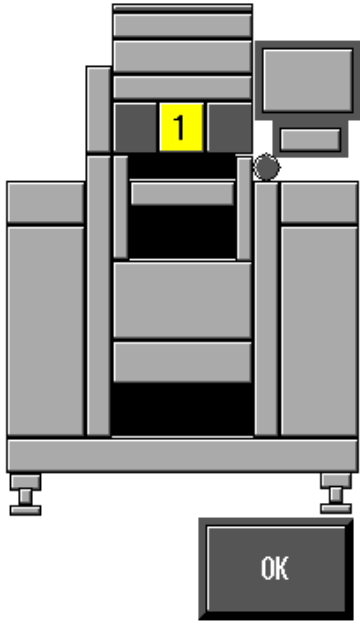
0302-0000

THE EMERGENCY STOP SWITCH IS NOT PRESSED

*Press EMERGENCY STOP switch.

[Error content]	Emergency stop switch is not pressed.
[Detail]	This occurs when the emergency stop switch is not pressed.
[Solution]	Press the emergency stop switch, [OK] button.
[Remarks]	
[Cause]	Emergency stop switch is not pressed.
[Response]	Press the emergency stop switch.

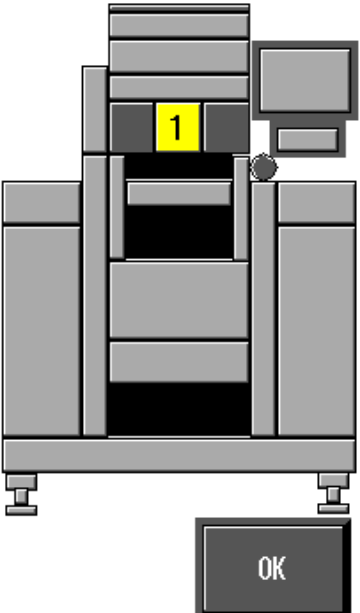
0303-0000

THE FRONT COVER IS OPEN

*Close front cover.

[Error content]	The front cover is open.
[Detail]	Occurs when the front cover is open before operation.
[Solution]	Close the front cover, [OK] button
[Remarks]	
[Cause]	The front cover is open.
[Response]	Close the front cover.

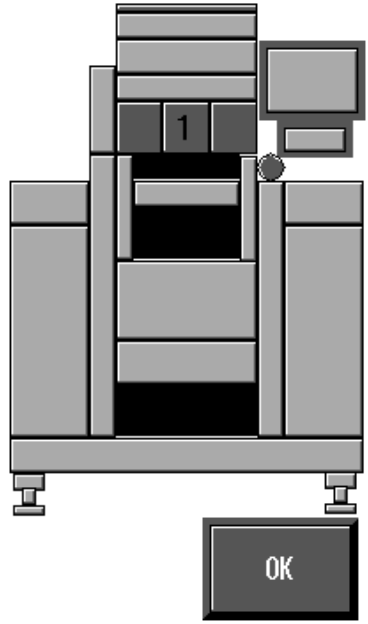
0304-0000

THE INFEED LOWER COVER IS OPEN

*Close infeed lower cover.

[Error content]	The infeed lower cover is open.
[Detail]	This occurs when the infeed lower unit cover is open before operation.
[Solution]	Close the infeed lower cover, [OK] button
[Remarks]	
[Cause]	The infeed lower cover is open.
[Response]	Close the infeed lower cover.

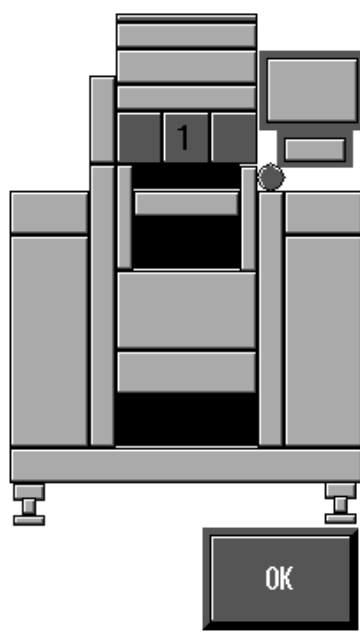
0305-0000

THE INFEED COVER IS OPEN

*Close infeed cover.

[Error content]	The infeed cover is open.
[Detail]	Occurs when the infeed unit is open before operation.
[Solution]	Close the infeed cover, [OK] button
[Remarks]	
[Cause]	The infeed cover is open.
[Response]	Set the infeed unit.

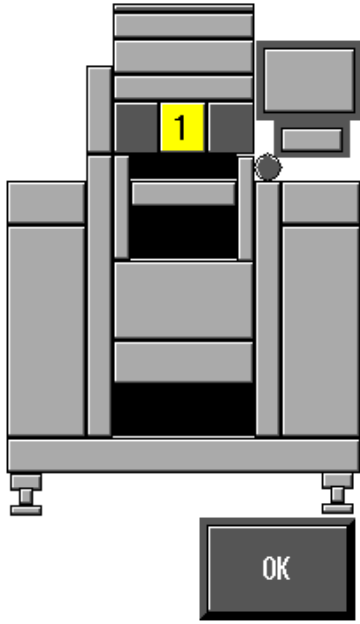
0307-0000

LEFT SIDE FILM REMOVAL DOOR IS OPEN

*Close film remove door.

[Error content]	Left side film removal door is open.
[Detail]	Occurs when the left side film removal cover is open before operation.
[Solution]	Close left side film removal door, [OK] button
[Remarks]	
[Cause]	Left side film removal door is open.
[Response]	Close left side film removal door.

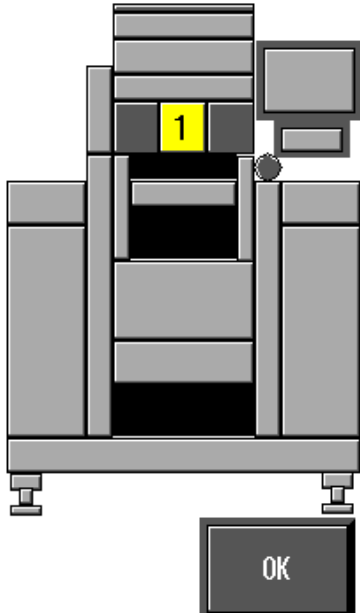
0310-0000

THE OUTFEED HAS PULLED UP

*Take down the outfeed.

[Error content]	The outfeed unit is pushed up.
[Detail]	Occurs when the outfeed unit is pushed up before operation.
[Solution]	Lower outfeed unit, [OK] button
[Remarks]	
[Cause]	The outfeed unit is pushed up.
[Response]	Lower outfeed unit.

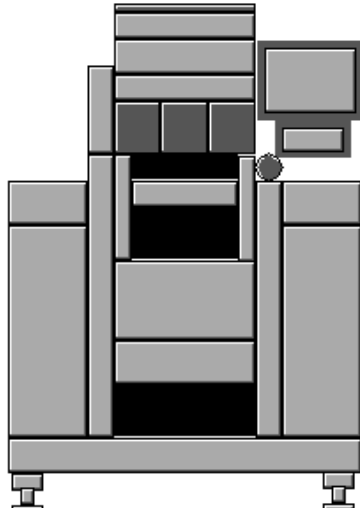
0312-0000

*Press numeric key to clear error.

[Error content]	Label remains in the printer when operation started.
[Detail]	Separated by Bit. Bit0 : Printer no. 1 Bit1 : Printer no. 2 Bit2 : Printer no. 3 Bit3 : Printer no. 4 Bit7 : Applicator Bit11 : Product in the wrapper
[Solution]	Remove label, numeric keys
[Remarks]	
[Cause]	Label remains in the printer when operation started.
[Response]	Remove the label according to the sub-error.

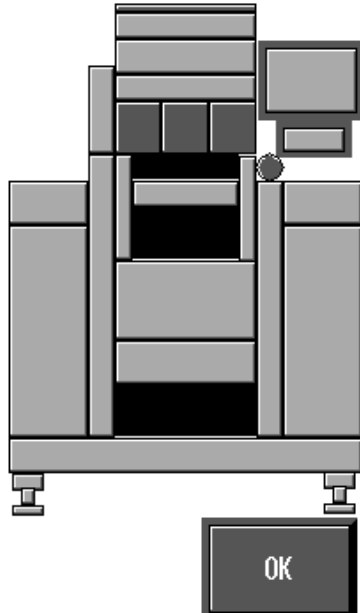
0313-0000

*The following thermal header is pulled up.

- 1)For Printer #1~2, open the front cover.
- 2)For Printer #4, Take out B-Label printer.
- 3)Set the thermal head of printer.

[Error content]	The printer thermal head is in the up position.
[Detail]	Separated by Bit. Bit0 : Printer no. 1 Bit1 : Printer no. 2 Bit2 : Printer no. 3 Bit3 : Printer no. 4
[Solution]	Set thermal head, [OK] button
[Remarks]	
[Cause]	The printer thermal head is in the up position.
[Response]	According to the sub-error 1. Set thermal head. 2. Check head up sensor.

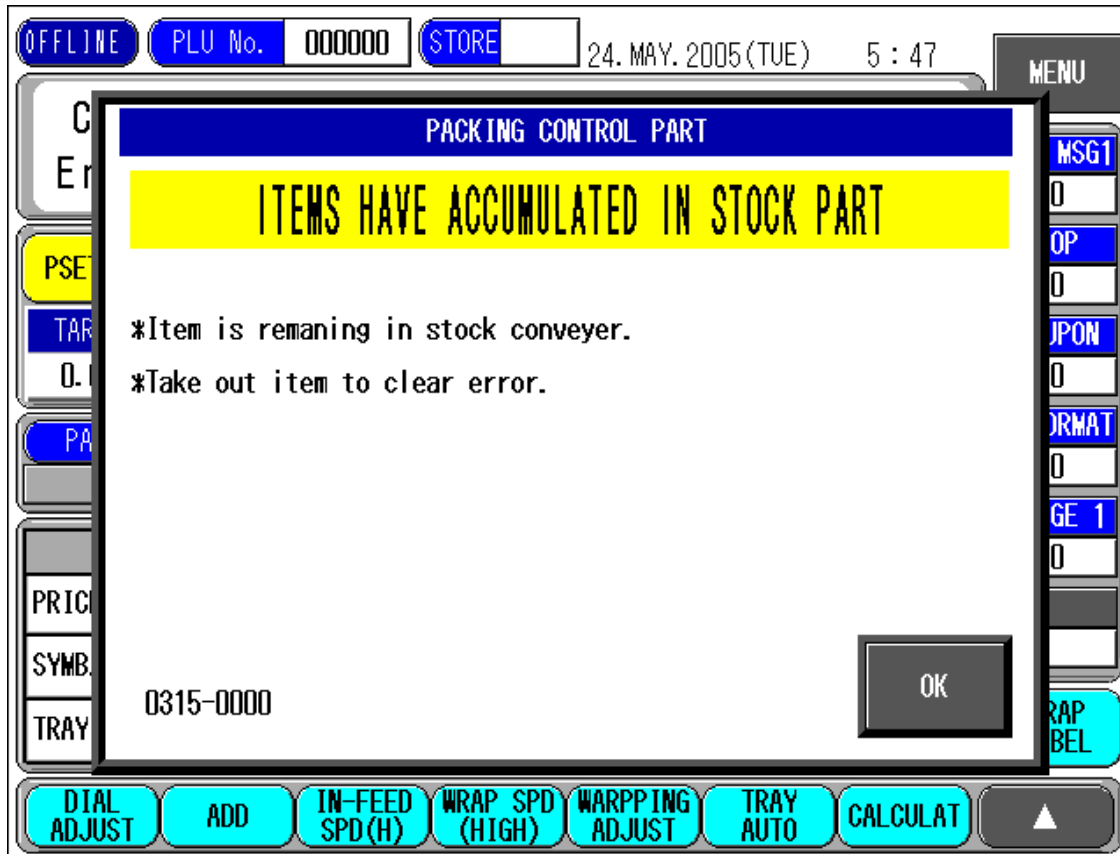
0315

[Error content]	Items remain in the stock unit.
[Detail]	
[Solution]	[OK] button, remove item in stock unit
[Remarks]	This error only occurs in type J.
[Cause]	Items remain in the stock unit.
[Response]	<ol style="list-style-type: none"> 1. Confirm that product does not remain in the stock unit. 2. Check capacity detection sensor movement.

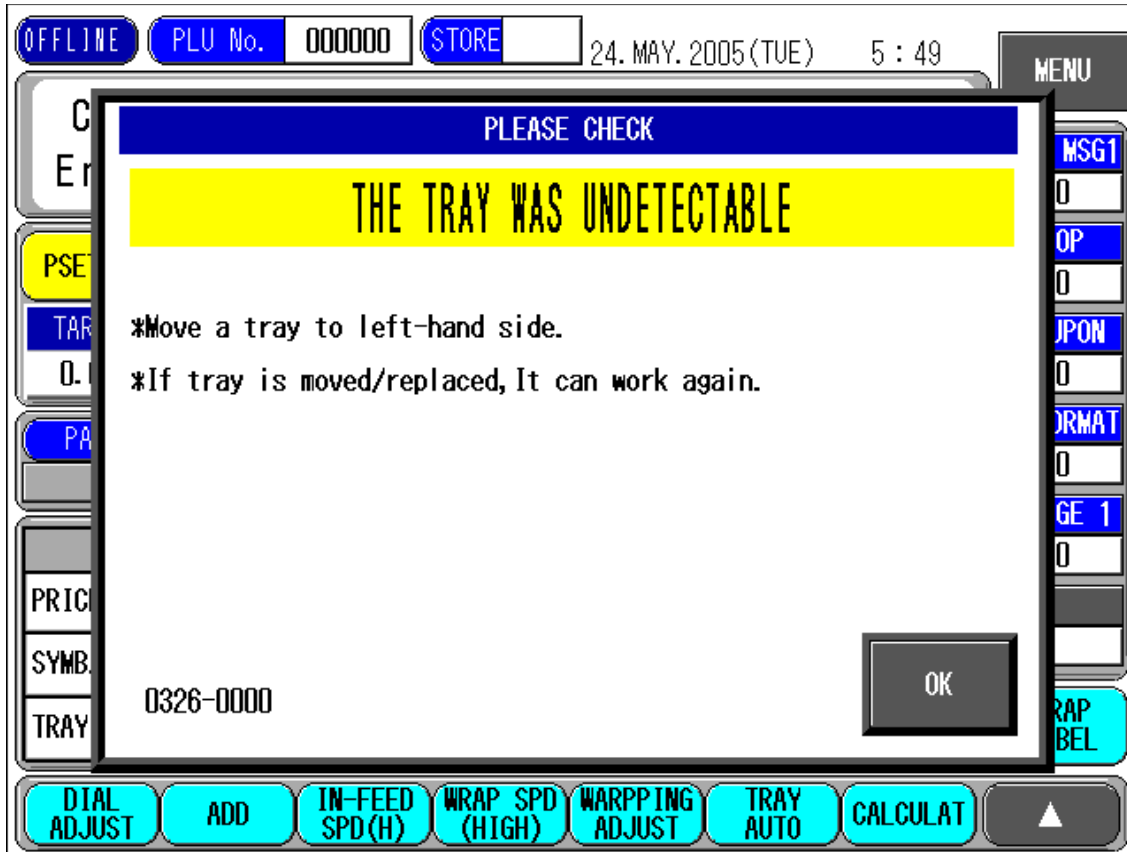
0326

[Error content]	Tray detection error.
[Detail]	The right side of the tray is protruding.
[Solution]	Fix tray placement, [OK] button
[Remarks]	
[Cause]	Tray detection error.
[Response]	<ol style="list-style-type: none"> 1. Fix tray placement. 2. If the error persists: <ul style="list-style-type: none"> ◦ Is the tray dirty? ◦ Is it exposed to direct sunlight? ◦ Have the surroundings changed since the camera was adjusted? ◦ Perform camera adjustment if the problem is not resolved by the above.

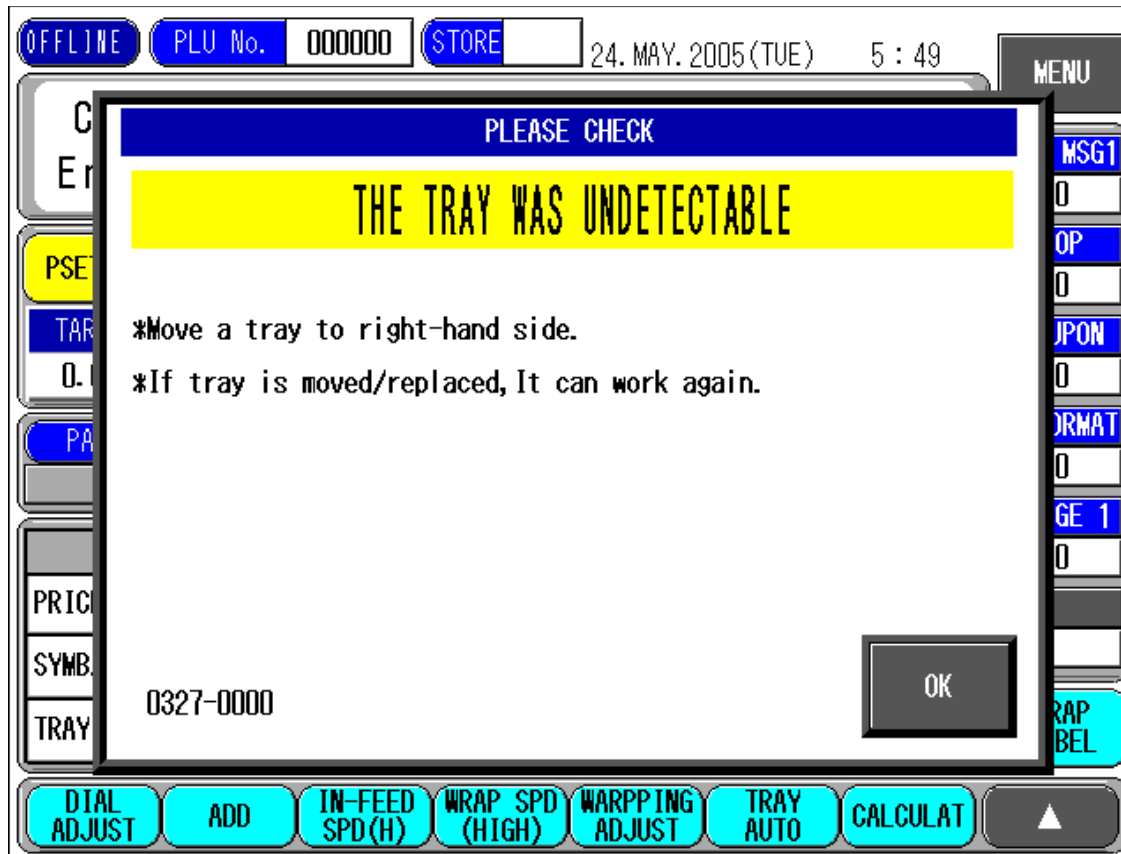
0327

[Error content]	Tray detection error.
[Detail]	The left side of the tray is protruding.
[Solution]	Fix tray placement, [OK] button
[Remarks]	
[Cause]	Tray detection error.
[Response]	<ol style="list-style-type: none"> 1. Fix tray placement. 2. If the error persists: <ul style="list-style-type: none"> ▪ Is the tray dirty? ▪ Is it exposed to direct sunlight? ▪ Have the surroundings changed since the camera was adjusted? ▪ Perform camera adjustment if the problem is not resolved by the above.

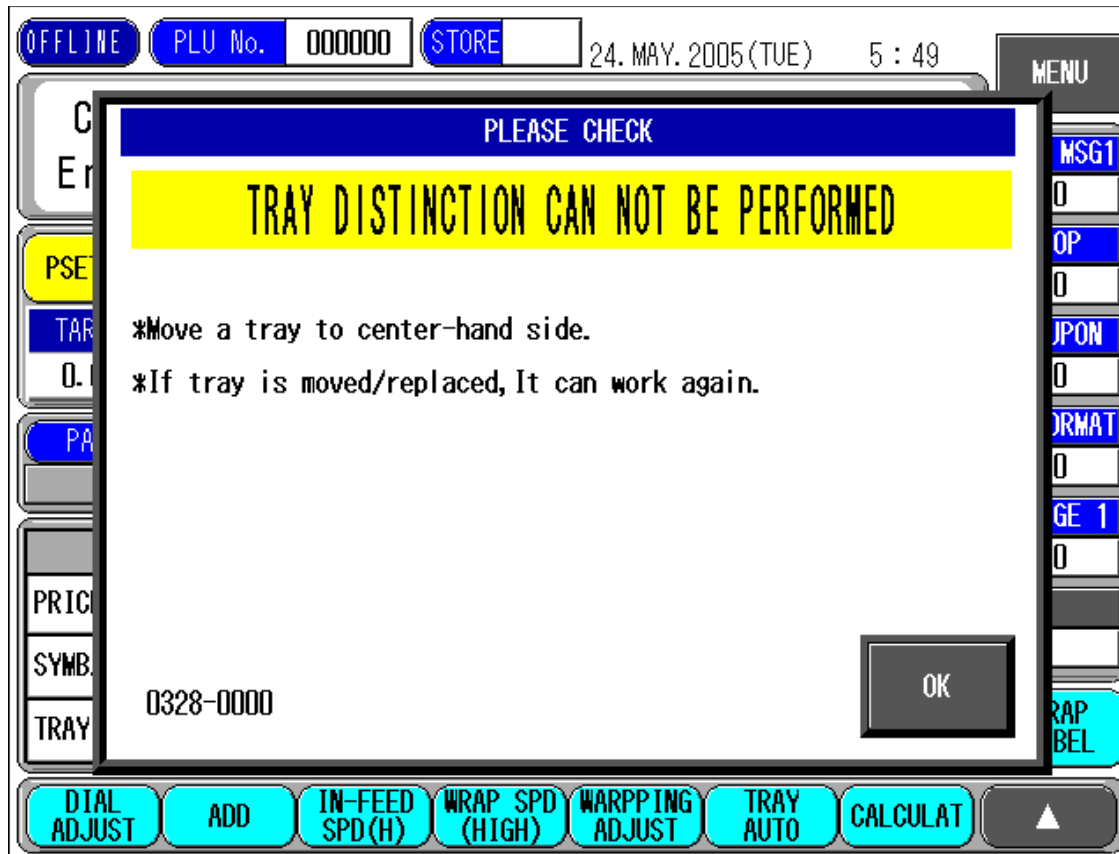
0328

[Error content]	Tray detection error.
[Detail]	Right and left sides of the tray are protruding. Sub-error 1 data anomaly
[Solution]	Fix tray placement, [OK] button
[Remarks]	
[Cause]	Tray detection error.
[Response]	<ol style="list-style-type: none"> 1. Fix tray placement. 2. If the error persists: <ul style="list-style-type: none"> ▪ Is the tray dirty? ▪ Is it exposed to direct sunlight? ▪ Have the surroundings changed since the camera was adjusted? ▪ Perform camera adjustment if the problem is not resolved by the above.

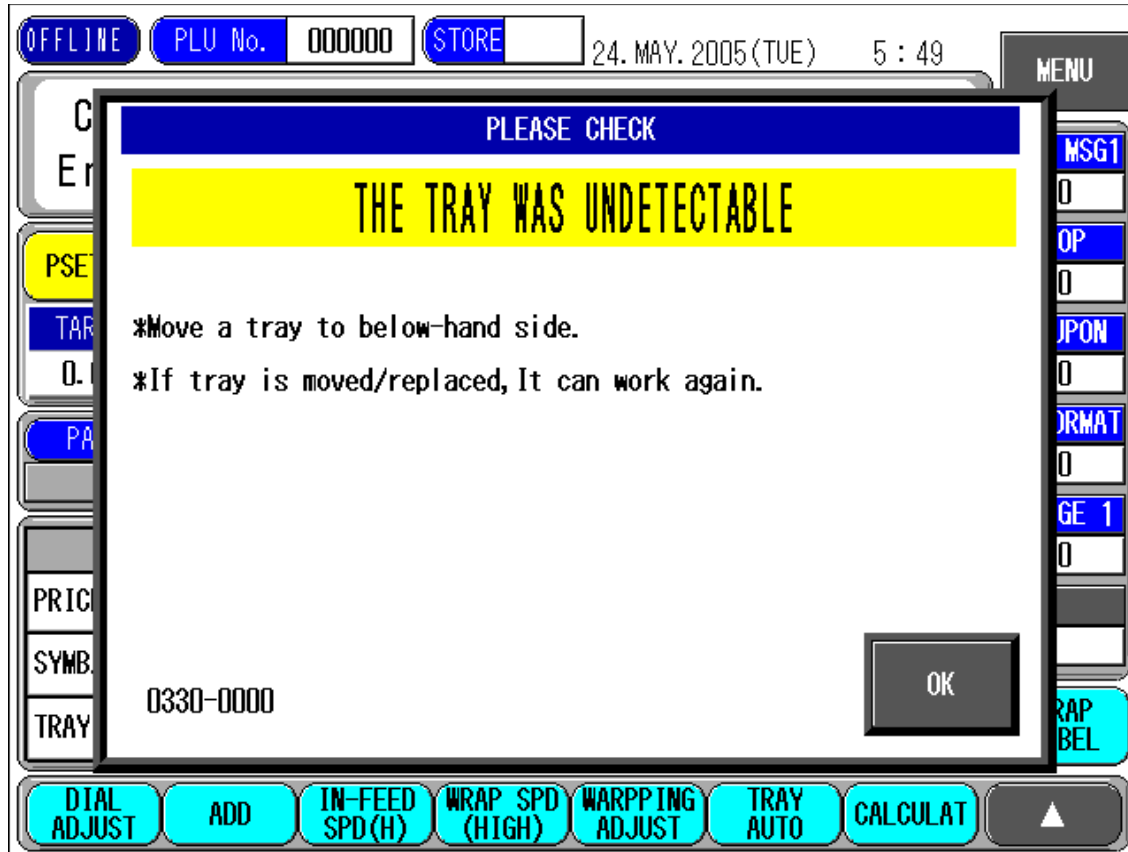
0330

[Error content]	Tray detection error.
[Detail]	Bottom of the tray is protruding.
[Solution]	Fix tray placement, [OK] button
[Remarks]	
[Cause]	Tray detection error.
[Response]	<ol style="list-style-type: none"> 1. Fix tray placement. 2. If the error persists: <ul style="list-style-type: none"> ◦ Is the tray dirty? ◦ Is it exposed to direct sunlight? ◦ Have the surroundings changed since the camera was adjusted? ◦ Perform camera adjustment if the problem is not resolved by the above.

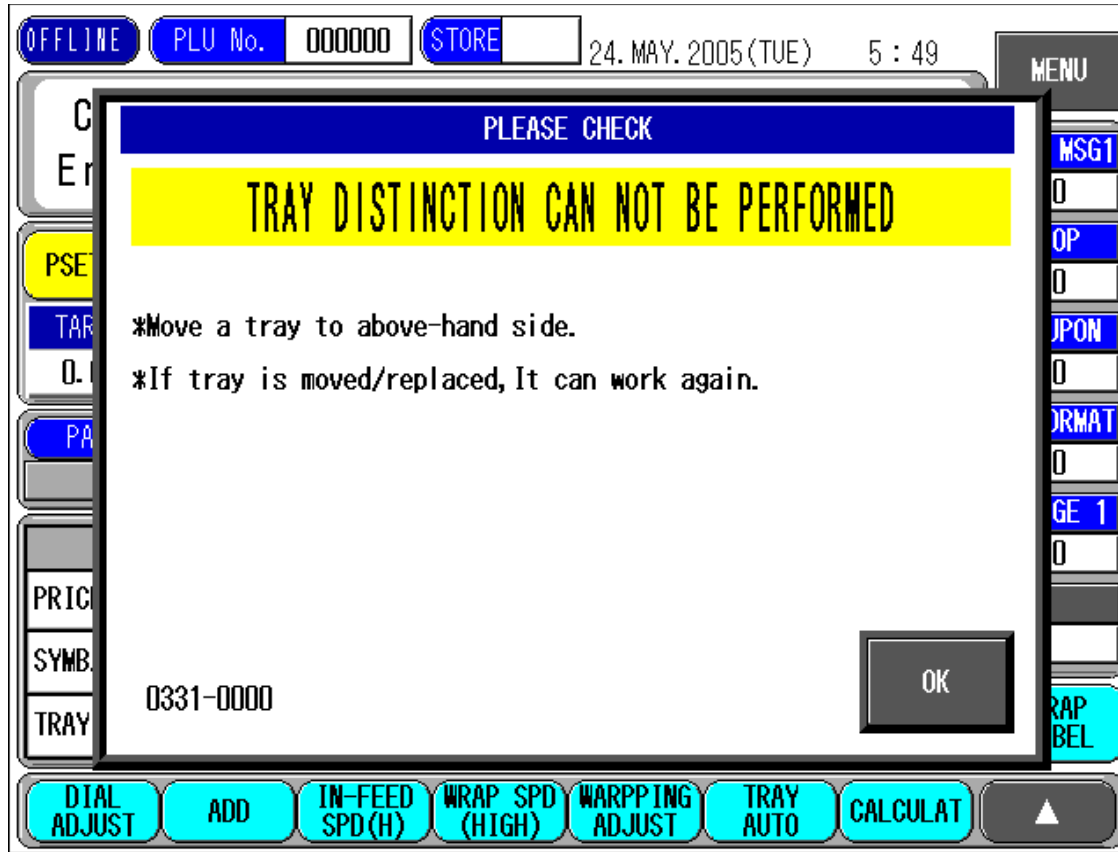
0331

[Error content]	Tray detection error.
[Detail]	Top and bottom of the tray are protruding.
[Solution]	Fix tray placement, [OK] button
[Remarks]	
[Cause]	Tray detection error.
[Response]	<ol style="list-style-type: none"> 1. Place tray as indicated. 2. If this error persists: <ul style="list-style-type: none"> ◦ Is the tray dirty? ◦ Is it exposed to direct sunlight? ◦ Have the surrounding changed since the camera was adjusted? ◦ Perform camera adjustment if the problem is not resolved by the above.
