WM-4000 AUTOMATIC WRAPPER

Error Codes and Solutions

100 – 399

March 2015

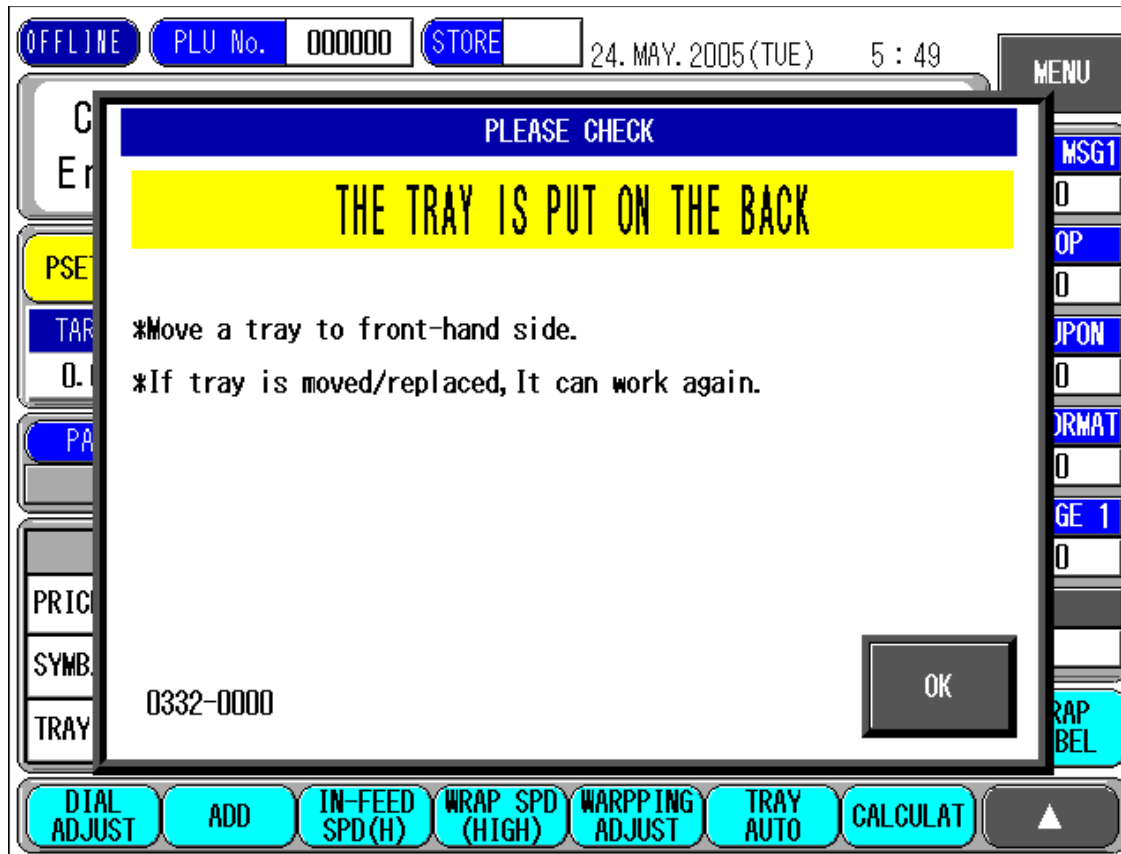
0332

[Error content]	Tray detection error.
[Detail]	Tray is located more than 5cm from the infeed bar.
[Solution]	Fix tray placement, [OK] button
[Remarks]	
[Cause]	Tray detection error.
[Response]	<ol style="list-style-type: none"> 1. Place tray as indicated. 2. If the error persists: <ul style="list-style-type: none"> ◦ Is the tray dirty? ◦ Is it exposed to direct sunlight? ◦ Have the surroundings changed since the camera was adjusted? ◦ Perform camera adjustment if the problem is not resolved by the above.

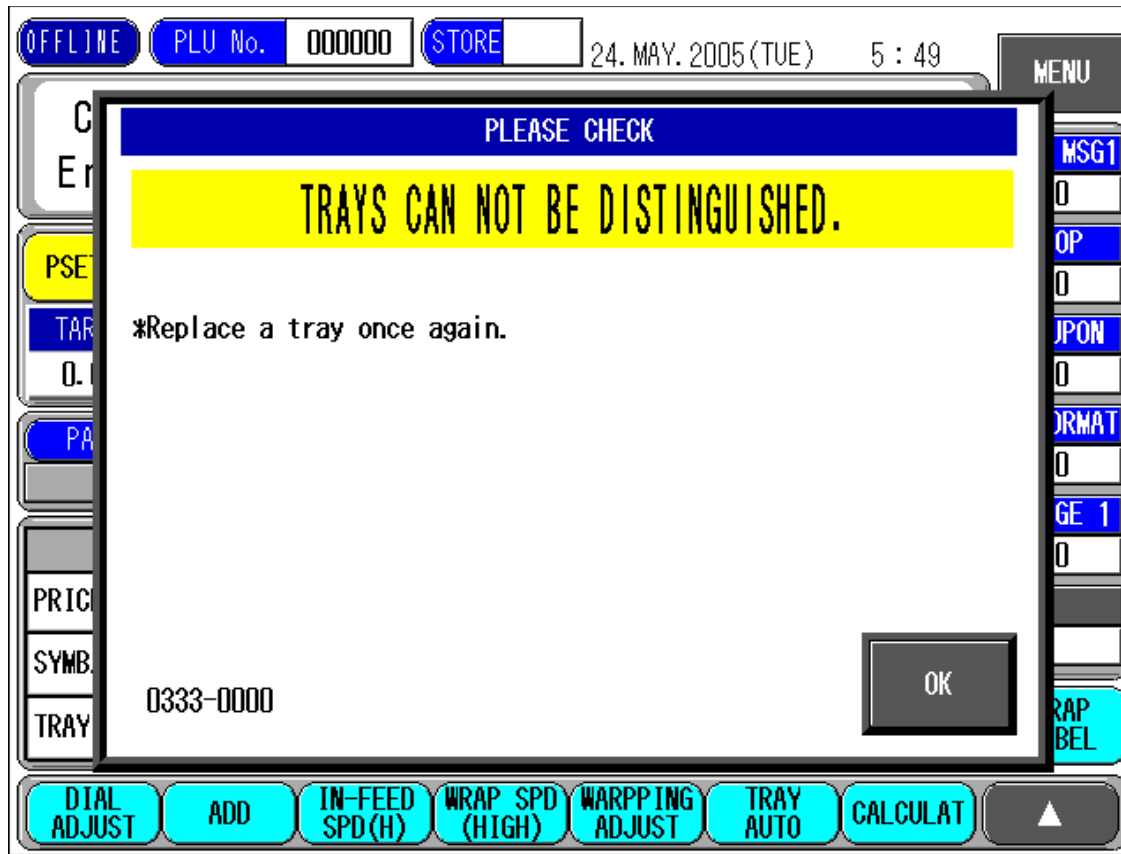
0333

[Error content]	Tray detection error.
[Detail]	Sub-error 0: No corresponding tray. Sub-error 1's column is 1: Detected length data is 0 Sub-error 10's column is 1: Detected narrow side data is 0 Sub-error 100's column is 1: Detected height data is 0
[Solution]	Fix tray placement, [OK] button
[Remarks]	
[Cause]	Tray detection error.
[Response]	<ol style="list-style-type: none"> 1. Fix tray placement. 2. If the error persists: <ul style="list-style-type: none"> ◦ Is the tray dirty? ◦ Is it exposed to direct sunlight? ◦ Have the surroundings changed since the camera was adjusted? ◦ Perform camera adjustment if the problem is not resolved by the above.

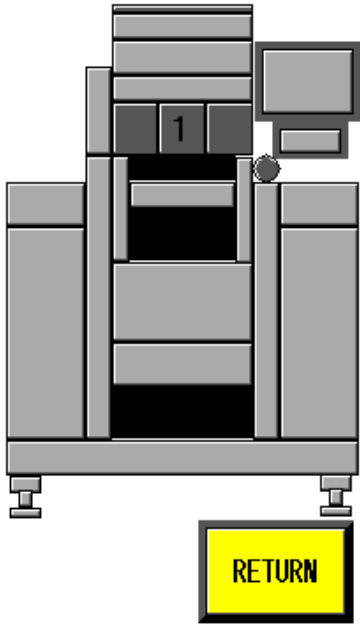
0337-0000

1) Press EMERGENCY switch, REMOVE item on lift and infeed conveyor.
 2) Open the front cover and remove the label.

*Display goes back when the label is removed.
 *Label feeds by pressing flashing yellow.

The diagram shows a cross-section of the machine's internal mechanism. A central vertical shaft is visible, with a component labeled '1' at the top. To the right, there is a control panel with a monitor. Below the machine, a yellow button with the word 'RETURN' in black text is shown.

[Error content]	Data has been deleted.
[Detail]	
[Solution]	Perform return processing by pressing the [RETURN] button.
[Remarks]	This screen is displayed when the data value and items in the wrapper become invalid.
[Cause]	Data has been deleted.
[Resolution]	Perform return processing by pressing the [RETURN] button.

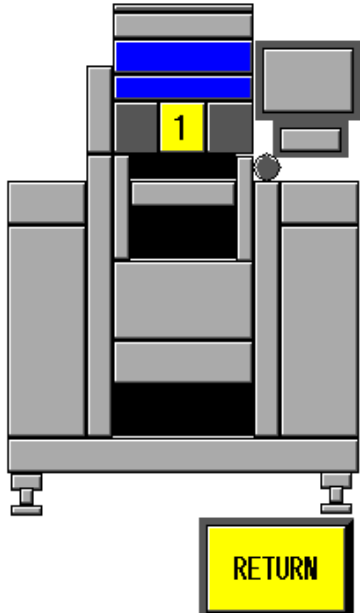
0340-0000

2) Open the front cover and remove the label.

*Display goes back when the label is removed.
 *Label feeds by pressing flashing yellow.

[Error content]	The item was deleted.
[Detail]	
[Solution]	Press the [RETURN] button to perform return processing.
[Remarks]	This screen is displayed when the item in the wrapper becomes invalid as a result of item deletion.
[Cause]	The item was deleted.
[Response]	Press the [RETURN] button to perform return processing.

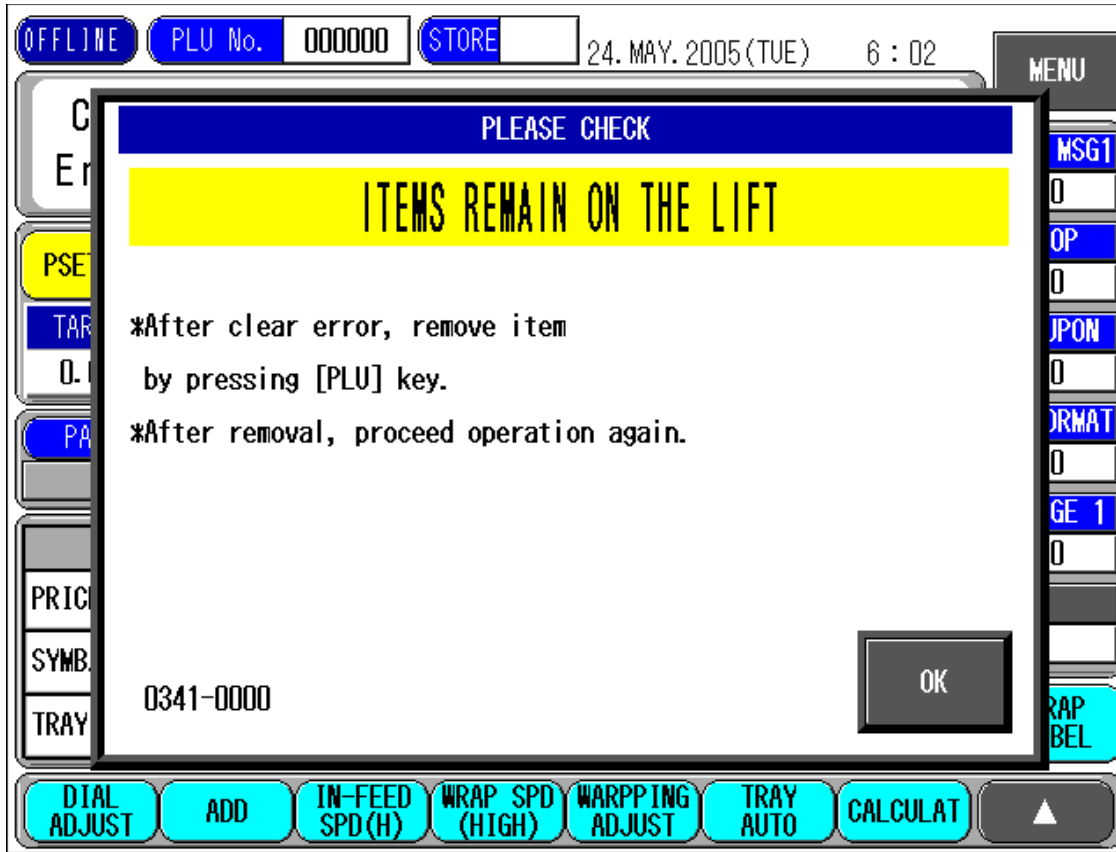
0341

[Error content]	Items remain on the lift.
[Detail]	
[Solution]	[OK] button
[Remarks]	Press the [PLU] button and remove the item after clearing the error.
[Cause]	Items remain on the lift.
[Response]	<ol style="list-style-type: none"> 1. Confirm no items remain on the lift. 2. Check the commodity on lift detection sensor.

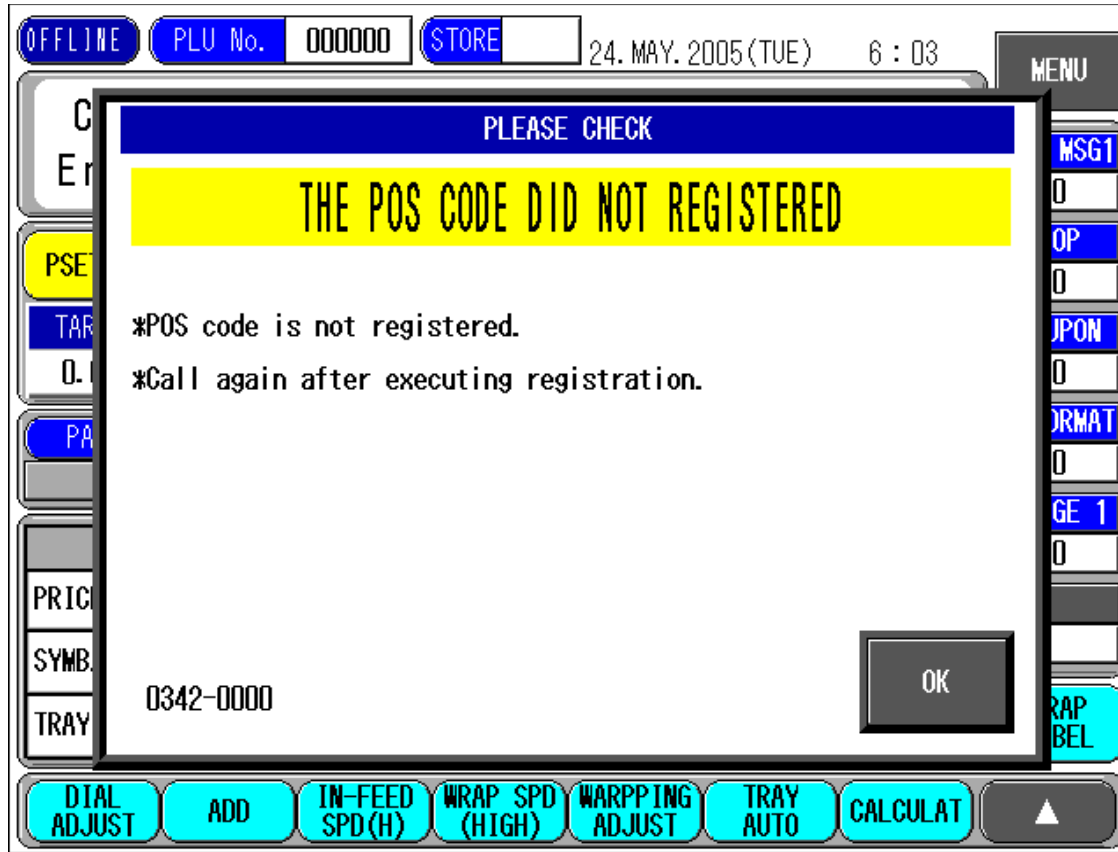
0342

[Error content]	POS code is not registered.
[Detail]	
[Solution]	[OK] button
[Remarks]	This error only occurs when "POS code unregistered error" is set. Labels cannot be issued.
	Shown when printing is not allowed in the event of a POS code unregistered error in setting mode 2 (error processing selection settings).
[Cause]	POS code is not registered.
[Response]	Register POS code.

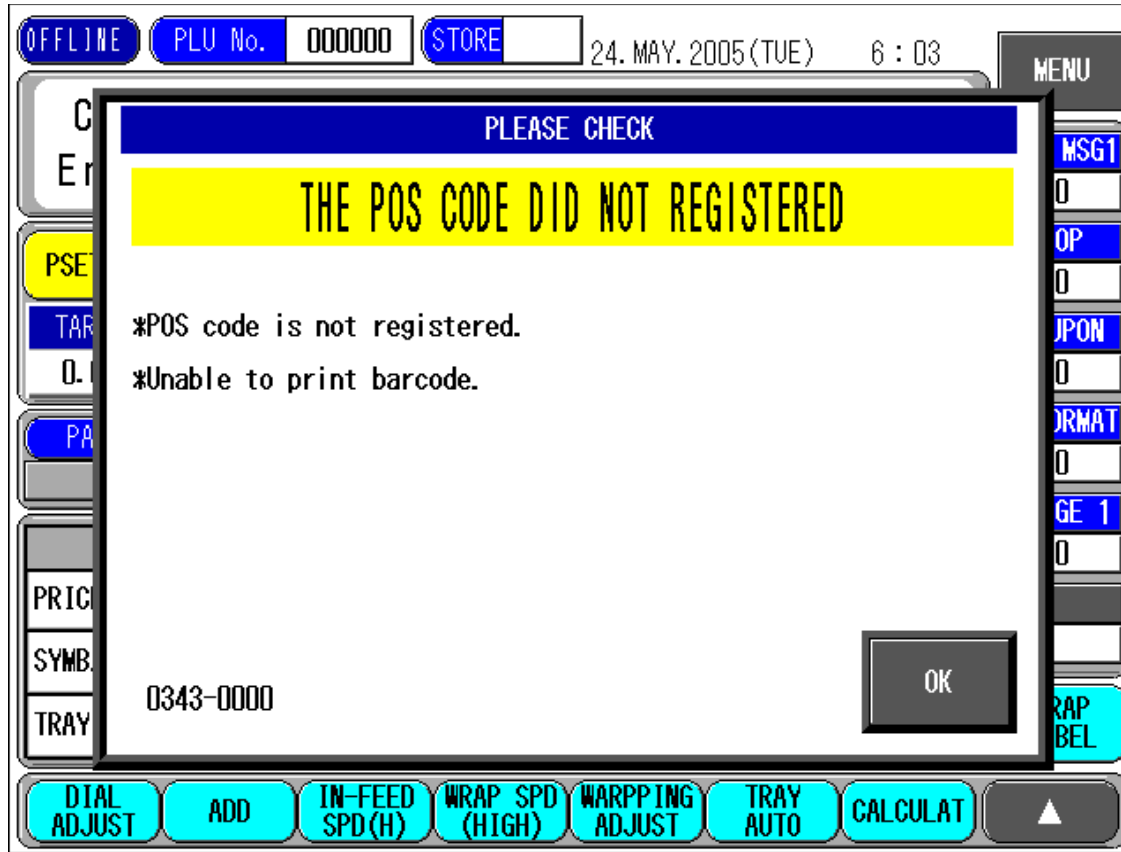
0343

[Error content]	POS code is not registered.
[Detail]	
[Solution]	[OK] button
[Remarks]	This error occurs only when "POS code unregistered error" is set. Labels can be issued, but barcodes will not be printed.
	Shown when "no barcode" is set for POS code unregistered error in setting mode 2 (error processing selection settings).
[Cause]	POS code is not registered.
[Response]	Register POS code.

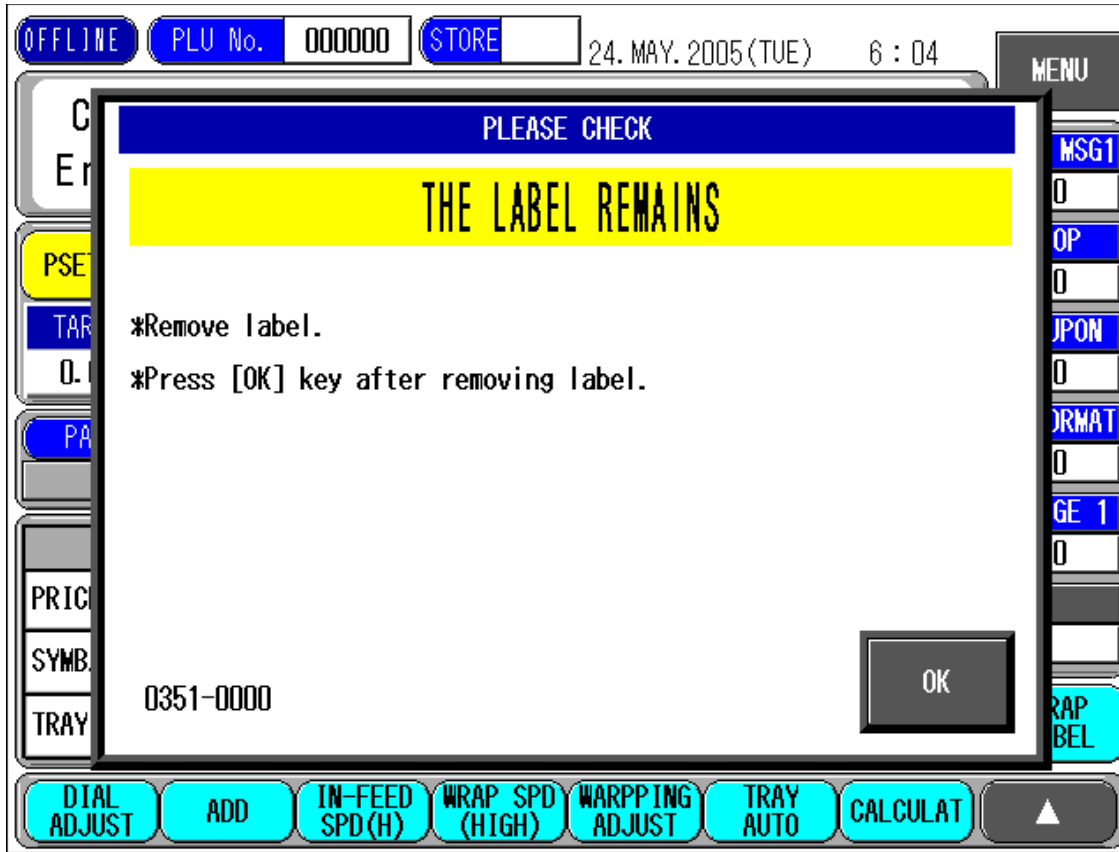
0351

[Error content]	A label remains.
[Detail]	
[Solution]	Remove label, [OK] button
[Remarks]	
[Cause]	A label remains.
[Response]	<ol style="list-style-type: none"> 1. Remove label. 2. Check label sensor.

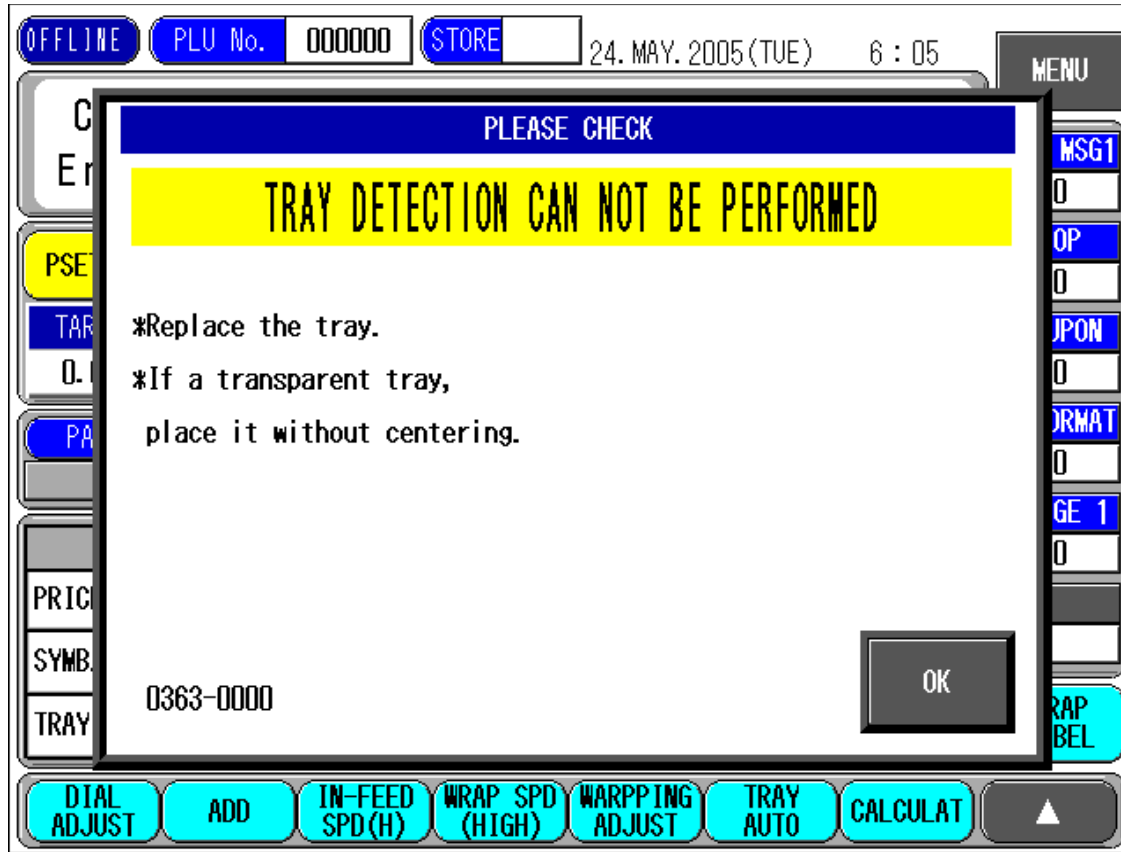
0363

[Error content]	Tray can't be detected
[Detail]	Occurs when a centered tray can't be detected normally. Occurs when a transparent tray is set to the above conditions.
[Solution]	Unstable, [OK] button
[Remarks]	
[Cause]	Tray can't be detected
[Response]	<ul style="list-style-type: none"> · If it is a clear tray, place it without centering. · If it is a regular tray, perform camera adjustment.

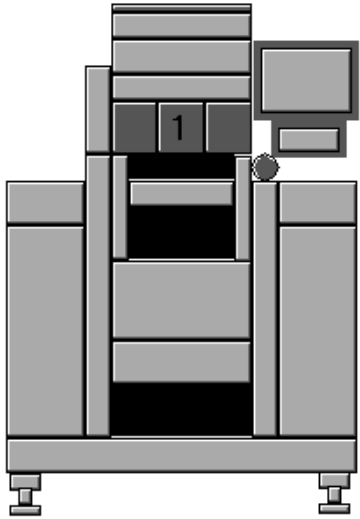
0368-0000

PLEASE CHECK

ITEMS REMAIN IN THE WRAPPER

*Close front cover.
*Then, Discharge by [PLU] key.

[Error content]	The front cover was opened when the wrapper stopped and items remained on the lift.
[Detail]	This is an error for when the front cover was opened in the initial stages.
[Solution]	[PLU] key
[Remarks]	Item is discharged by pressing the [PLU] key. Added to the total amount.
[Cause]	The front cover was opened when the wrapper stopped and items remained on the lift.
[Response]	To close the cover, press the [PLU] key to discharge the item.

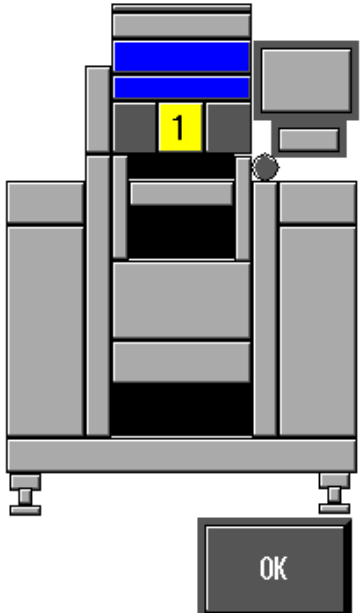
0372-0000

*AUTO LABELING → Close the front cover,
Set the printer #4(B-Label).

*DP mode → Open the front cover,
Pull out the printer #4(B-Label)

[Error content]	Choose auto-paste/DP mode
[Detail]	This only occurs for items with b-labels in the following cases of scale stability: The front cover is opened and the B-label printer is set. The front cover is closed and the B-label printer is pulled out.
[Solution]	Set bottom applicator and close the front cover. Pull out the bottom applicator and open the front cover. [OK] button
[Remarks]	This error only occurs in versions with a bottom applicator.
[Cause]	When the front cover is opened and the B-label printer is set. When the front cover is closed and the B-label printer is pulled out.
[Response]	<ol style="list-style-type: none"> 1. Bottom applicator is set: check if the front cover is closed 2. Bottom applicator is pulled out: check if the front cover is closed 3. Check the bottom label sensor operation 4. Check the wiring [sensor - P922 (XJ1)]

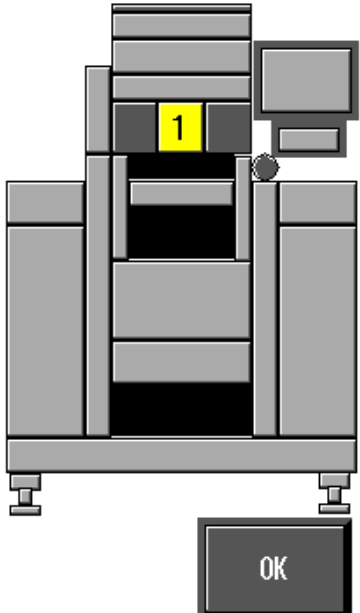
0373-0000

It is necessary to set a stock part.

*Set it to clear error.

[Error content]	Set a stock part
[Detail]	The following occurs for items with b-labels when the scale is stable and a stock unit part is not set.
[Solution]	Set a stock part [OK] button
[Remarks]	This error only occurs in variations with a bottom applicator
[Cause]	The following occurs for items with b-labels when the scale is stable and a stock unit part is not set.
[Response]	<ol style="list-style-type: none"> 1. Is the stock conveyor un-folded? 2. Check the folding sensor operation 3. Check the wiring [sensor - P922 (XJ15)]

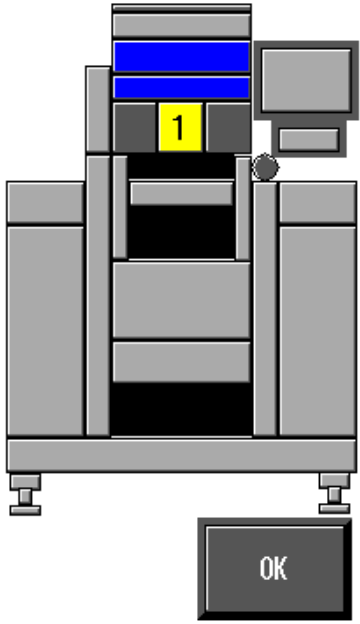
0375-0000

*The machine can operate in DP Mode only.

*Open the front cover,
Pull out the printer #4(B-Label)

[Error content]	Produce in DP mode
[Detail]	There are three labels issued for each product with a bottom label. Regular + Additional label + Bottom label
[Solution]	[OK] button
[Remarks]	This error only occurs in variation with a bottom applicator
[Cause]	The machine is not in DP mode.
[Response]	<ol style="list-style-type: none"> 1. Is the front cover open? 2. Is the bottom applicator not set?
