WM-4000 AUTOMATIC WRAPPER

Error Codes and Solutions

400 – 499

Ishida WM-4000 Error Codes and Solutions (400-499)

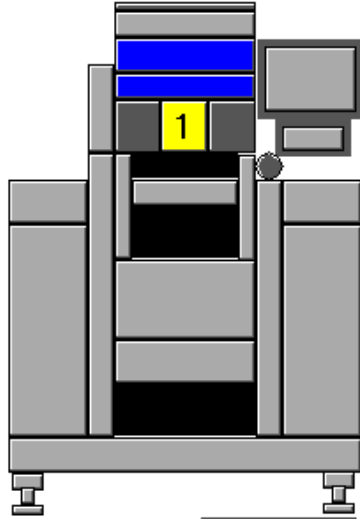
0410-0000

[Error content]	Lift motor error
[Detail]	Lift motor operation did not finish normally. Sub-error meanings are as follows: 0001 : Operation wasn't completed when the operation protection timer ran out.
[Solution]	[RETURN] button
[Remarks]	
[Cause]	There is a load on the lift drive motor and operation did not finish in the normal amount of time.
[Response]	Perform lift test in test mode and check the mechanism to confirm the motor can move freely.

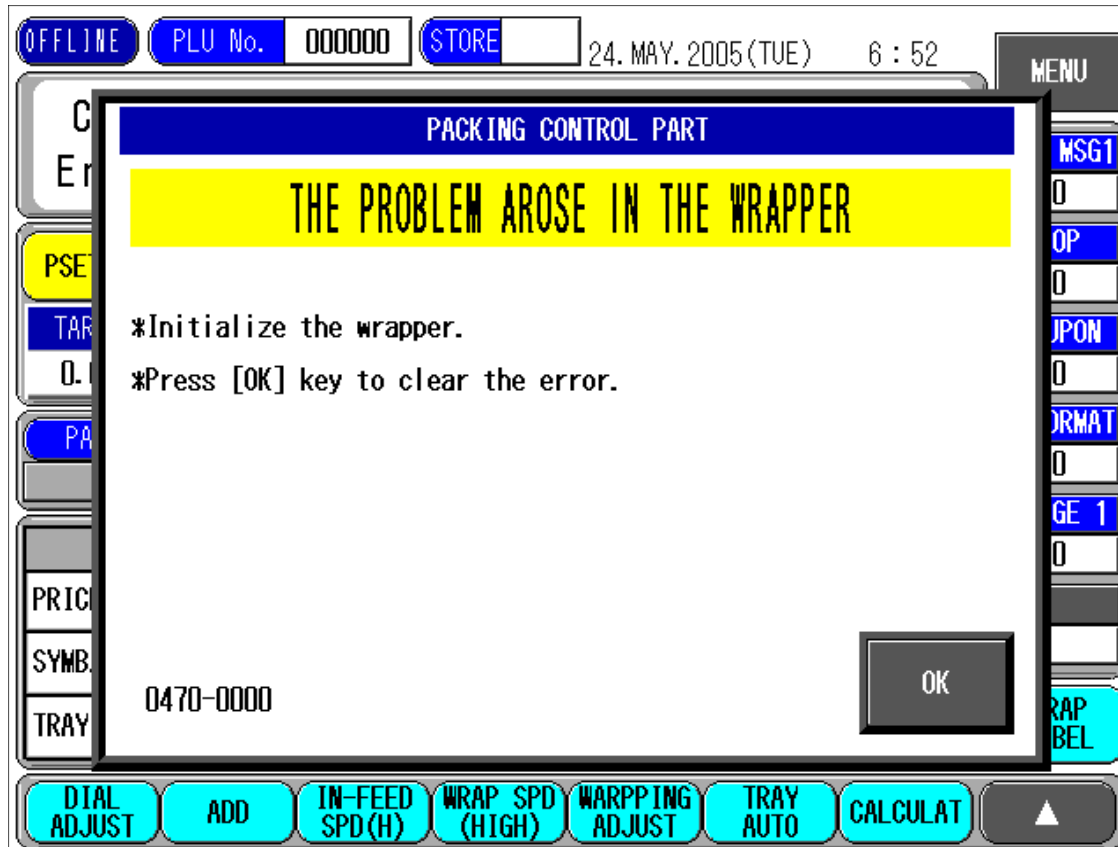
0470

[Error content]	Wrapper is not initialized.
[Detail]	Wrapper E2ROM is not initialized (Stored E2ROM checksum error).
[Solution]	[OK] button
[Remarks]	Initialize wrapper in test mode wrapper settings after cancelling the error.
[Cause]	E2ROM checksum stored for the wrapper error.
[Response]	<ol style="list-style-type: none"> 1. Initialize wrapper in test mode wrapper settings. 2. If the same error re-occurs, P-920 malfunction

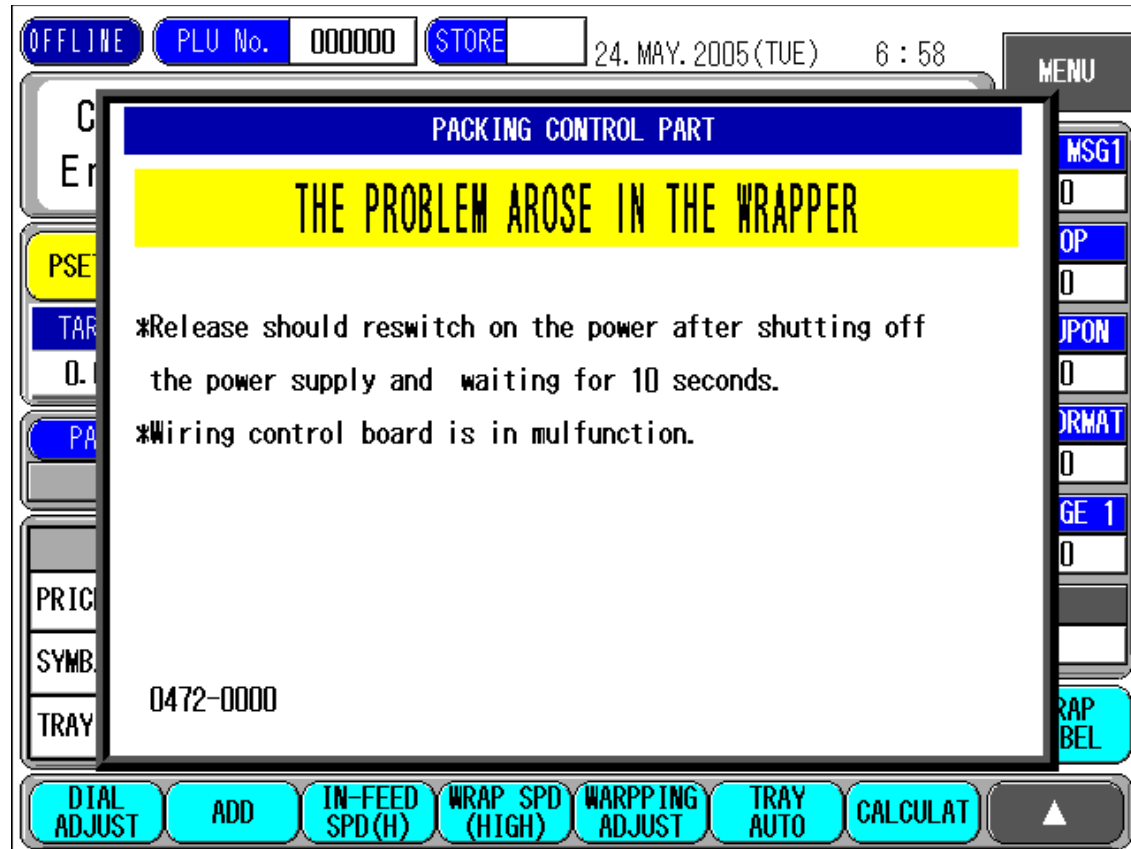
0472

[Error content]	Wrapper wiring board abnormality	
[Detail]	A communication abnormality occurred in the wiring communication LSI Parent (wrapper control board: P-920) and child (board: P-921 or P-922).	
	Sub-error represents address bit mask of the location of the abnormality.	
	Locations of abnormalities are as follows:	
	0001-0255	Communication is abnormal with one of the following: Film roll control (right) (P-922) Feeder mover control (rear) (P-922) Feeder mover control (front) (P-922)
0257-0511	Communication is abnormal with one of the following: Heater control (P-922) Bottom applicator (P-922) PS-EMZ (P-922 x 2 boards)	
0513-0767	Communication is abnormal with one of the following: Infeed unit (P-921) Film roll control (left) (P-922)

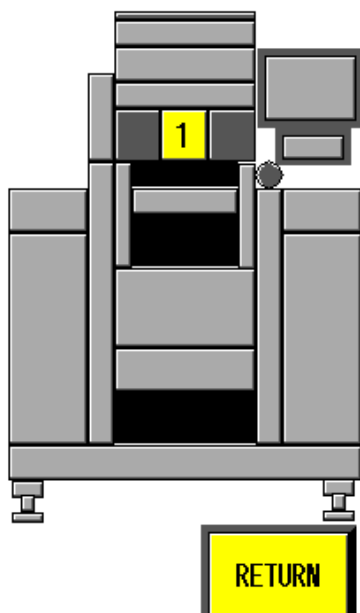
0487-0000

[Error content]	Label application timing for a product with a b-label was achieved, but printer solenoid did not allow the ON signal.
[Detail]	Same as above
[Solution]	[RETURN]
[Remarks]	<ul style="list-style-type: none"> • This only occurs in variations with b-label printers • Check signal line between the wrapper and b-label printer. Wiring [P-910:XJ1 - P-922:XJ13]
[Cause]	<ol style="list-style-type: none"> 1. B-label pasting signal was not confirmed. 2. The wrapped product was not delivered to the discharge conveyor.
[Response]	<ol style="list-style-type: none"> 1. In the case of a disconnected signal wire between the wrapper and b-label board, connect the wire. 2. Respond by investigating the reason why the product was not sent.

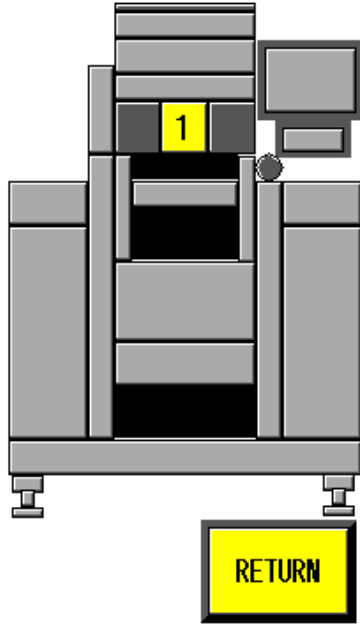
0488-0000

[Error content]	Bottom label pasting signal could not be confirmed.
[Detail]	Pasting signal line between the wrapper and b-label board disconnected. Wiring [P-910:XJ11 - P-922:XJ13]
[Solution]	[RETURN] button
[Remarks]	Possible to discharge products in the wrapper by pressing the [PLU] key
[Cause]	1. Bottom label pasting signal could not be confirmed. 2. The wrapped product was not sent to the discharge conveyor.
[Response]	1. In the case of a disconnected signal wire between the wrapper and b-label board, connect the wire. 2. Respond by investigating the reason why the product was not sent.

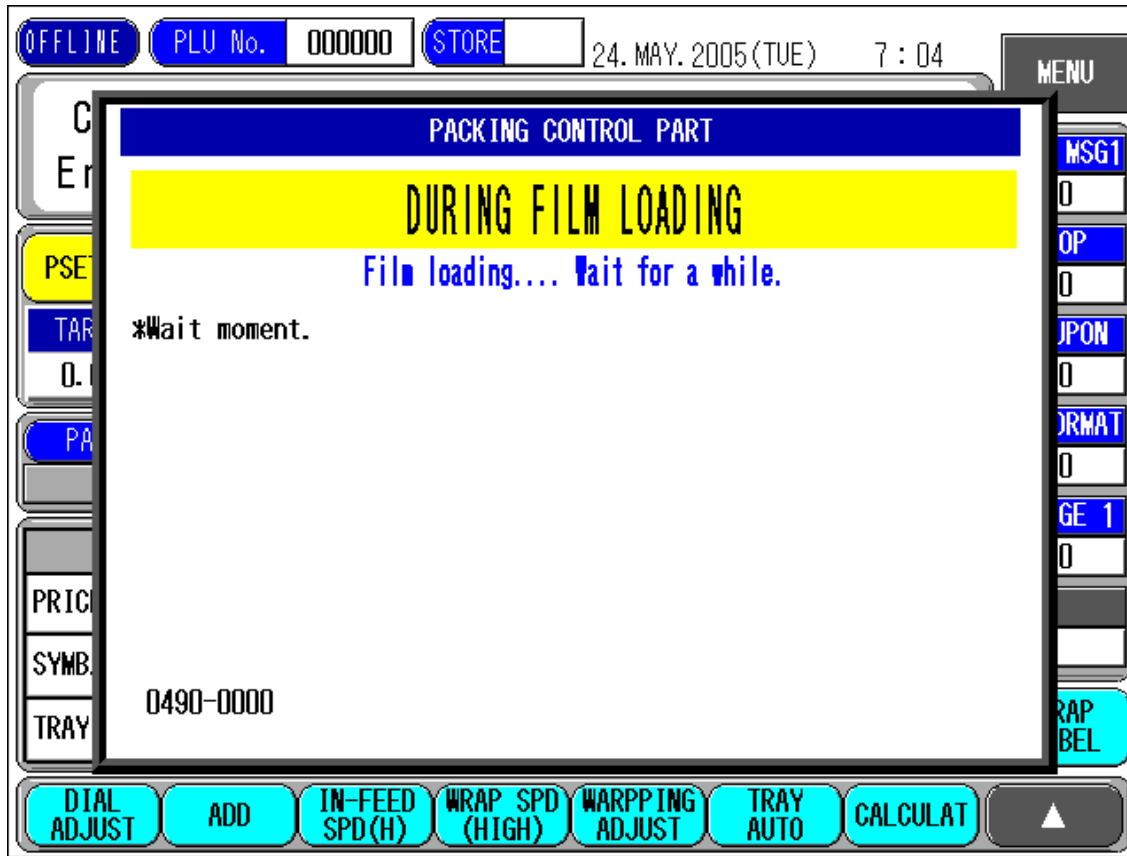
0490

[Error content]	Initiating film loading
[Detail]	Film loading operation initiated after film loading procedure completion. Film loading operation began after pressing the film set button.
[Solution]	Ends automatically after film loading has completed
[Remarks]	
[Cause]	Film loading initiated.
[Response]	Ends automatically after film loading has completed.

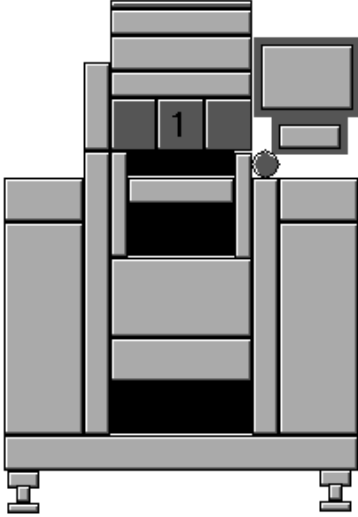
0491-0000

[Error content]	Film loading was completed.
[Detail]	Film loading was completed.
[Solution]	Open the film removal door, remove film, and close the door
[Remarks]	
[Cause]	Film loading was completed.
[Response]	Open the film removal door, remove film, and close the door

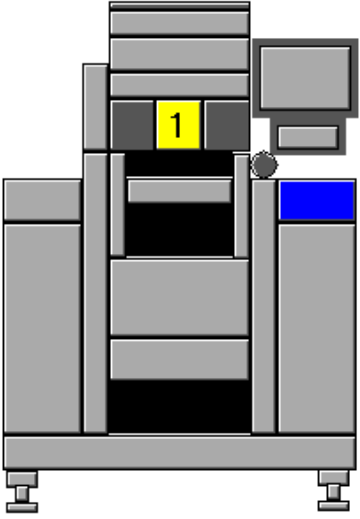
0492-0000

[Error content]	Film removal operation was completed.
[Detail]	
[Solution]	Open RIGTH(LEFT) film removal door. Remove the filme. Close filme removal door and release.
[Remarks]	
[Cause]	
[Response]

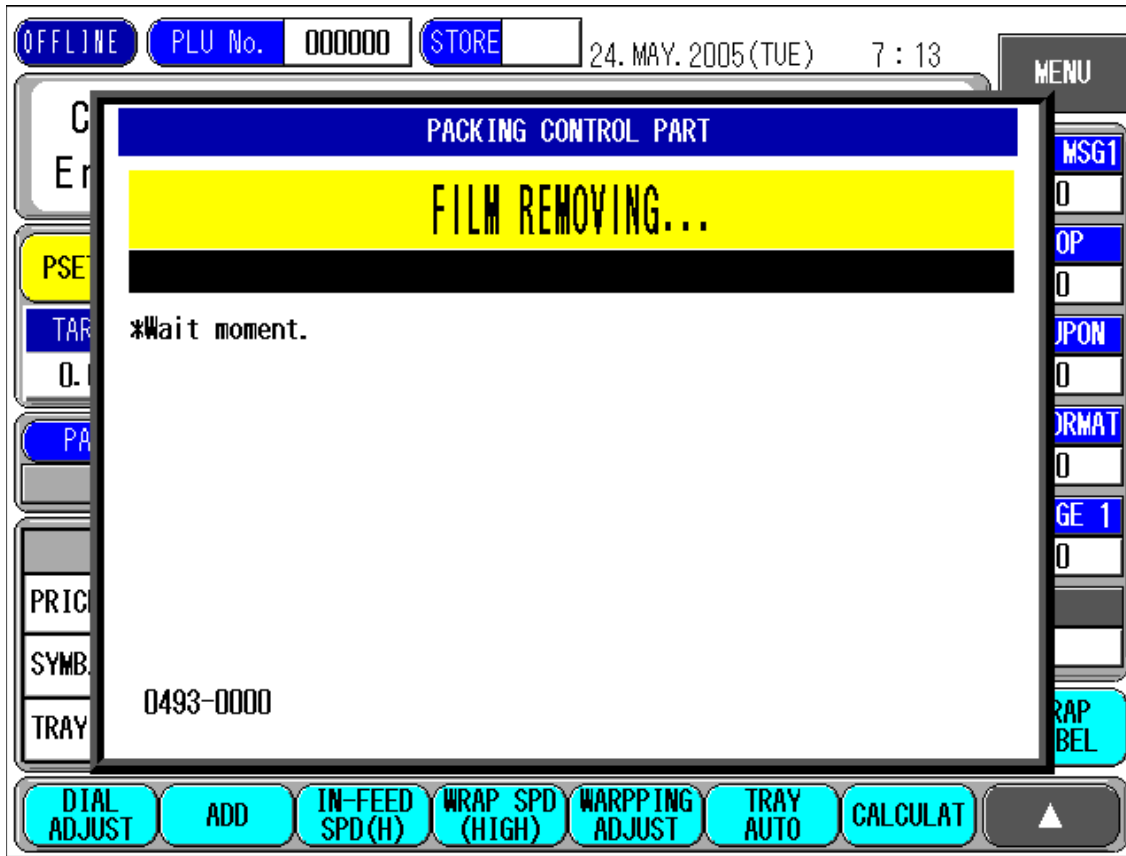
0493

[Error content]	Removing film
[Detail]	Return necessary (when film removal is needed) and necessary film removal when film removal operation has begun.
[Solution]	Ends automatically after film is removed
[Remarks]	
[Cause]	Return necessary (when film removal is needed) and necessary film removal when film removal operation has begun.
[Response]	Ends automatically after film is removed.

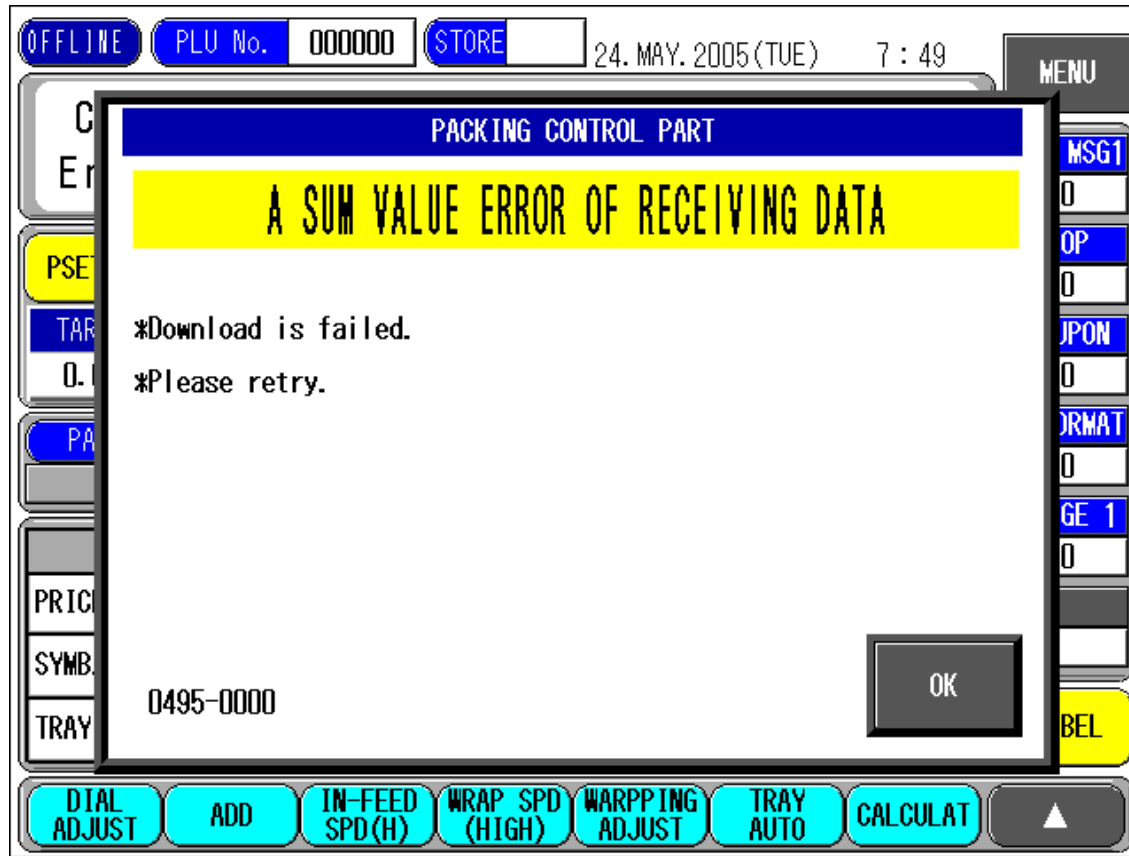
0495

[Error content]	Data sum downloaded from the wrapper is abnormal
[Detail]	The program data sum value received from the wrapper is different from the sum value in the message.
[Solution]	[OK] button
[Remarks]	Needs to be re-downloaded
[Cause]	The program data sum value received from the wrapper is different from the sum value in the message.
[Response]	Re-download.

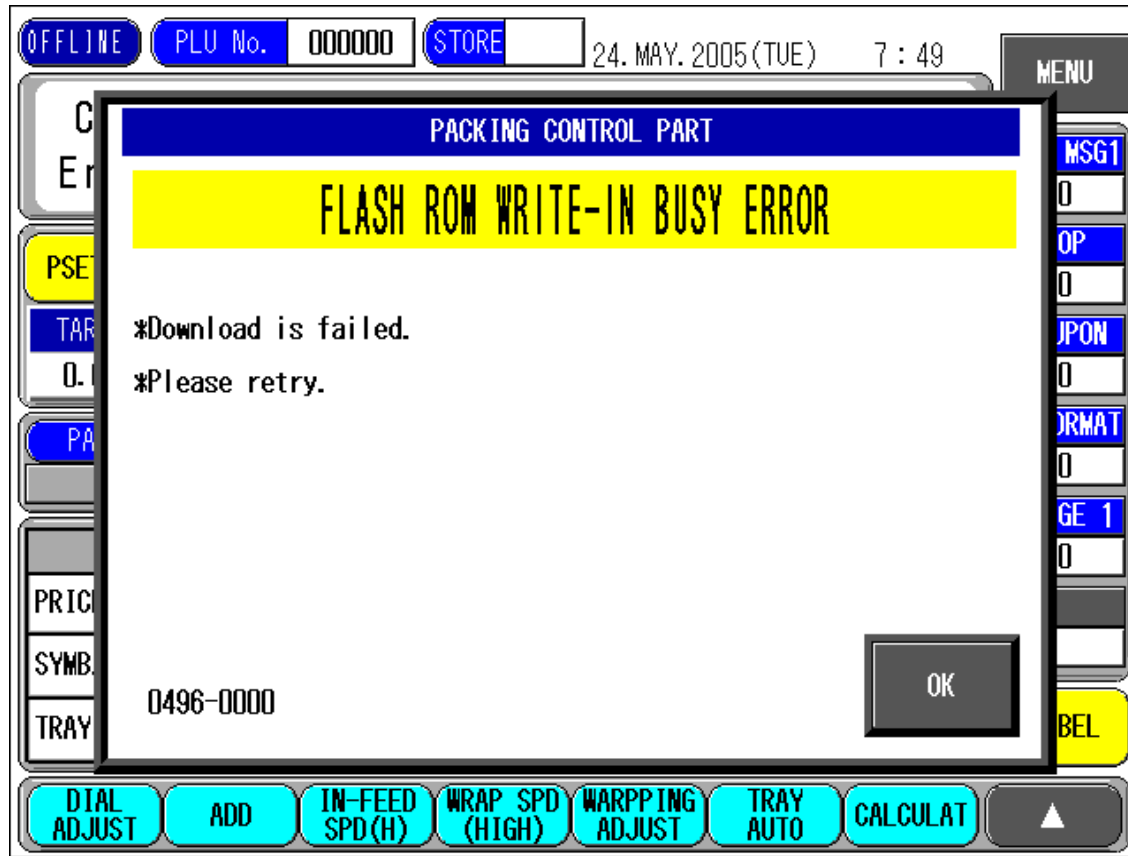
0496

[Error content]	Flash ROM write condition exceeded the specified time amount
[Detail]	Does not change even if the flash ROM write condition exceeds the specified time amount in wrapper application program download.
[Solution]	[OK] button
[Remarks]	Need to re-download.
[Cause]	Flash ROM write error in program data received by the wrapper.
[Response]	Re-download. If the same error re-occurs, the P-920 board can be considered malfunctioning.

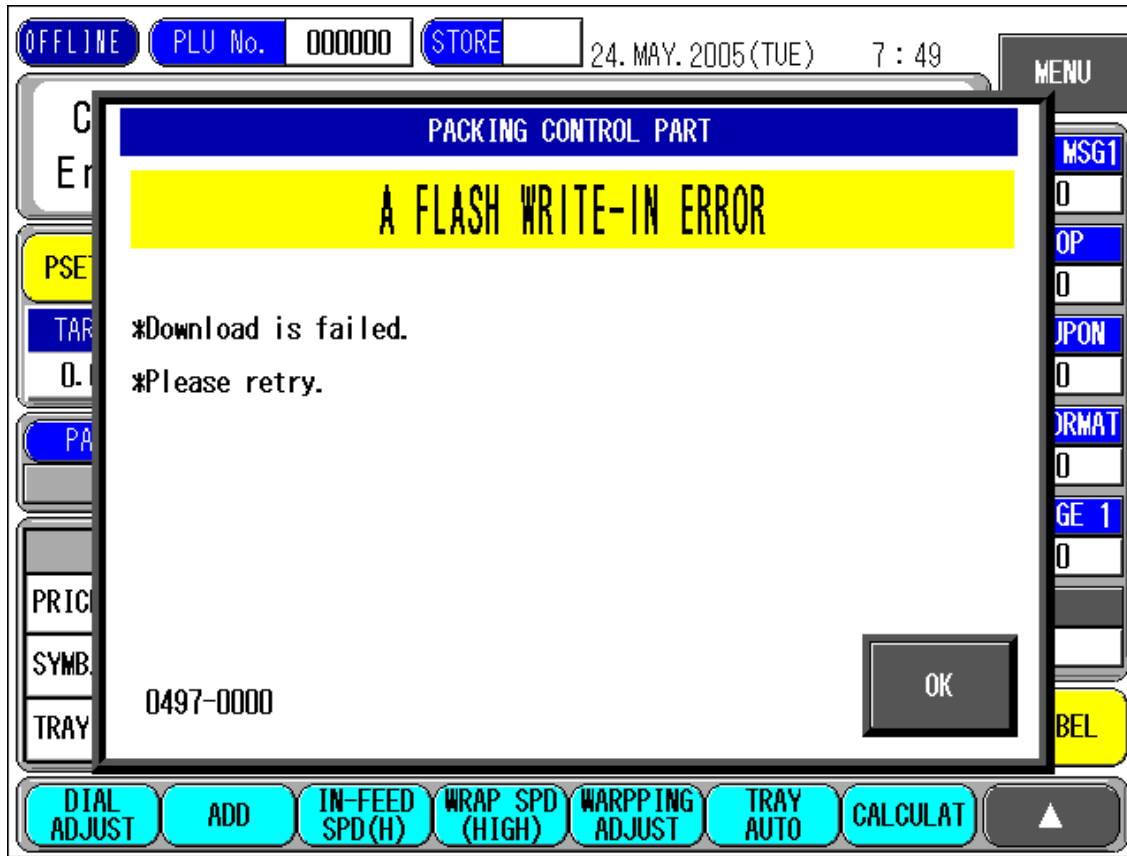
0497

[Error content]	Flash ROM write-in error in wrapper program download.										
[Detail]	<p>An error occurred when writing program data received from the wrapper to the flash ROM. Sub-error meaning are as follows:</p>

0001	Flash ROM erasure failure.	0002	Application program flash ROM write-in failure.	0003	Application program sum value flash ROM write-in error.	0004	Message sequence extending to flash ROM write-in is mismatched.	0005	Received a download command even though it is not in boot mode (during application program operation).
0001	Flash ROM erasure failure.										
0002	Application program flash ROM write-in failure.										
0003	Application program sum value flash ROM write-in error.										
0004	Message sequence extending to flash ROM write-in is mismatched.										
0005	Received a download command even though it is not in boot mode (during application program operation).										
[Solution]	[OK] button										
[Remarks]	Need to re-download.										
[Cause]	An error occurred when writing program data received from the wrapper to the flash ROM.										
[Response]	Re-download. If the same error re-occurs, the P-920 board can be considered malfunctioning.
