# WM-4000 AUTOMATIC WRAPPER

## Error Codes and Solutions

600 – 2099

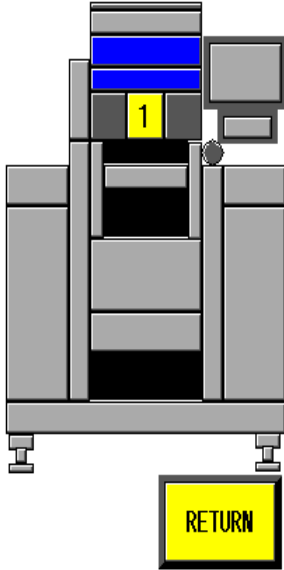
0612-0000

[Error content]	Label could not be pasted to the commodity.
[Detail]	Pasting timing signal was not received.
[Solution]	[RETURN] button
[Remarks]	Pasting is carried out by the pasting timing signal sent from board P-920 and received by P-916. This signal was not received.
[Cause]	Pasting timing signal from board P-920 was not received.
[Response]	1. Cable disconnected between P-920(XJ35) -> P-916(XJ-18). 2. Replace board P-920 3. Replace board P-916

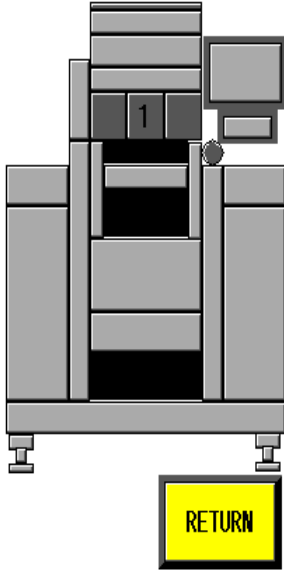
0614-0000

[Error content]	A hand was put inside the front cover.
[Detail]	The applicator safety switch did not receive light during applicator operation.
[Solution]	[RETURN] button
[Remarks]	
[Cause]	Applicator (discharge unit) safety sensor (B25) did not receive light during applicator operation.
[Response]	Service applicator (discharge unit) safety sensor (B25)

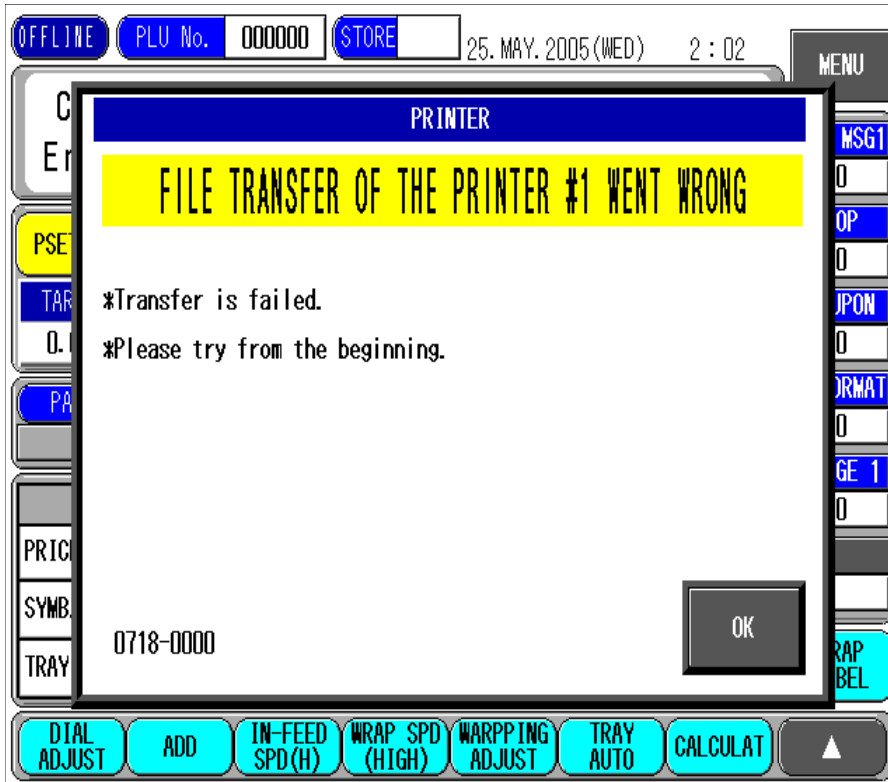
0718

[Error content]	File transfer from the console to the printer failed.
[Detail]	[Sub-error] 0000: No CF card on the printer side. 0001: File failed to open. 0002: File failed to close. 0003: File read failure. 0004: File write failure. 0005: No file.
[Solution]	
[Remarks]	This only occurs in printers #3 and #4 because there is no need to send files to printers #1 and #2.
[Cause]	Error occurs during printing from printers #3 and #4.
[Response]	Respond according to the sub-error.

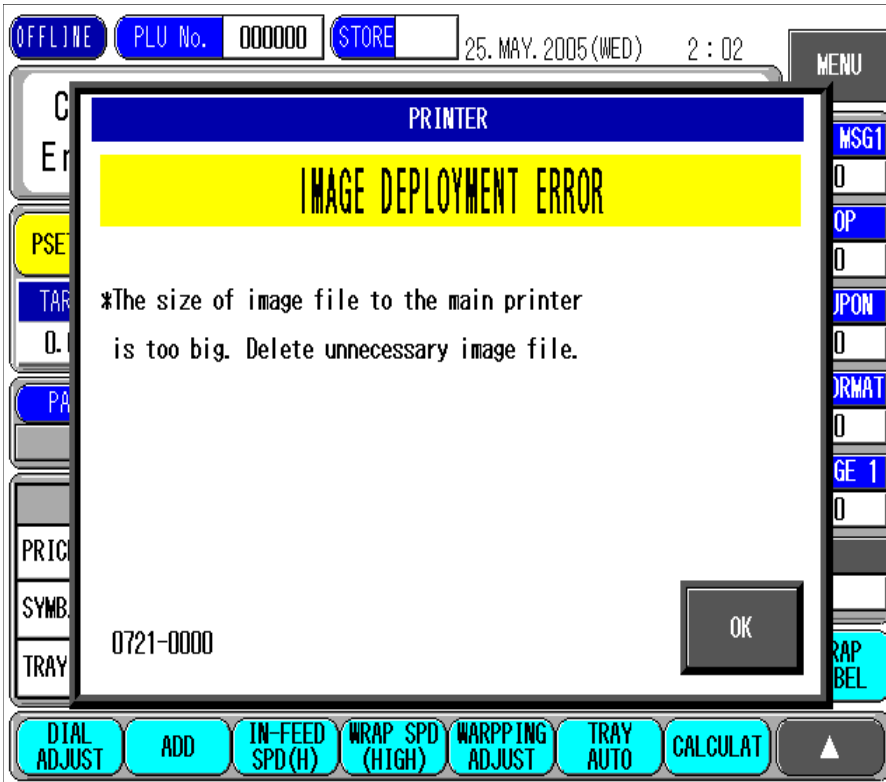
0721

[Error content]	4M exceeded when attempting to exchange the image file internal data.
[Detail]	
[Solution]	[OK] button
[Remarks]	
[Cause]	4M exceeded when attempting to exchange the image file internal data.
[Response]	Delete unnecessary images.

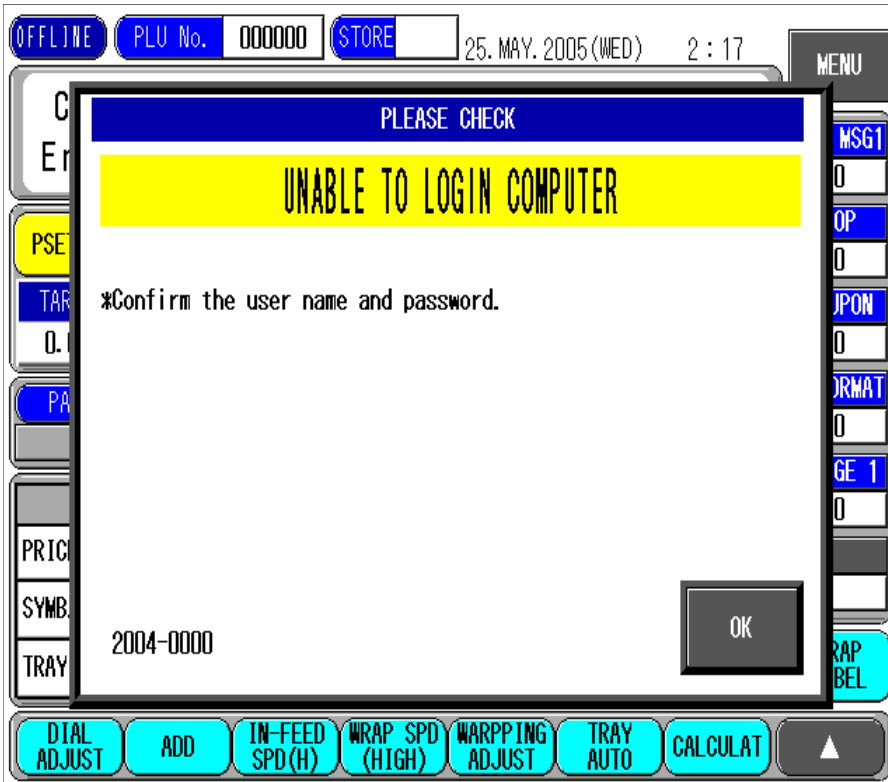
2004

[Error content]	Unable to login to the computer
[Detail]	A error occurred in the authorization process with the computer
[Solution]	OK
[Remarks]	Check user name and password settings.

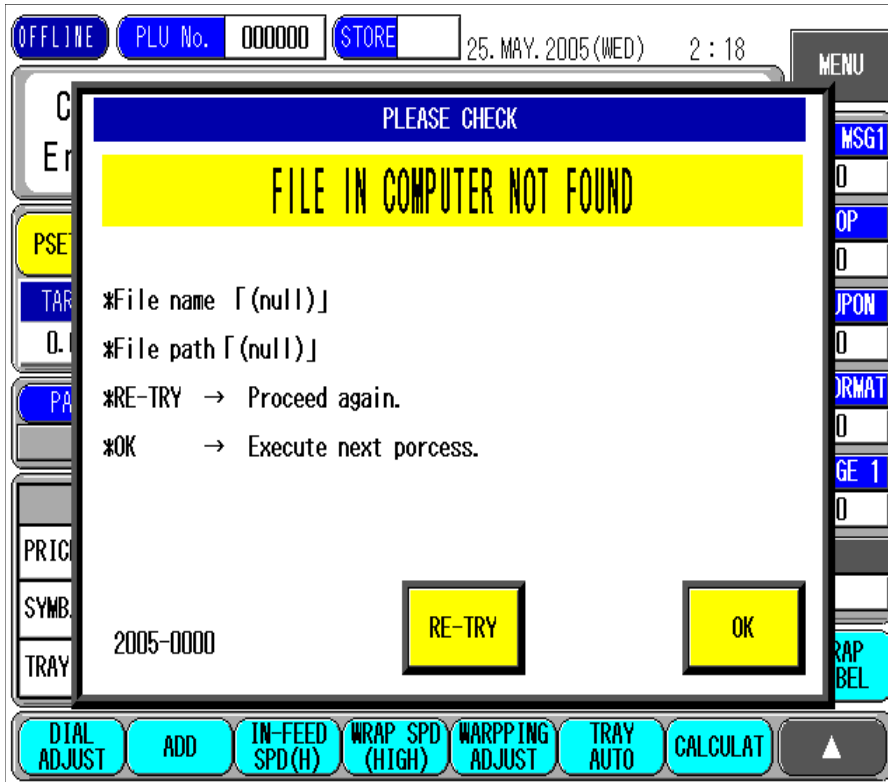
2005

[Error content]	There is no file in the computer
[Detail]	A file in the computer was requisitioned by FTP, but does not exist.
[Solution]	[RETRY], [OK]
[Remarks]	ftpfile.txt and host computer settings are different.

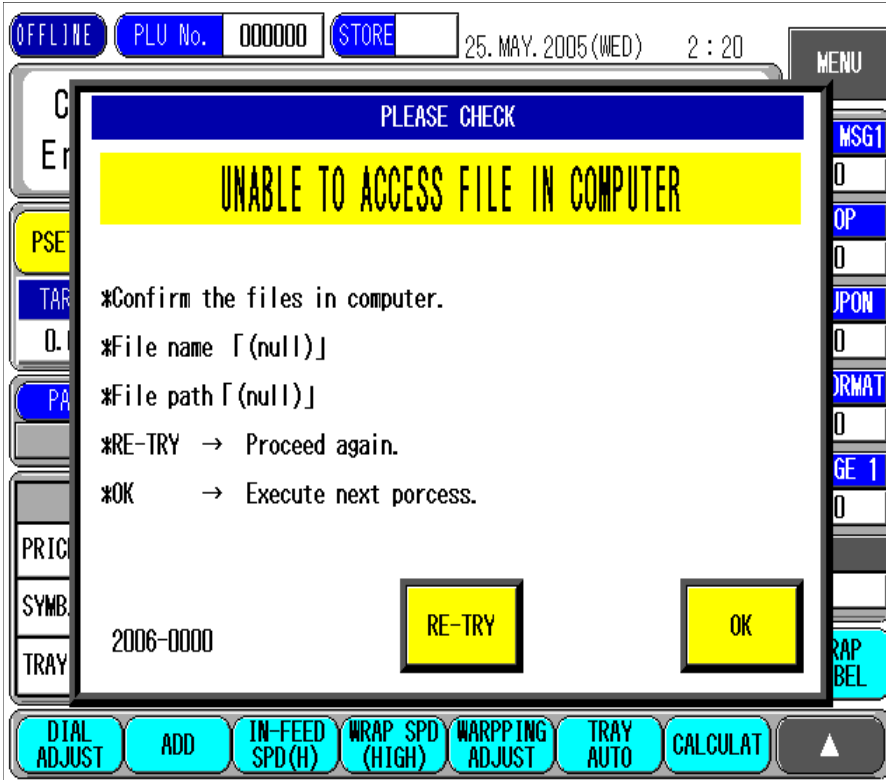
2006

[Error content]	Unable to access file in the computer
[Detail]	Exclusive control is applied to files in the computer and cannot be updated. Check that the file is not open in a different application.
[Solution]	[RETRY], [OK]
[Remarks]

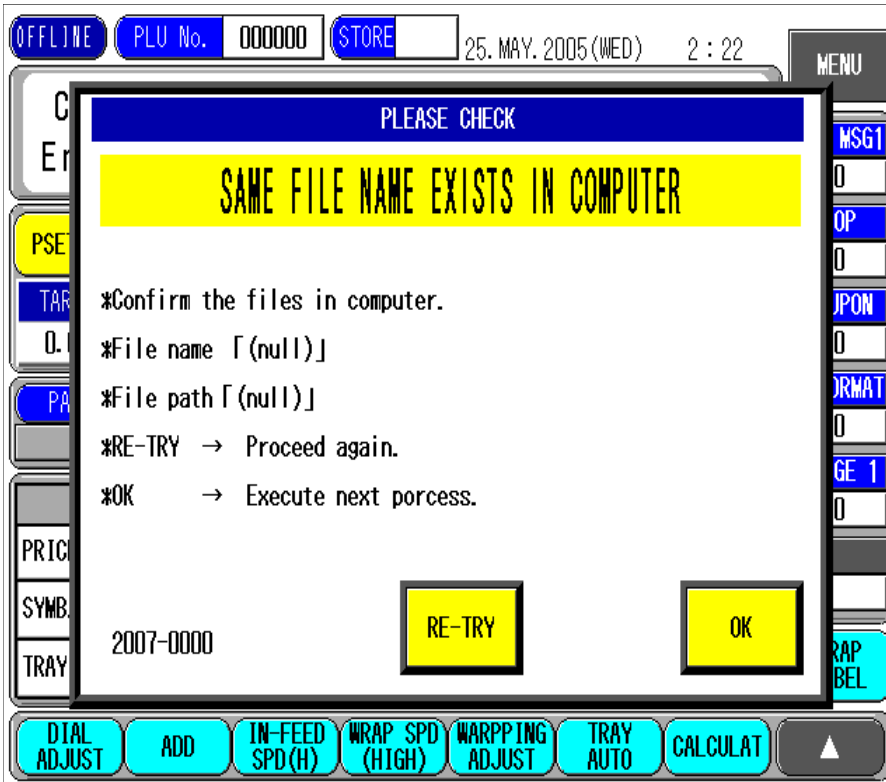
2007

[Error content]	Same file name exists in the computer.
[Detail]	Conditions of this error occurring are: 1) The log is sent as a different transaction 2) The same file name exists in the computer when attempting to send the log file from the scale to the computer.
[Solution]	[RETRY], [OK]
[Remarks]

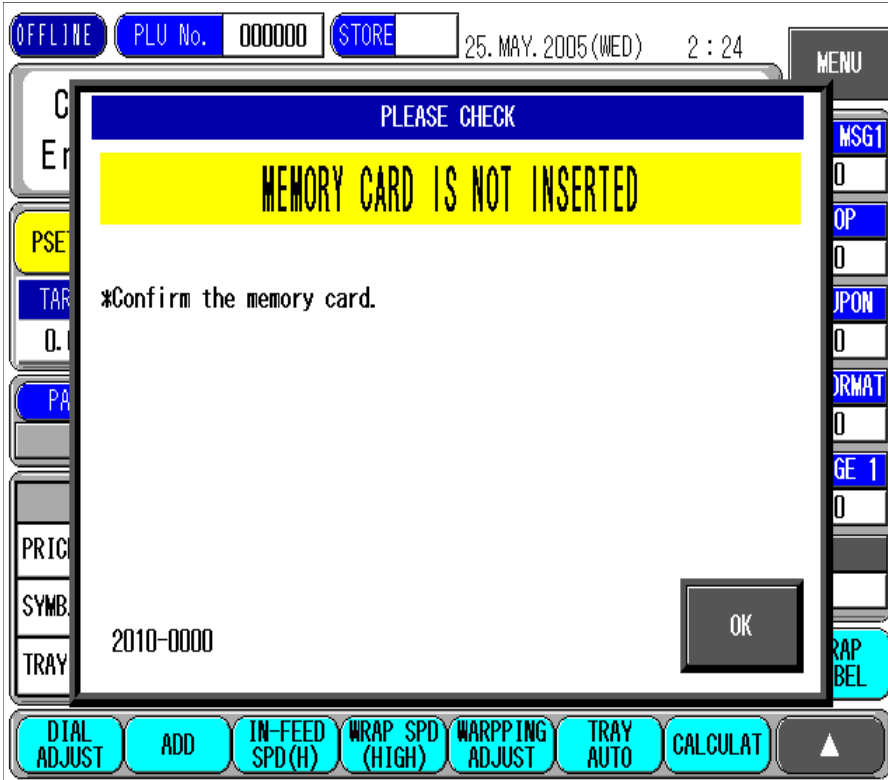
2010

[Error content]	Memory card is not inserted.
[Detail]	
[Solution]	[OK] button
[Remarks]

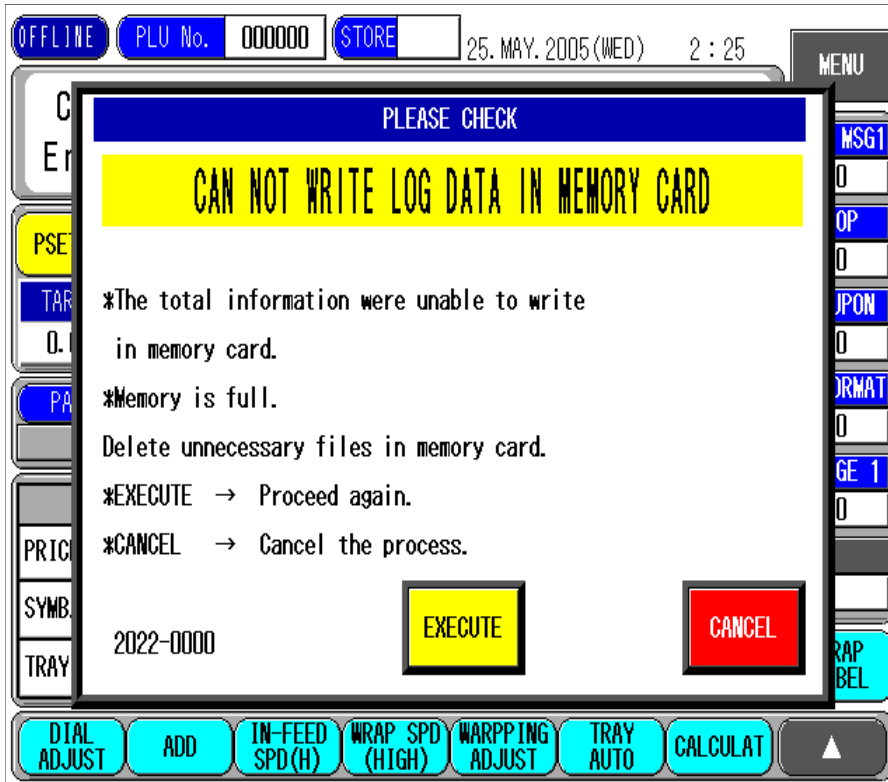
2022

[Error content]	Unable to create log file in the memory card.
[Detail]	Attempted to create log CSV file in the memory card, but the memory card was full.
[Solution]	[EXECUTE], [CANCEL]
[Remarks]
